AAIB Reference Number: EW/C2008/01/01

Aircraft Type and Registration: Boeing 777-236, G-YMMM

Date & Time: 17 January 2008 at 1243 hrs

Title: Accident to Boeing 777-236, G-YMMM at London Heathrow Airport on 17 January 2008

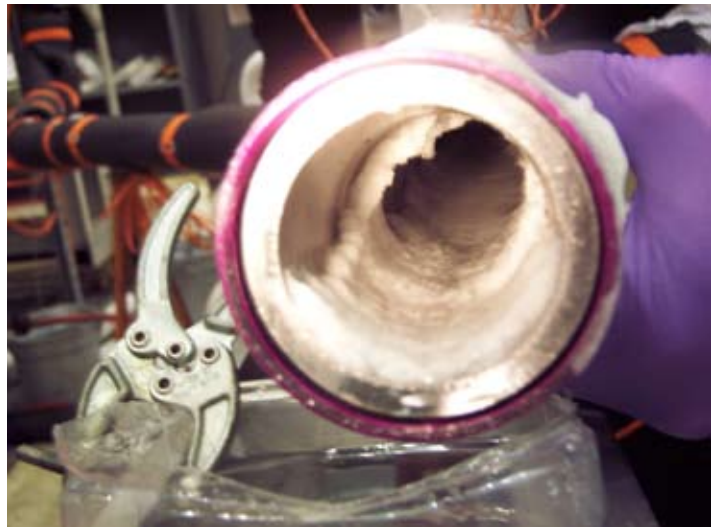
Figure 1

- Very little ice formed on the inside of the fuel feed pipes when the fuel temperature was at -34°C (-29°F).
- There was less repeatability in the amount of ice found in the fuel pipes at the end of the accumulation runs when the duration was increased from 3 to 6 hours. Several tests were carried out, using the same batch

of fuel, at a fuel temperature of -20°C (-4°F) with quite different results. The amount of ice within the system ranged from very little ice to a build up of approximately 6 mm along the bottom of the pipe and 1 to 2 mm around the circumference of the pipe (Figure 1). However, it is possible that on some of the runs, ice might have been released before the end of the test.

Ice in the flexible hose located at the rear of the strut
