# National Transportation Safety Board

## Safety Recommendation

**Date:** September 29, 2009

**In reply refer to:** A-09-72 through -81  
and A-06-23 (Reiteration)

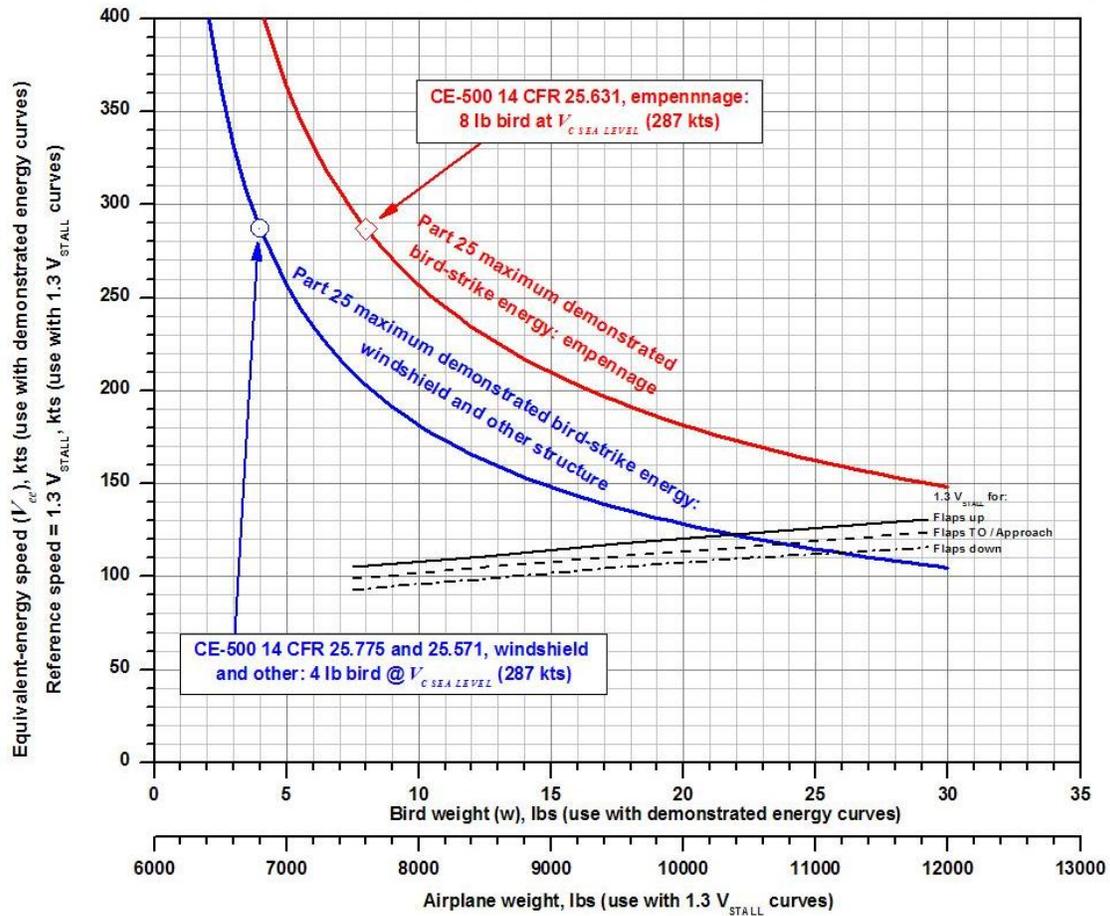
For example, the following figure shows how these two sets of airspeeds can be illustrated for an airplane like the Cessna 500. The figure shows two bird-strike energy speed curves: The blue line corresponds to the certification standard for the airplane’s windshield, wing, and other structures (which are based on an impact from a 4-lb bird at 287 kts), and the red line corresponds to the certification standard for the empennage (which uses an 8-lb bird at 287 kts). The figure also shows the exemplar airplane’s minimum safe airspeed (defined as 1.3 times the stall speed), as a function of weight, in various flap configurations (shown in solid, dashed, or dotted black lines).

**Figure.** Exemplar reference chart showing airplane speed and bird-weight relationships for equivalent bird-strike energy.

Using this chart, if a pilot of the exemplar airplane operating at a gross weight of 11,200 lbs were concerned about the possibility of a collision on the airplane's wing structure with birds as large as 10 lbs during a flaps-up climb, then the pilot might choose an airspeed between about 129 and 180 kts until reaching an altitude where the risk of a bird strike is reduced; the limits of this range represent the airplane's minimum safe airspeed for the specified gross weight and the maximum airspeed that would allow for a collision with a 10-lb bird while remaining below the airplane's bird-strike energy for the wing structure demonstrated in compliance with regulations. Similarly, using the same airplane scenario but assuming a 20-lb bird, the chart shows that the airspeed range for sustaining such a strike narrows considerably to about 129 to 130 kts.

Require aircraft manufacturers to develop aircraft-specific guidance information that will assist pilots in devising precautionary aircraft operational strategies for minimizing the severity of aircraft damage sustained during a bird strike, should one occur, when operating in areas of known bird activity. This guidance information can include, but is not limited to, airspeed charts that depict minimum safe airspeeds for various aircraft gross weights, flap configurations, and power settings; and maximum airspeeds, defined as a function of bird masses, that are based on the aircraft's demonstrated bird-strike energy. (A-09-74)
