National Transportation Safety Board

Safety Recommendation

Date: September 29, 2009

In reply refer to: A-09-72 through -81
and A-06-23 (Reiteration)

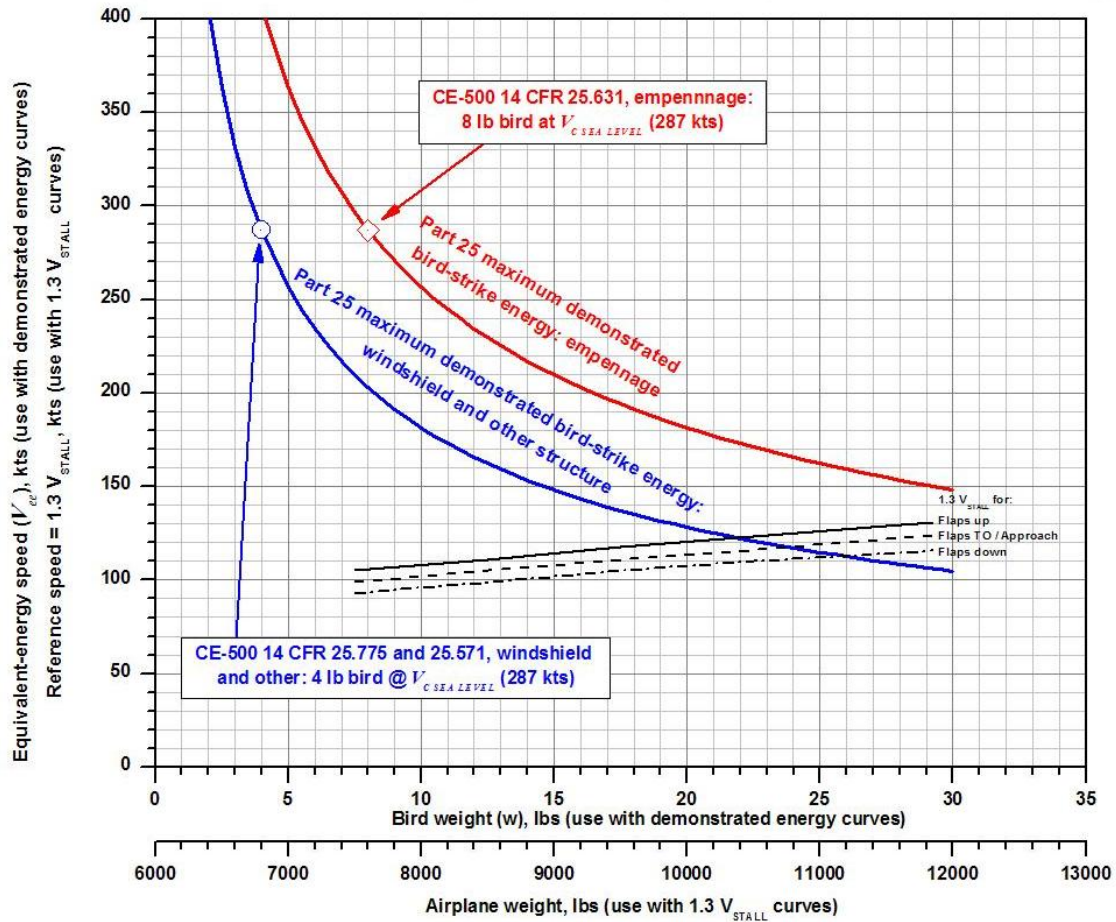
For example, the following figure shows how these two sets of airspeeds can be illustrated for an airplane like the Cessna 500. The figure shows two bird-strike energy speed curves: The blue line corresponds to the certification standard for the airplane’s windshield, wing, and other structures (which are based on an impact from a 4-lb bird at 287 kts), and the red line corresponds to the certification standard for the empennage (which uses an 8-lb bird at 287 kts). The figure also shows the exemplar airplane’s minimum safe airspeed (defined as 1.3 times the stall speed), as a function of weight, in various flap configurations (shown in solid, dashed, or dotted black lines).

Figure. Exemplar reference chart showing airplane speed and bird-weight relationships for equivalent bird-strike energy.

Using this chart, if a pilot of the exemplar airplane operating at a gross weight of 11,200 lbs were concerned about the possibility of a collision on the airplane's wing structure with birds as large as 10 lbs during a flaps-up climb, then the pilot might choose an airspeed between about 129 and 180 kts until reaching an altitude where the risk of a bird strike is reduced; the limits of this range represent the airplane's minimum safe airspeed for the specified gross weight and the maximum airspeed that would allow for a collision with a 10-lb bird while remaining below the airplane's bird-strike energy for the wing structure demonstrated in compliance with regulations. Similarly, using the same airplane scenario but assuming a 20-lb bird, the chart shows that the airspeed range for sustaining such a strike narrows considerably to about 129 to 130 kts.

Therefore, the NTSB concludes that reference charts that depict both the airspeeds at which the airframe can sustain strikes from various-sized birds without exceeding certification standards and minimum safe airspeeds could help pilots devise precautionary operational strategies for minimizing potential airframe bird-strike damage in high-risk areas for bird strikes. The NTSB further concludes that reliable information about the mass, numbers, and activity of birds likely to be encountered near the airports of operation is necessary for pilots who wish to devise precautionary operational strategies for minimizing potential airframe bird-strike damage. Therefore, the NTSB recommends that the FAA require aircraft manufacturers to develop aircraft-specific guidance information that will assist pilots in devising precautionary aircraft operational strategies for minimizing the severity of aircraft damage sustained during a bird strike, should one occur, when operating in areas of known bird activity. This guidance information can include, but is not limited to, airspeed charts that depict minimum safe airspeeds for various aircraft gross weights, flap configurations, and power settings; and maximum airspeeds, defined as a function of bird masses, that are based on the aircraft's demonstrated bird-strike energy.

Require aircraft manufacturers to develop aircraft-specific guidance information that will assist pilots in devising precautionary aircraft operational strategies for minimizing the severity of aircraft damage sustained during a bird strike, should one occur, when operating in areas of known bird activity. This guidance information can include, but is not limited to, airspeed charts that depict minimum safe airspeeds for various aircraft gross weights, flap configurations, and power settings; and maximum airspeeds, defined as a function of bird masses, that are based on the aircraft's demonstrated bird-strike energy. (A-09-74)
