**ATSB TRANSPORT SAFETY REPORT**

Aviation Occurrence Investigation – AO-2009-012

Preliminary

**Tail Strike  
Melbourne Airport, Vic.  
20 March 2009  
A6-ERG  
Airbus A340-500**

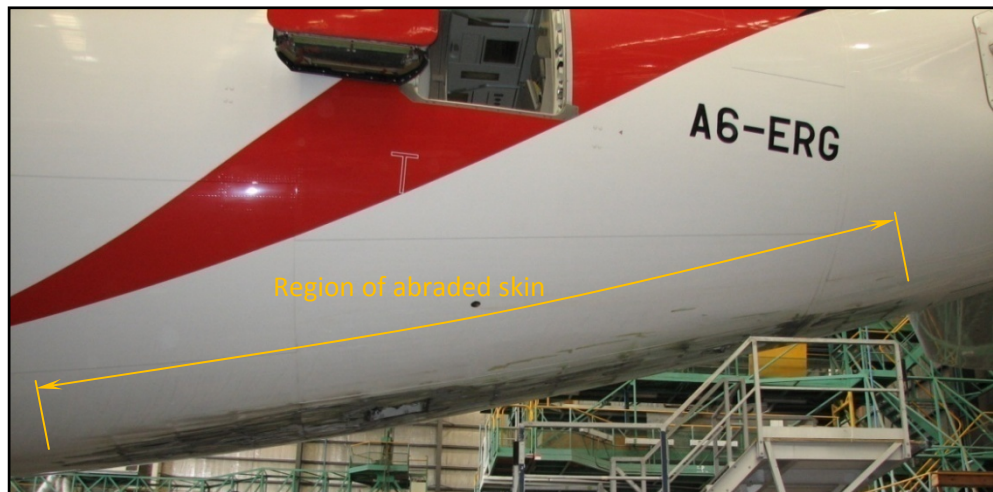
An initial inspection of the aircraft revealed that the rear of the fuselage was seriously damaged<sup>7</sup>. The lower skin panels were abraded by contact with the runway surface (Figure 1), and in some areas the skin had worn through the full thickness (Figure 2). A service panel had been dislodged (Figure 2) and was found by airport personnel at the end of the runway, along with numerous pieces of metal consistent with the abraded skin panels. Numerous fuselage frames and stringers in the region were deformed and several contained cracks (Figure 3). The rear pressure bulkhead<sup>8</sup> contained cracks in the composite structure and deformation of the diaphragm support ring (Figure 4). There were also scrapes on the right side of the fuselage consistent with contact with external objects. One contact mark had an orange colouration and was located forward of the skin abrasion, immediately below the right, rear cargo door (Figure 5). The other contact mark was located adjacent to the skin abrasion and consisted of several, fine, divergent marks running rearwards and slightly upwards (Figure 6). There was also a contact mark on the left main landing gear, inboard rear tyre (Figure 7).

**Figure 1: Skin abrasion**

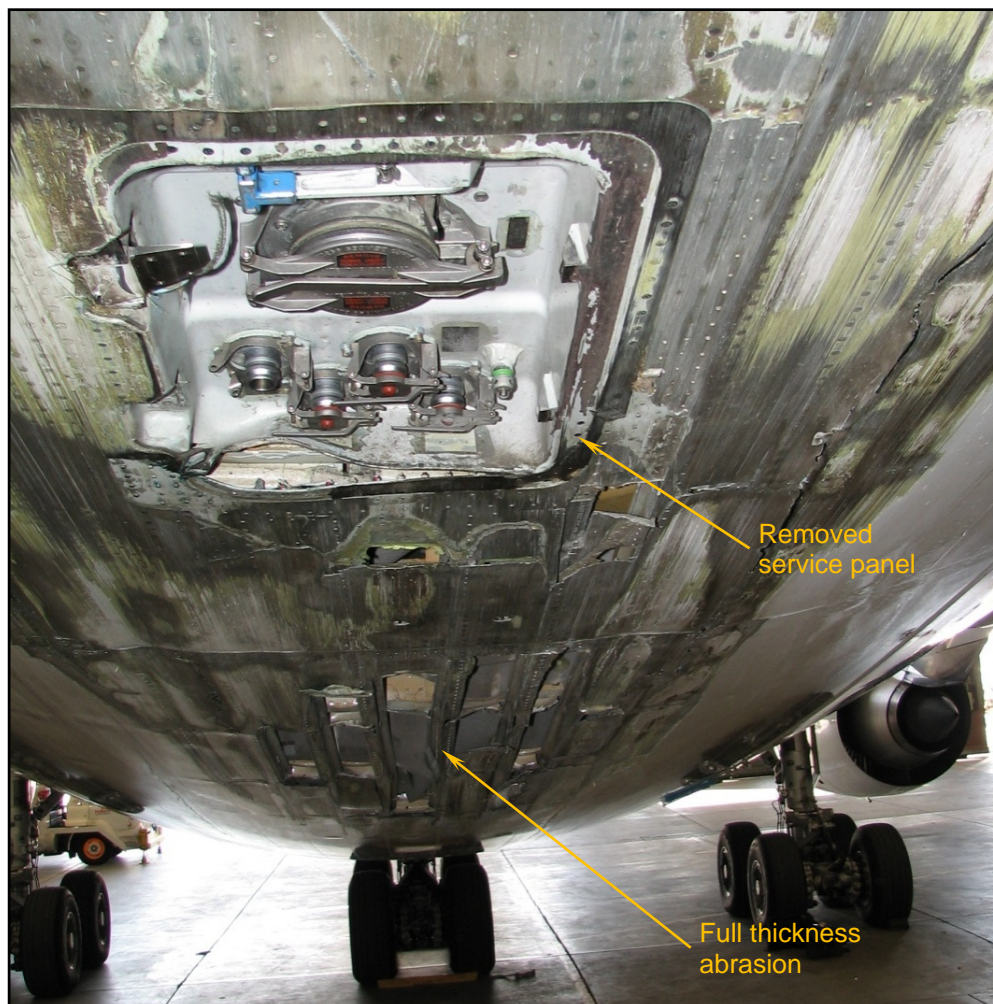
**Figure 2: Skin abrasion detail**

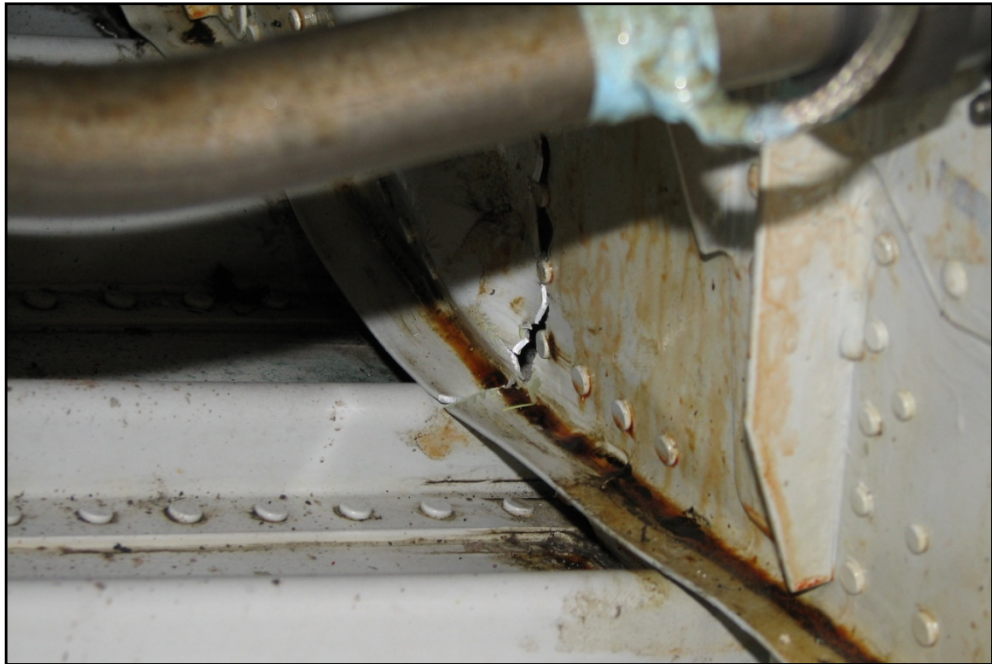
**Figure 3: Example of frame deformation and cracking**

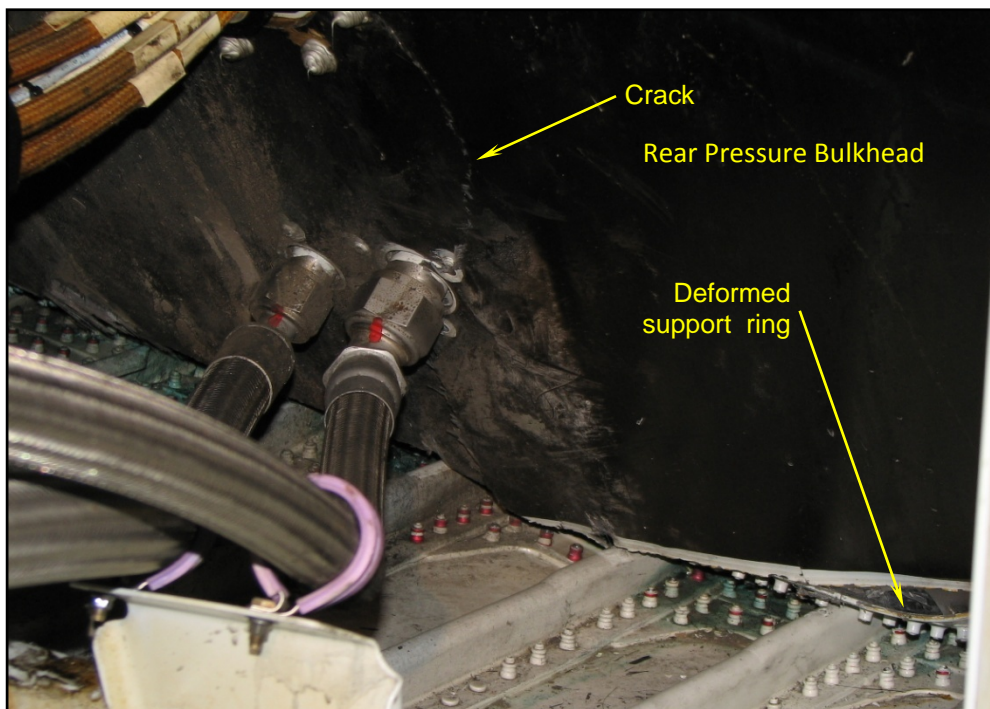
**Figure 4: Example of rear pressure bulkhead damage**

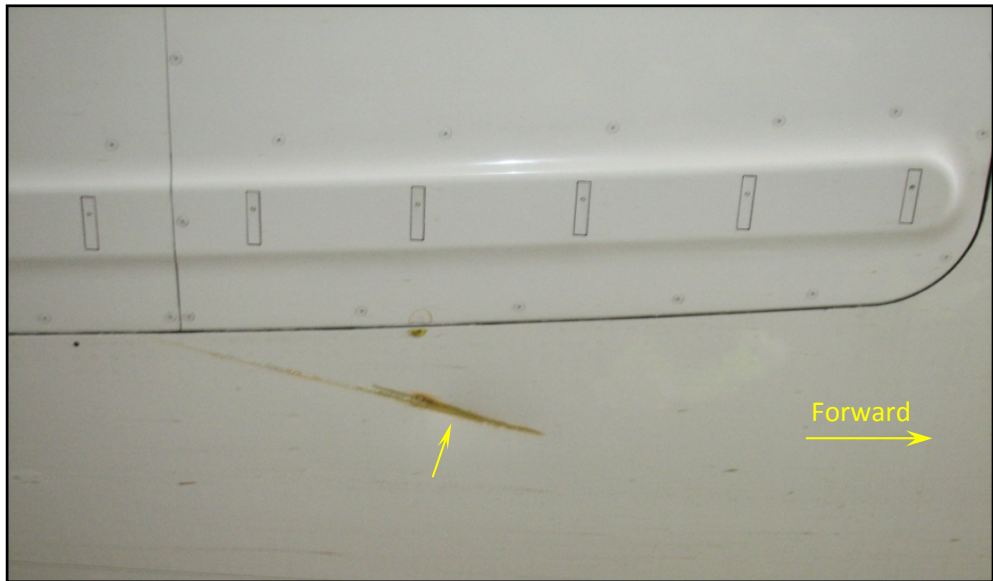
**Figure 5: Contact mark below right, rear cargo door**

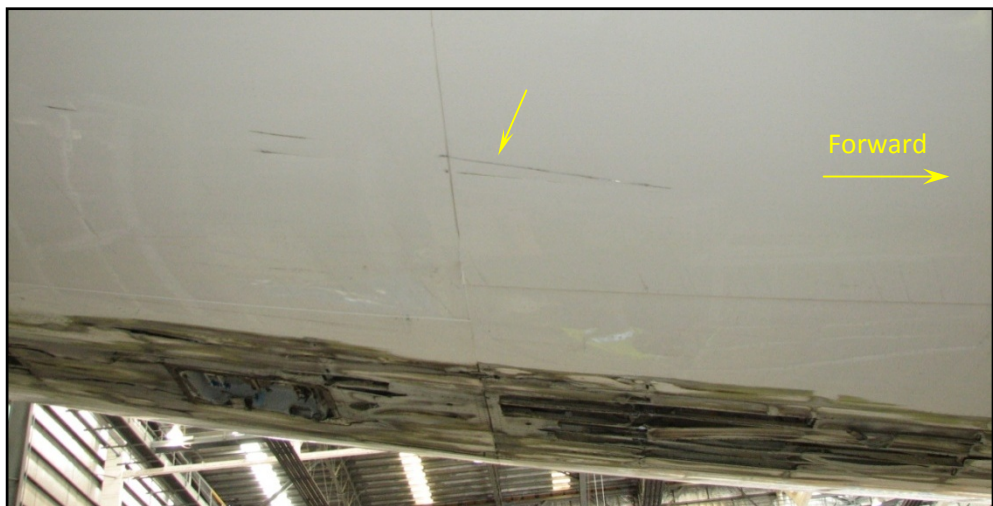
**Figure 6: Contact marks adjacent to skin abrasion**

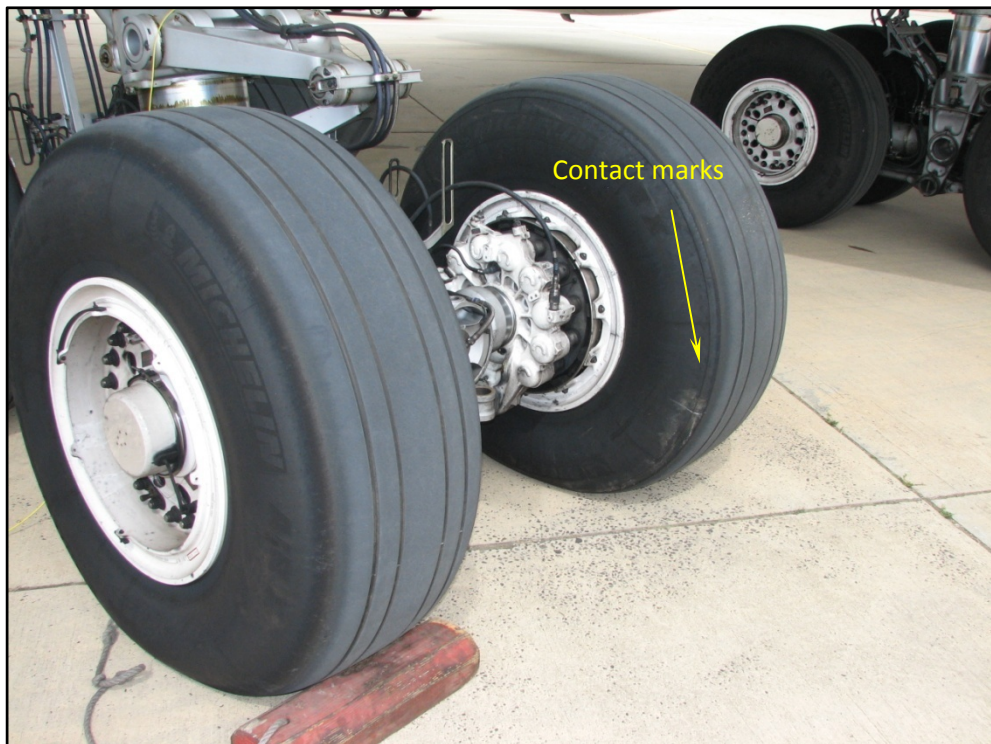
**Figure 7: Contact mark on left main landing gear, inboard rear tyre**

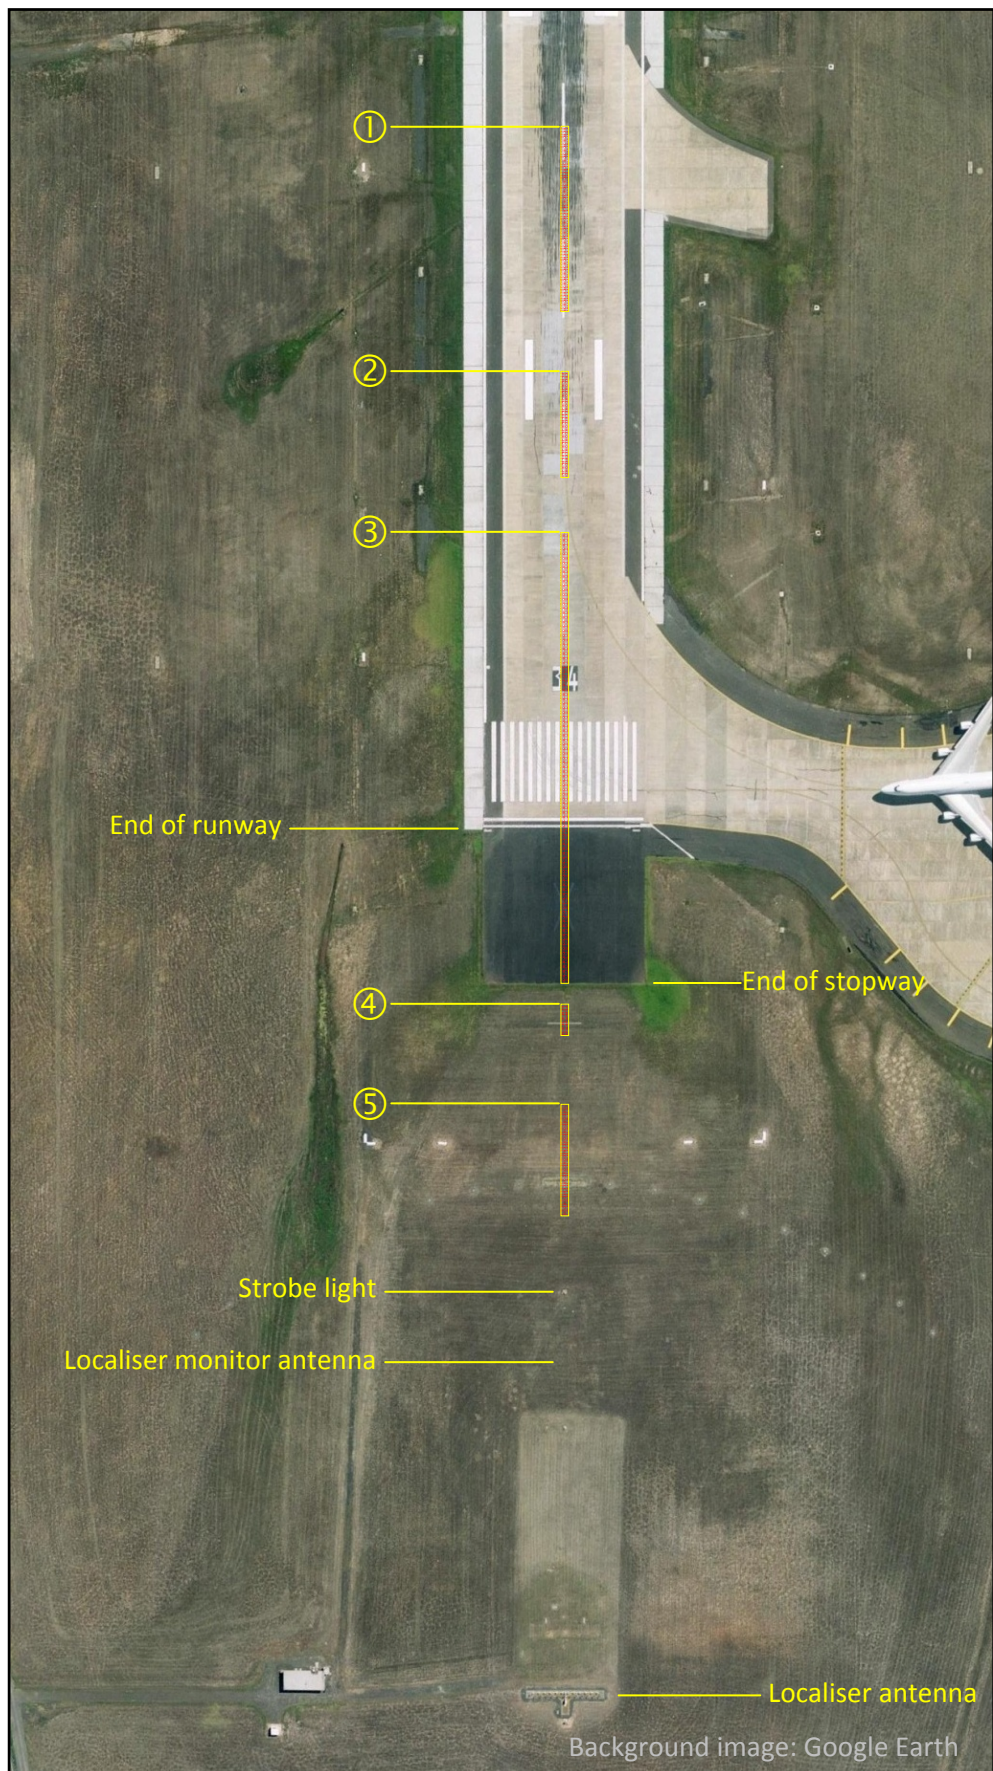
An inspection of the runway and overrun areas identified multiple contact marks (Figure 8). The tail of the aircraft made contact with the runway at three locations, each starting at the positions indicated by ① ② and ③ in Figure 8. After leaving the stopway, two contact marks were identified in the grassed area, indicated by ④ and ⑤ in Figure 8. Figure 9 shows typical ground contact marks. The aircraft also made contact with ground infrastructure; a runway 34 high-intensity approach lighting centreline strobe light (Figure 10), and the runway 16 localiser monitor antenna (Figure 11). The runway 16 localiser antenna (Figure 12) was contacted by the left main landing gear inboard-rear tyre. The damage to the localiser antenna disabled the localiser function.

Figure 8: Ground contact marks

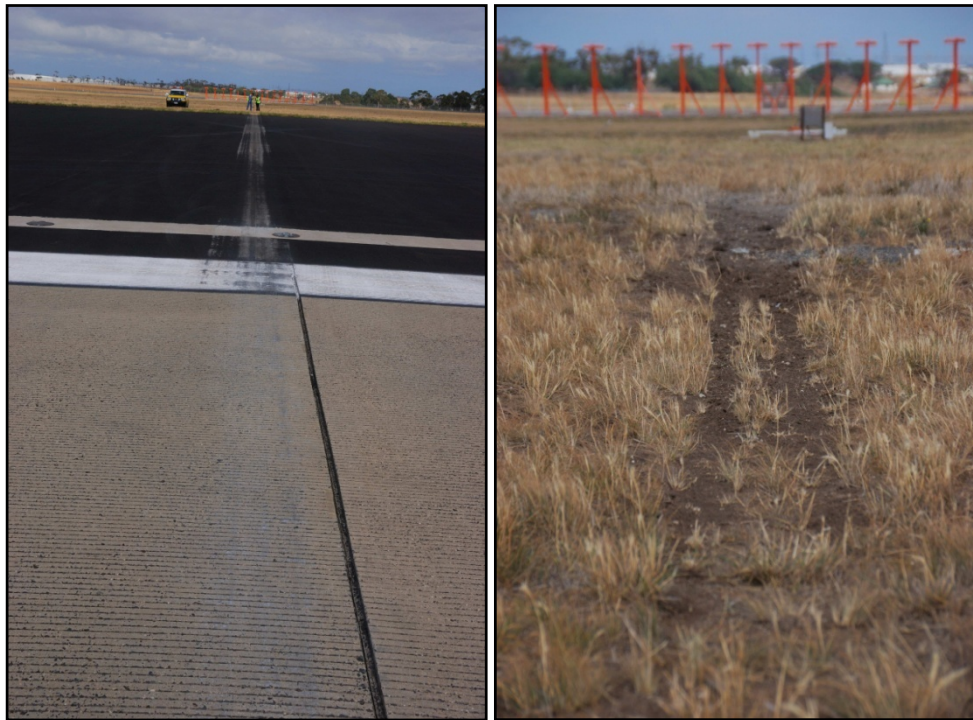
**Figure 9: Typical contact marks on runway, stopway and grassed areas**

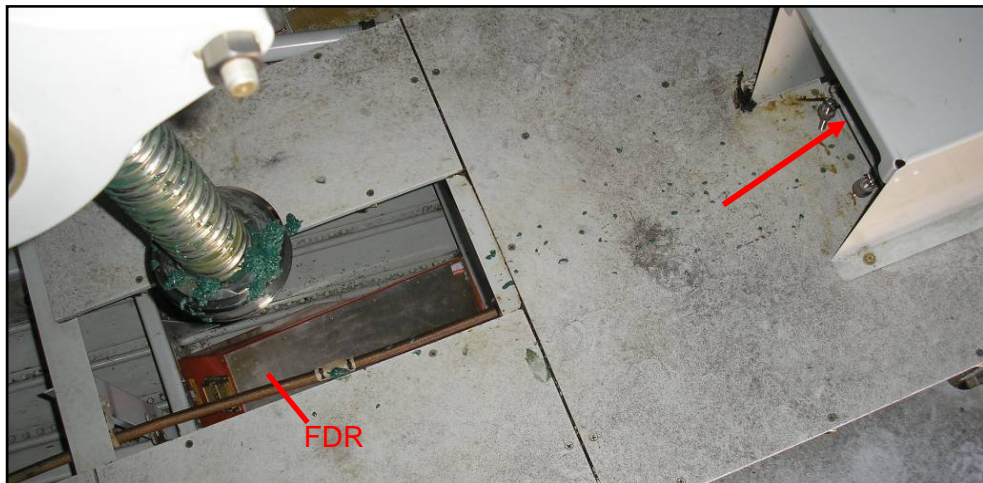
The examination and retrieval of the flight recorders was undertaken under Australian Transport Safety Bureau (ATSB) supervision on 21 March 2009. The FDR had separated from its mounting rack and was located in a small compartment directly to the rear of the mounting rack and adjacent to the tail lower skin.

**Figure 13: Location of FDR as found with FDR mounting rack in view (arrowed)**

The FDR mounting rack displayed evidence of deformation with part of one securing nut found to have also separated from the rack.
