ATSB TRANSPORT SAFETY REPORT

Aviation Occurrence Investigation AO-2008-053

Preliminary

**Depressurisation
475 km north-west of Manila, Philippines
25 July 2008
Boeing Company 747-438, VH-OJK**

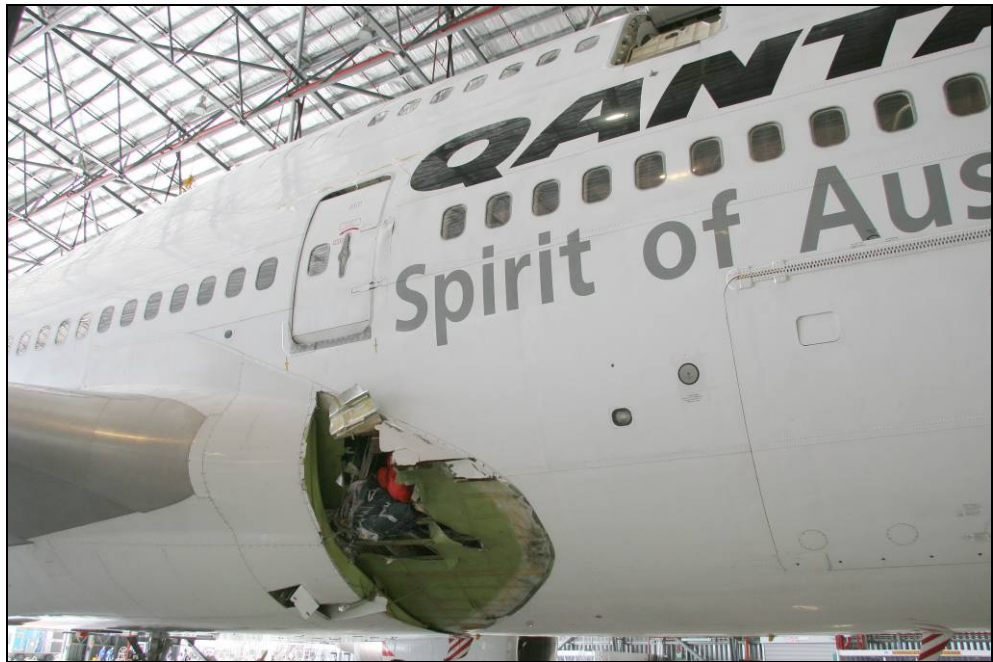
An initial inspection of the external aircraft surfaces on the ground in Manila revealed the complete loss of the right wing forward leading edge-to-fuselage fairing, with separation occurring along the lines of interconnection between the fairing and fuselage skins (Figure 1). In the area exposed by the fairing loss was an inverted T-shaped rupture in the fuselage skin, with several items from within the forward cargo hold partially protruding from the rupture (Figure 2). The approximate vertical centreline of the skin rupture was positioned at fuselage station⁵ (STA) 820, with skin damage extending longitudinally for 79 inches (201 cm), from STA 777 to STA 856. Vertically, the rupture extended for approximately 60 inches (152 cm) between fuselage stringer⁶ 31 at the top, to stringer 38 at the lower extent of the damage. While some of the fuselage skin had folded outward and away from the rupture, it was evident that an area of skin and structure equal to approximately one-half of the total ruptured area had separated from the aircraft and was not recovered. On the basis of measurements taken around the ruptured areas, the total area of the skin rupture was estimated at around 1.74 square metres (2,700

Figure 1: Fuselage rupture – external view

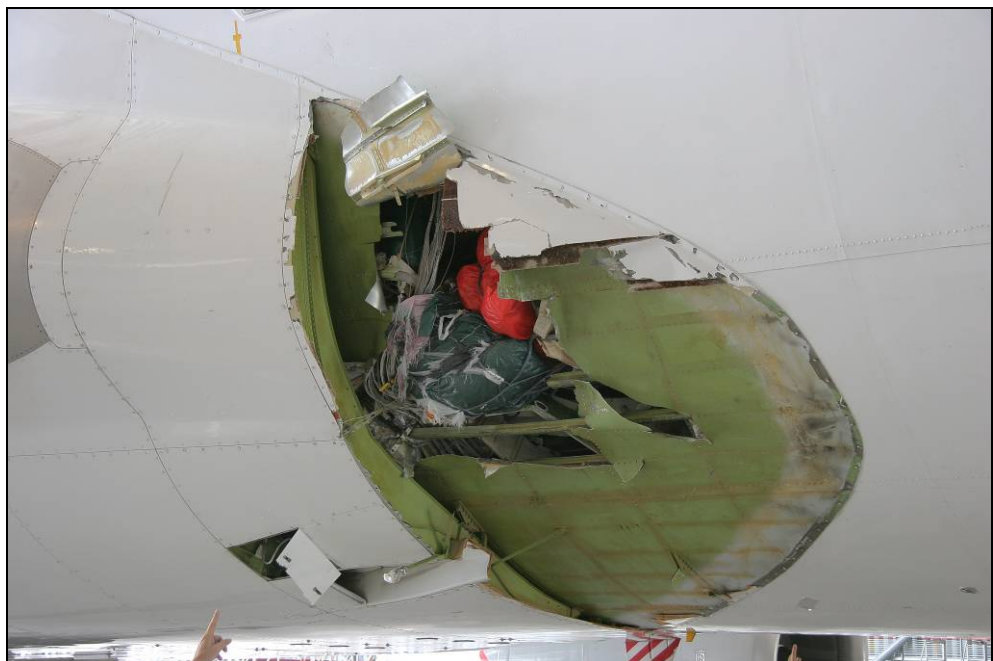
Figure 2: Fuselage rupture with protruding cargo

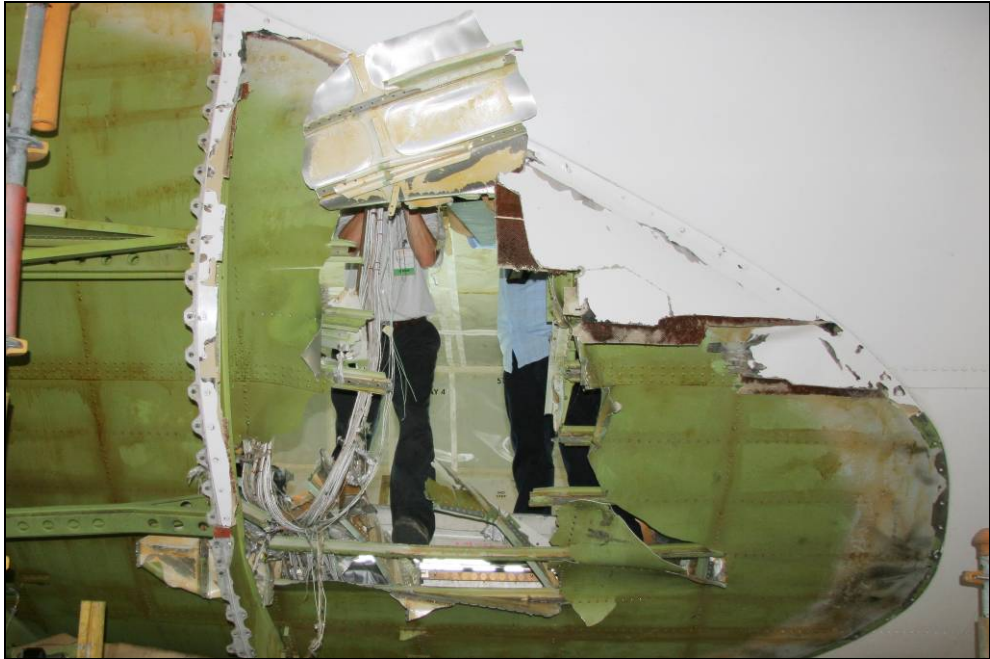
square inches). Figure 3 illustrates the extent of the fuselage rupture as viewed from outside the aircraft.

Figure 3: Extent of the fuselage rupture, after removal of further transition fairings

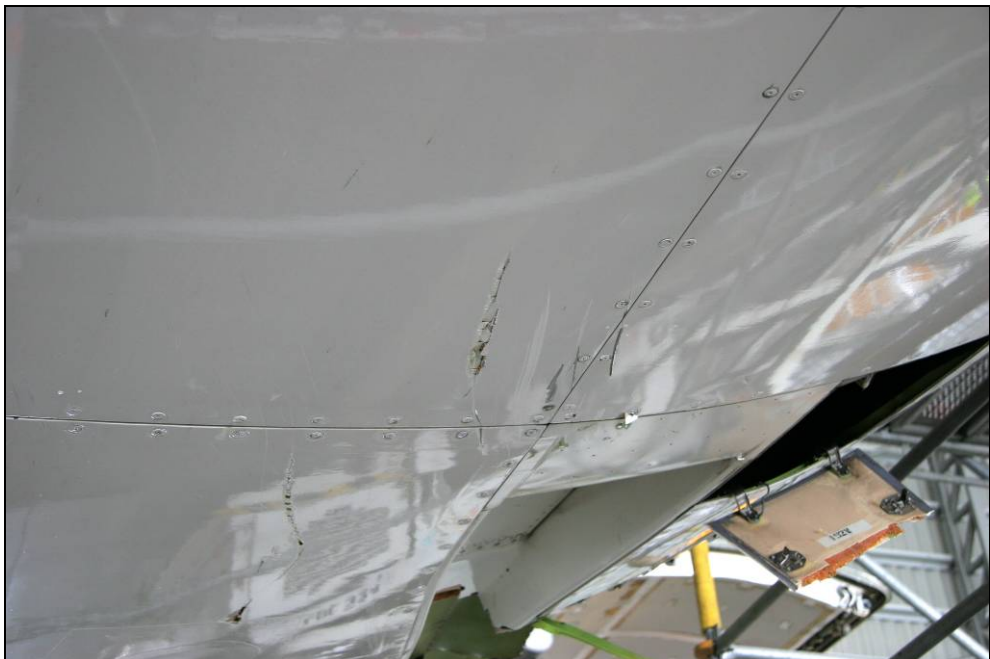
Rearward of the fuselage rupture, several localised areas of scuffing, puncture and scoring were evident along the underside of the aircraft, extending along a diagonal path from the ruptured area rearward toward the left body landing gear (Figure 4). Elongated score marks were also noted extending for several metres around the left side of the rear fuselage – typically around STA 1880 to STA 2000.

Figure 4. Panel damage to the rear of the rupture site

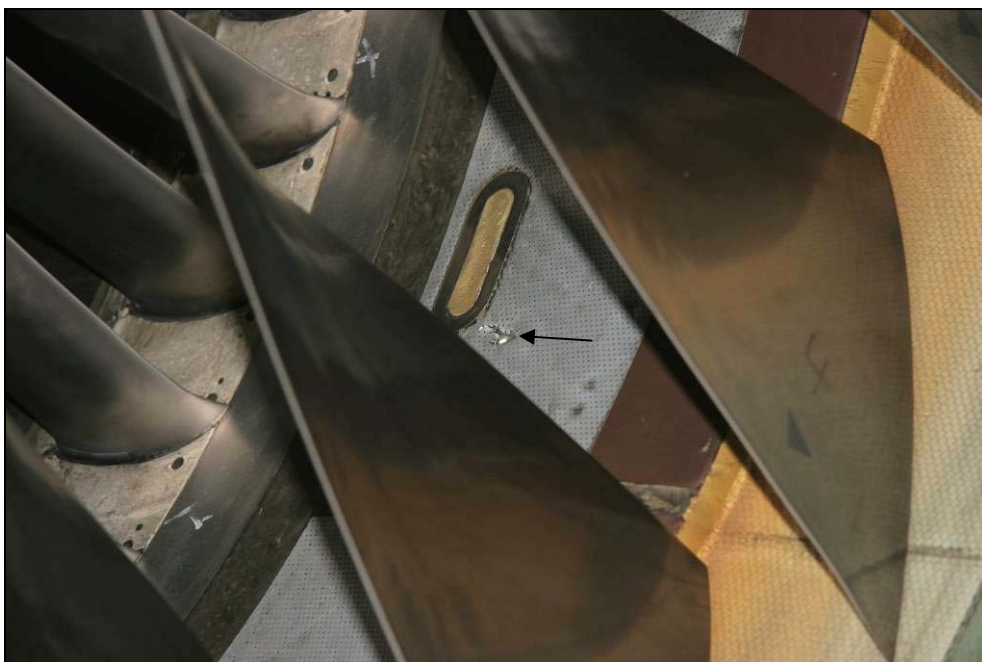
Several small pieces of structural honeycomb material of the type comprising the wing leading edge fairing were found trapped around the edges of panels within the left side of the number-3 engine pylon (side facing the rupture). A small indentation and cut was found within the number-3 engine intake acoustic panelling, located immediately inside the plane of rotation of the engine fan (Figure 5). There was no

evidence of damage to the fan blades themselves, nor was there any evidence of the ingestion of debris into the engine core.

Figure 5: Damage to acoustic lining (arrowed) behind the number-3 engine fan

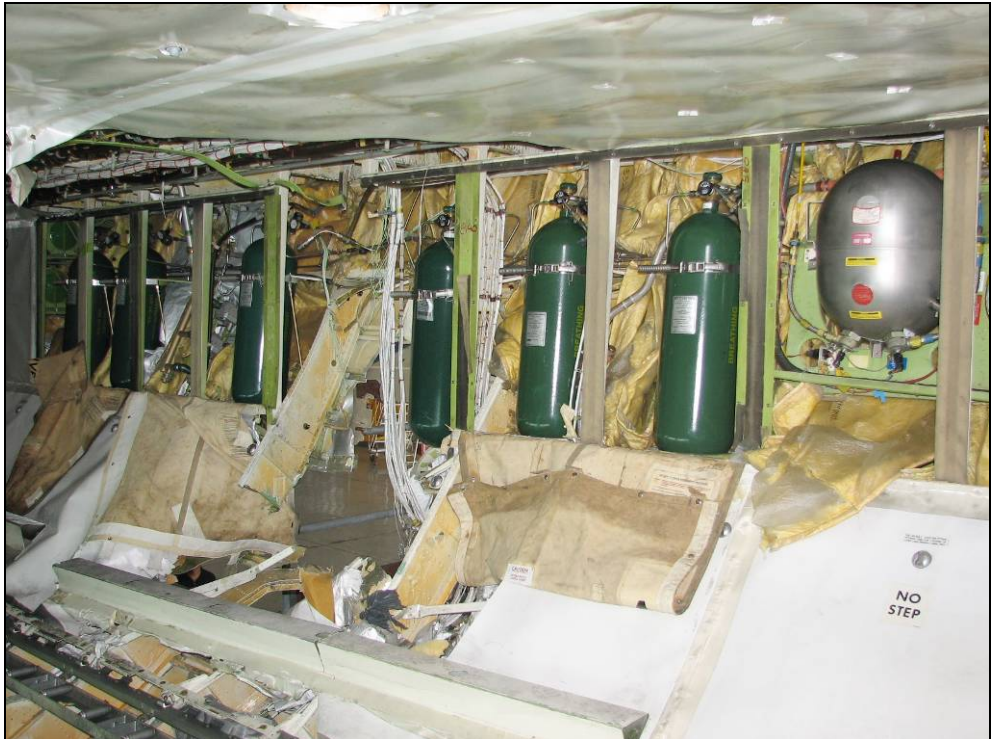
Following removal of all cargo materials and lowering of the hold right-side curtain panels, it was found that the fuselage rupture was aligned with the nominal position of the number-4⁷ passenger emergency oxygen cylinder; one of seven such cylinders in a bank along the right side of the hold (Figure 6). A further six cylinders were located in a central location within the ceiling of the cargo hold. The number-4 cylinder was missing from the bank, with the upper support bracket bent downward and both the retaining strap and lower cradle not present (Figure 7). The adjacent number-5 cylinder lower support cradle had been pulled downward and away from the cylinder as a result of the fuselage rupture. However, the upper cylinder mount and strapping remained secure and the cylinder gas connections intact. Each of the passenger oxygen cylinders had three connected stainless steel lines – an overpressure relief vent line, a delivery line and a filling line. The filling and delivery lines were fed through a tee-piece from a common cylinder connection, with a pressure regulator and transducer integral to the assembly (Figure 8). All three lines to the missing number-4 cylinder had fractured, with remnants of the delivery regulator and filling connection fittings remaining attached to their respective lines. Close examination of all exposed connections, fittings and lines showed no evidence of heating, sooting or discolouration that might have suggested localised combustion had occurred within or in proximity to the cylinder and its connections. Similarly, all structural, panel and cargo surfaces that surrounded the fuselage rupture showed no evidence of heating or damage associated with combustion effects. The pressure gauges on all 12 remaining

Figure 6: Forward cargo hold wall with remaining six oxygen cylinders

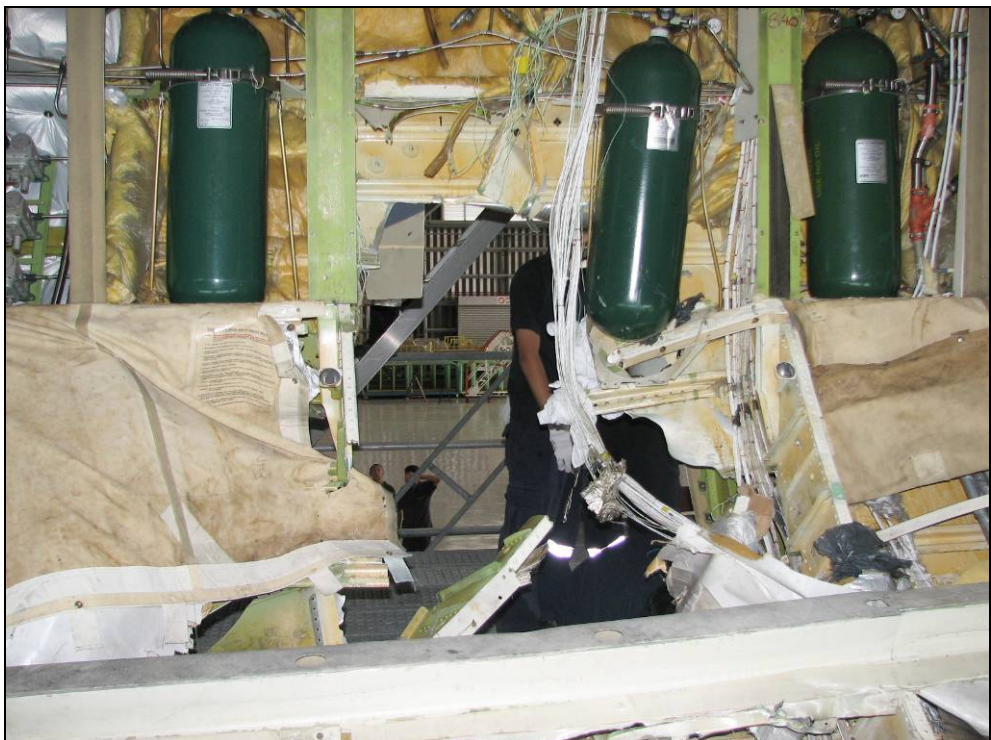
Figure 7: Fuselage rupture coincident with mounting position of the number-4 oxygen cylinder

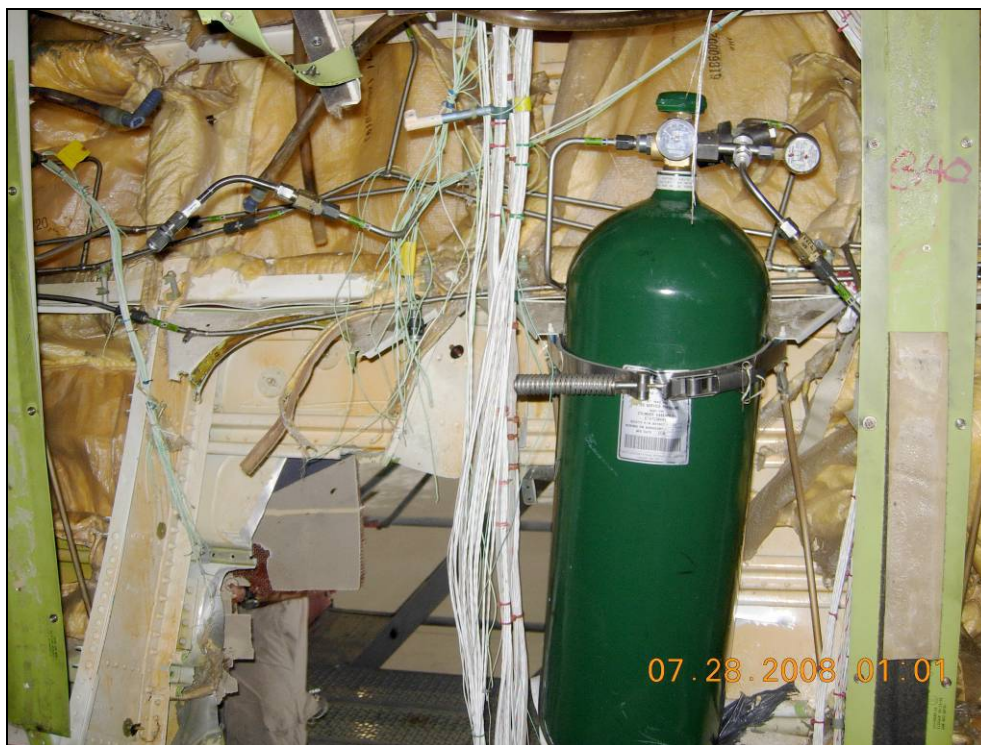
Figure 8: Number-5 oxygen cylinder adjacent to fractured fittings and lines from the number-4 cylinder

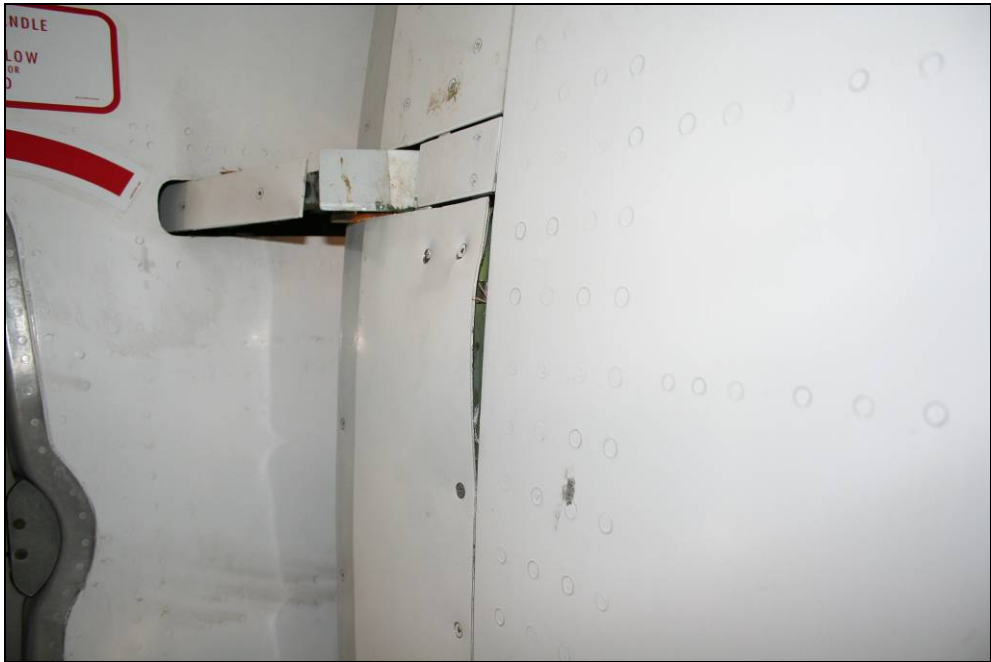
The R2⁸ door into the aircraft's main cabin was located directly above the fuselage rupture (at STA 830). An external panel located between the two door hinges showed localised outward bulging from a point immediately below the upper hinge, with the forward edge of the panel raised above the surrounding fuselage skin (Figure 9). The main external door handle was in the fully closed position, however the upper and lower door gates⁹ were partially retracted.

Figure 9: Cabin R2 door – damage to external panelling

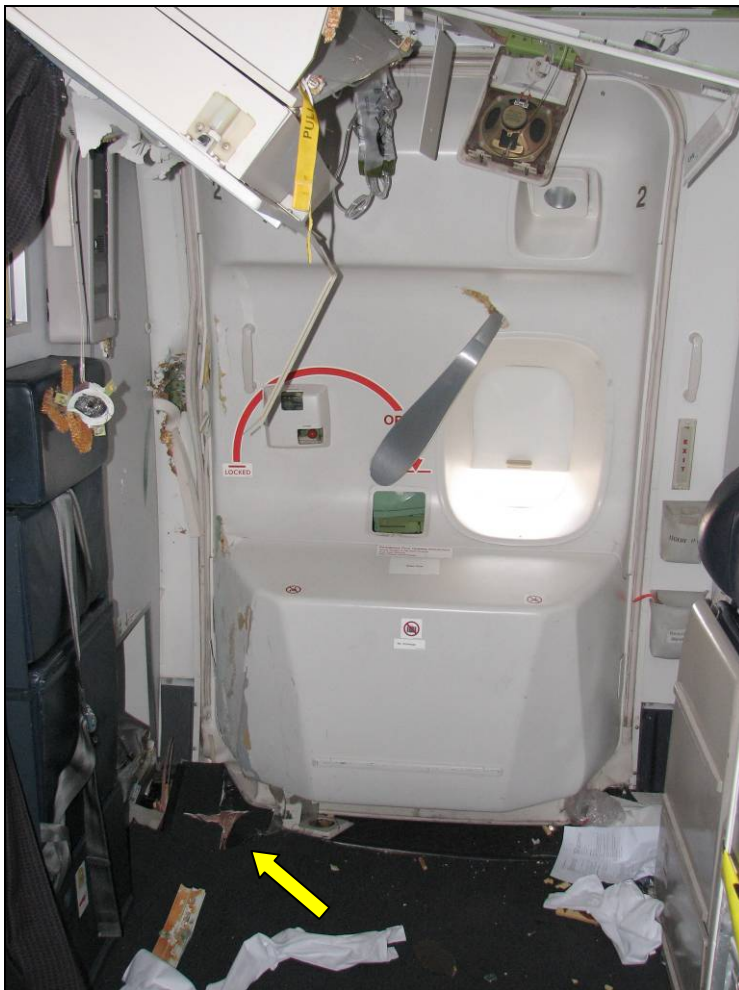
Within the aircraft, the cabin around the R2 door had sustained substantial damage and disruption (Figure 10). The cabin floor to the left and immediately inside the R2 door frame had sustained an impact that created a single circular perforation approximately 20 cm (8 inches) in diameter, located immediately above the number-4 oxygen cylinder position (Figure 11). Fragments of the cabin flooring and covering extended down into the hole. Above the hole, the forward partitioning panel between the door and the row 26J,K seats showed an elongated green coloured abrasion, leading upward to an area of impact damage at the mid-height position of the forward R2 door frame (Figure 12). The door escape slide shroud (bustle) also showed vertically-oriented scoring and green smear marks along the corner and forward facing surface. The portable walk-around oxygen cylinder normally located in an alcove just inside the R2 door was not present, and was not accounted for in a subsequent search of the aircraft.

Figure 10: Interior of R2 door and cabin – location of floor hole arrowed

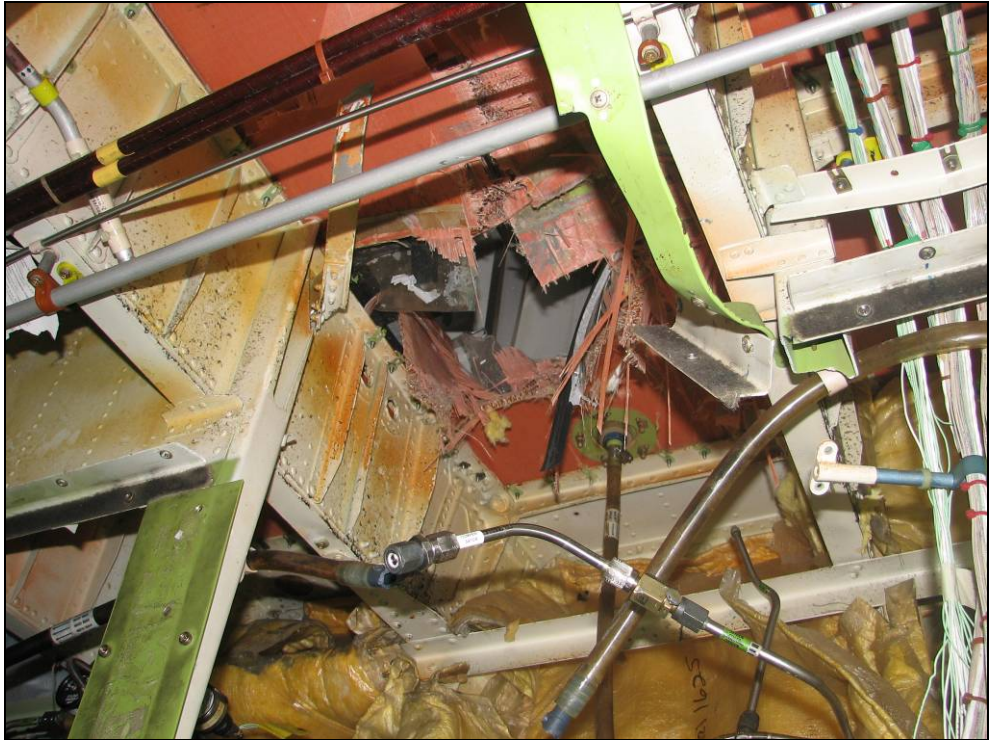
Figure 11: Hole in cabin floor – viewed from position of number-4 oxygen cylinder

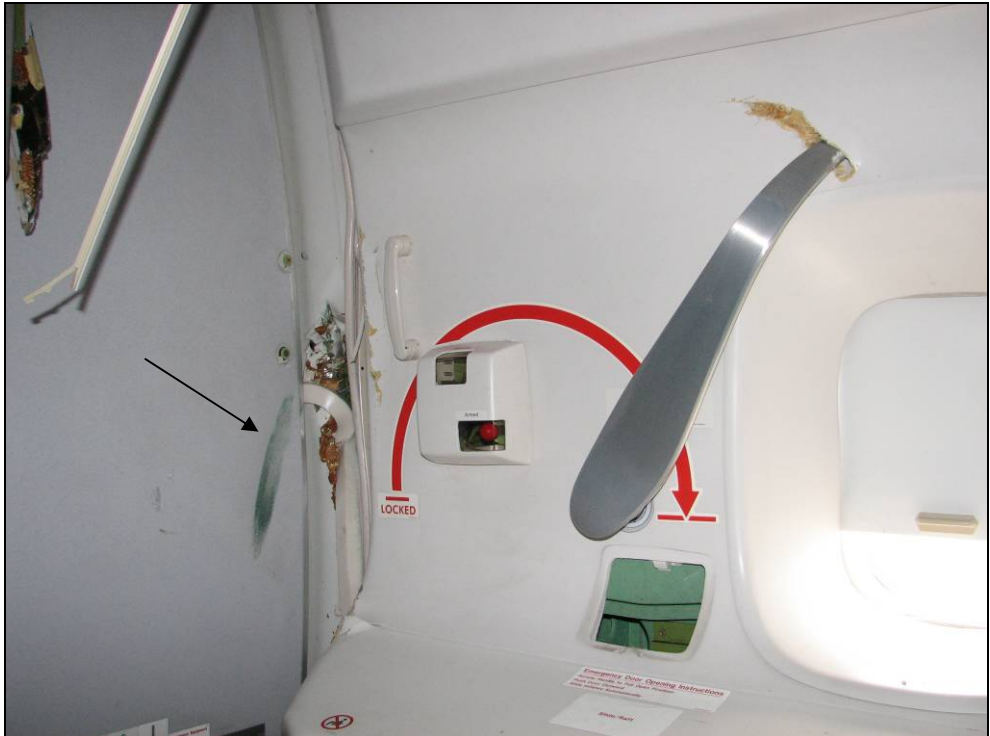
Figure 12: Door frame damage, green paint smear and rotated R2 door handle

The internal door handle was found in approximately the one-o'clock position (looking from inside), with the turned-in handle end embedded into the door lining material. That position was consistent with a movement through approximately 120 degrees from the fully-closed (locked) position. A 180 degree handle movement represented the fully open position. The downward facing surfaces of the handle end (when the door is in the locked position) showed damage and abrasion consistent with impact against another object. Inspection of the internal door systems showed the handle shaft had fractured and the actuating cam plate and retainer had pulled away from its associated mechanism (Figure 13), allowing the handle to rotate freely. As such, the handle position as observed inside the cabin was not indicative of the actual door security.

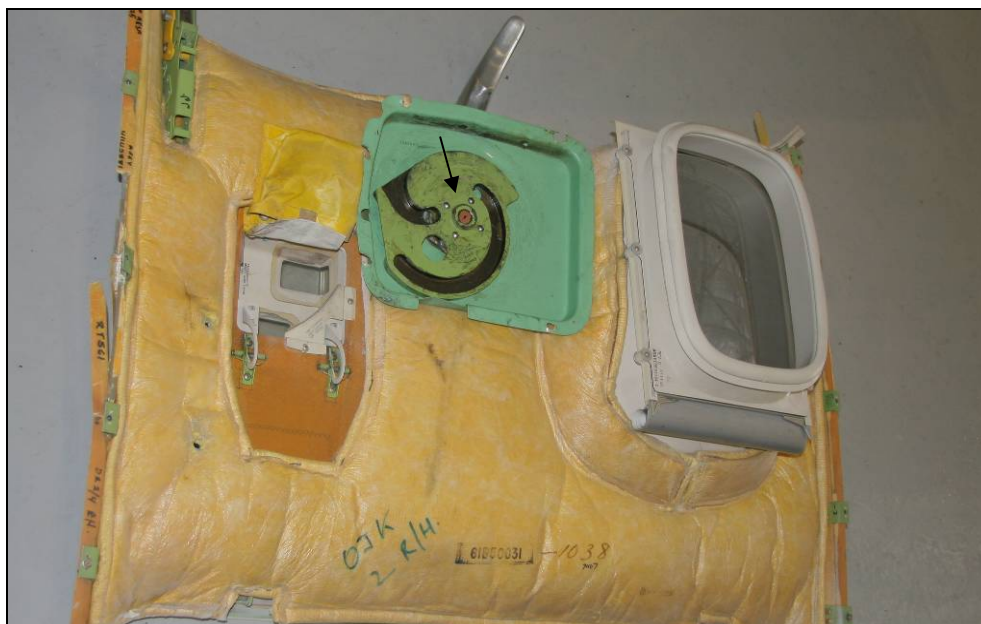
Figure 13: R2 door panel underside – fractured shaft and separated plate

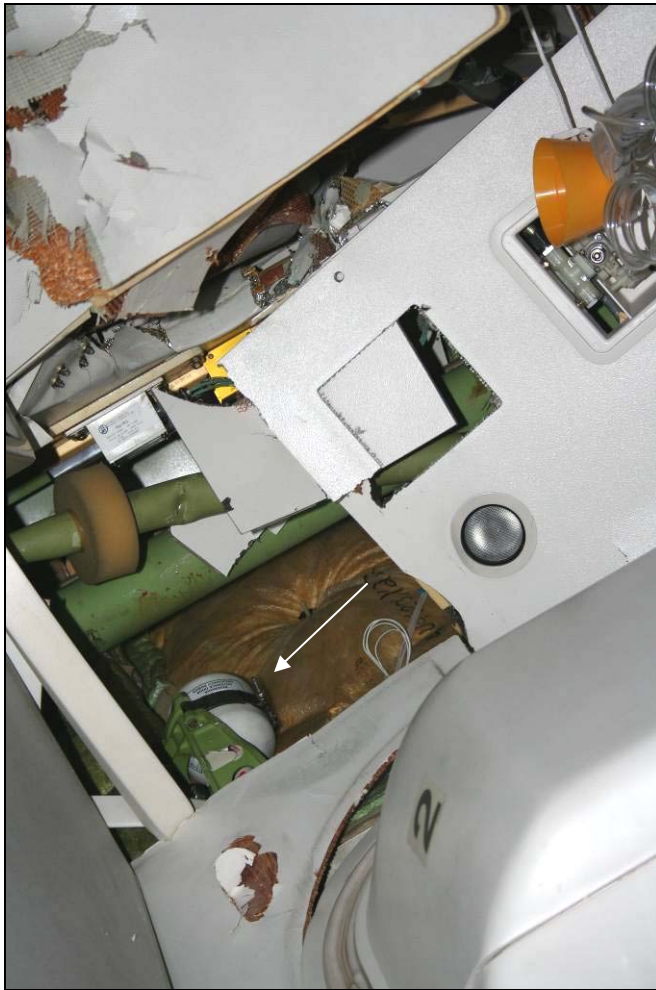
Above the R2 door within the cabin, the overhead panelling, fixtures and utility storage compartments had sustained extensive impact damage. The panels above the door frame had been pushed inward, exposing the overhead structure and pressure reservoir for the door emergency power assist opening system (EPAS, Figure 14). Amongst the impact damage, it was observed that an unusually uniform semi-circular section had been forcibly cut from the panelling and access door (Figure 15), with the cut-out section later recovered from above the damaged storage compartment casing. The diameter of the cut-out region closely matched that of the passenger oxygen cylinders (Figure 16). Adjacent to the cut-out opening was a semi-circular area of crushing damage to a partitioning panel (Figure 17); the damage being of a similar diameter to the cut-out section. A light fitting, normally present in the overhead panels had sustained upward crushing damage and presented clear green paint smears of a similar colouration to the marks on the partition panel and door bustle.

Figure 14: Damage above R2 door, exposing the EPAS cylinder (arrowed)

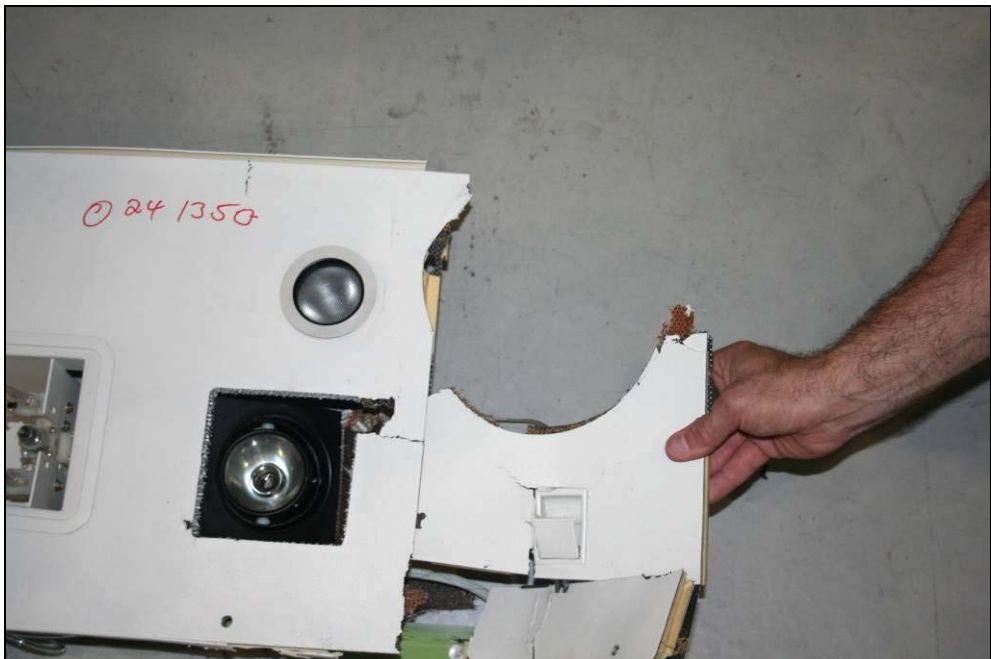
Figure 15: Cut-out section found in panels above the R2 door

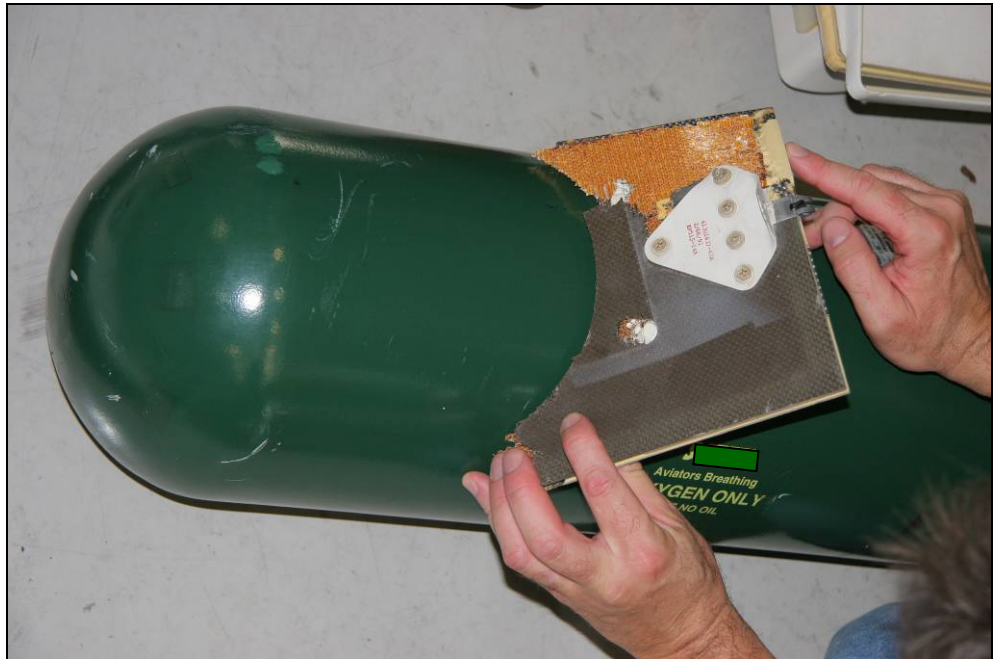
Figure 16: Panel with cut-out placed against another oxygen cylinder to illustrate the conformance in diameter

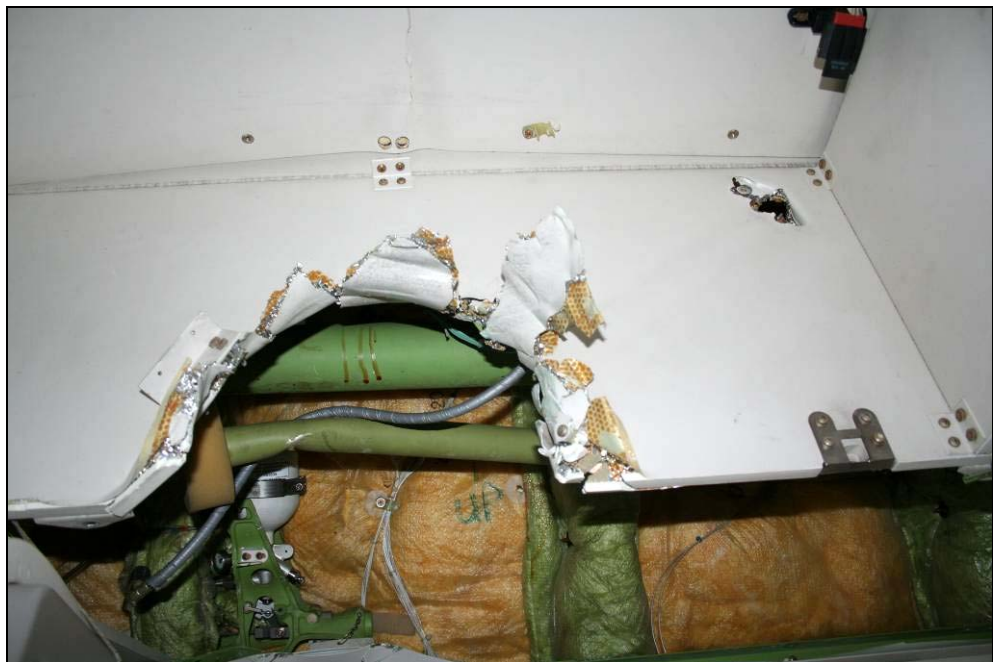
Figure 17: Semi-circular damage in partition of compartment above R2 door

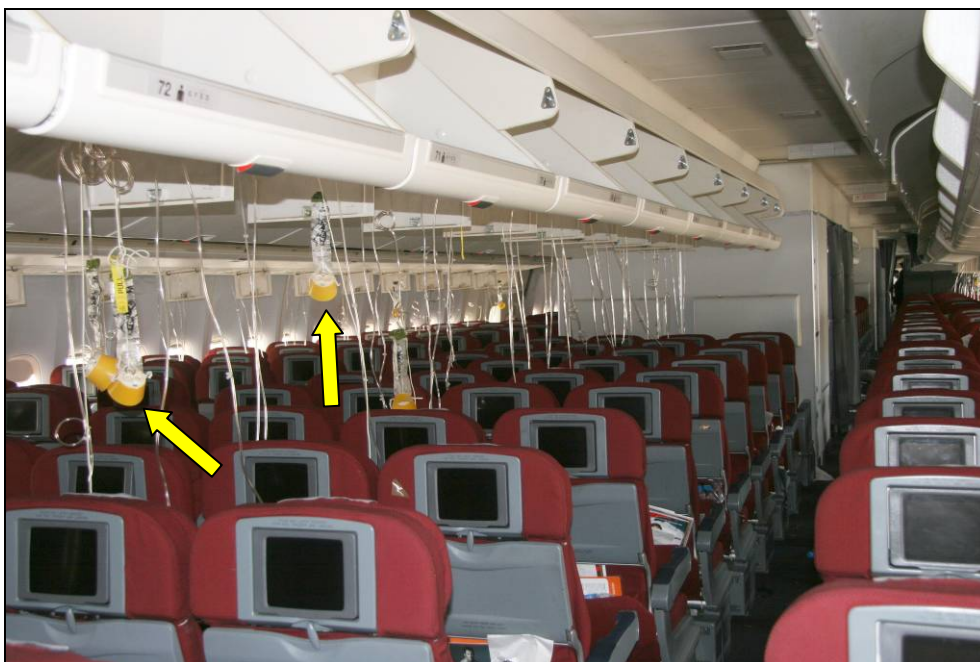
Investigators conducted a comprehensive walk-through examination of the aircraft's cabin and a survey of the safety systems; in particular, the status of the passenger oxygen masks and equipment (Figure 18).

- there were 353 passenger seats in the aircraft
- 476 passenger oxygen masks had deployed from their overhead compartments
- 426 passenger oxygen masks were pulled down (i.e. activated for use)
- row 53 centre overhead passenger service unit was hanging down
- forward crew rest and customer support manager station masks had not deployed
- the covering on the rear surface of the partition in front of seats 40A,B,C was damaged
- floor pressure relief panels were open at seats 24A (2), 25A, 37K and 54A
- one mask hose was detached from the ceiling fitting at seat 4K (3 masks deployed).

Figure 18: Typical appearance of cabin. Note passenger masks dropped and activated, and those dropped and not activated (arrowed)

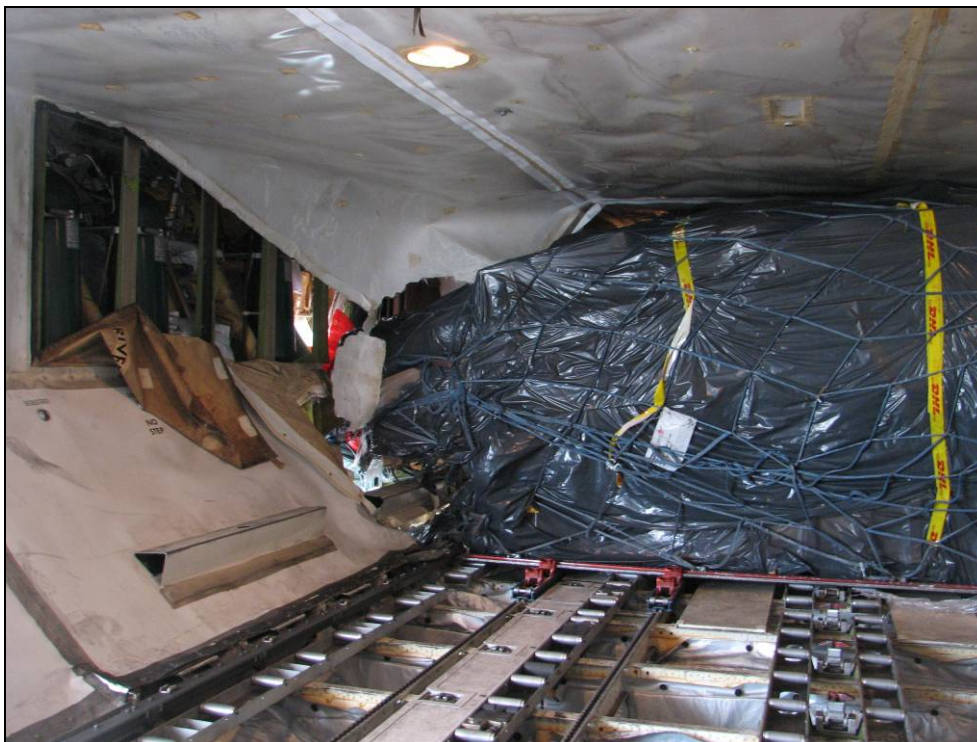
The forward hold of the aircraft contained both containerised and palletised cargo. All passenger baggage was located within conventional metal containers positioned forward of the point of rupture. None of the containers within the hold showed evidence of damage or other markings that could be associated with the rupture event. The cargo adjacent to the fuselage rupture was a plastic wrapped and netted pallet of general freight in cardboard boxes and similar. The cargo packed along the side closest to the rupture had been pulled towards the opening, with several items becoming lodged within, and protruding from, the void (Figure 19). Items packed near to the fuselage rupture showed varying degrees of forced impact type damage and a section of aluminium structure from the hold framework was recovered from amongst the packaging. There was no evidence of an explosive event having originated from within the cargo itself, and a review of the cargo manifests showed no items that could be considered capable of causing or contributing to such an event. Reconciliation of the recovered cargo by the freight service provider accounted for all items on the manifest.

Figure 19: Cargo pallet adjacent to fuselage rupture (view looking to the rear)

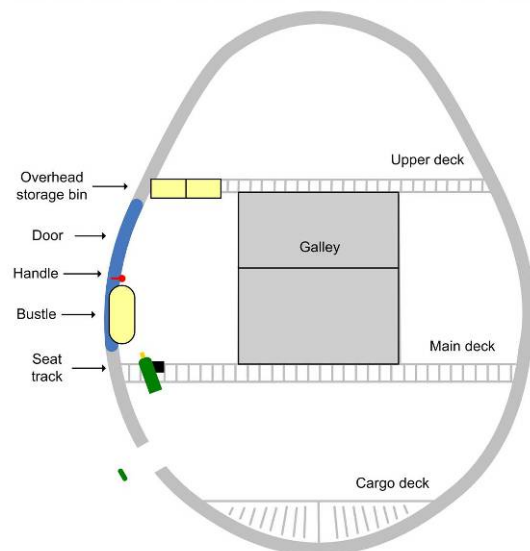
2. Cylinder failure produces fuselage rupture, with bulk of the cylinder length propelled upward through the cabin floor. See Figure 11.

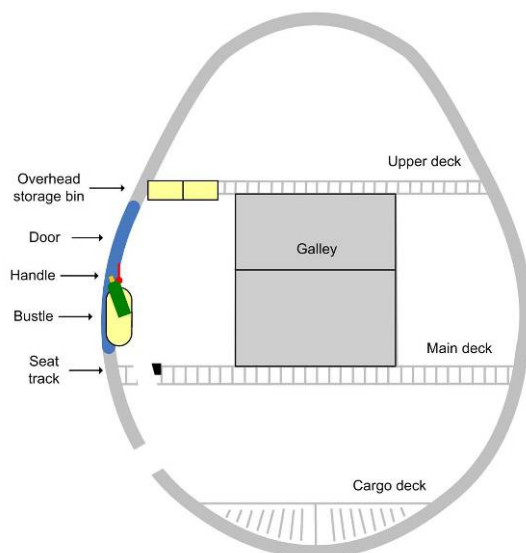
3. Cylinder impacts R2 door frame and internal door handle. See Figures 10 & 12.

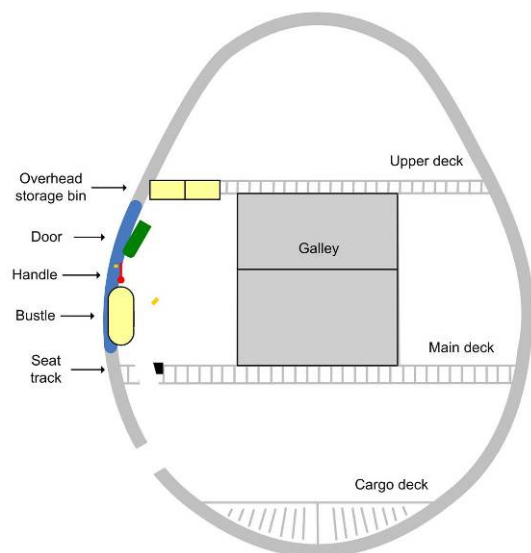
4. Door frame impact breaks off cylinder valve and causes cylinder to invert while continuing to travel upward.

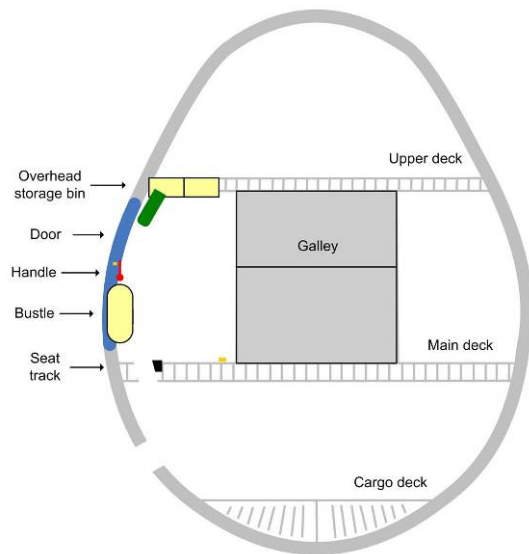
5. Cylinder impacts overhead panelling end-on, producing circular cut-out type damage. See Figures 14-16.

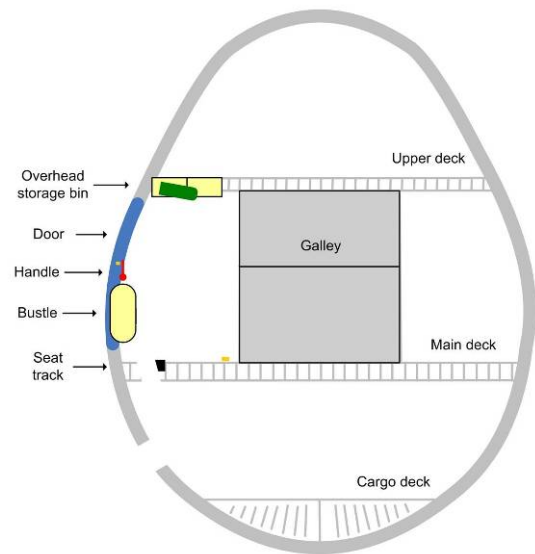
6. Still rotating cylinder impacts overhead storage bin, producing semi-circular crushing damage. See Figure 17.

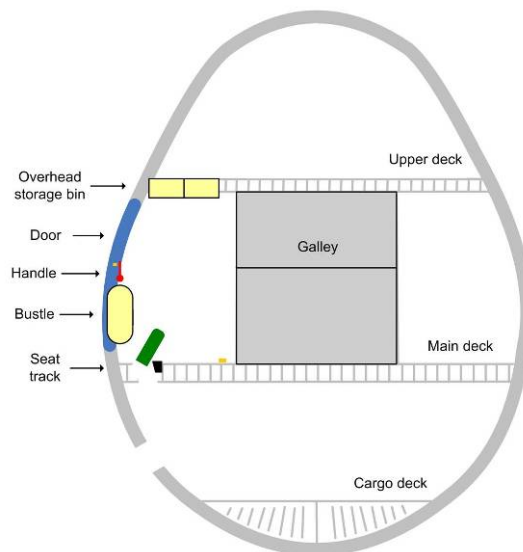
7. Cylinder falls to cabin floor and exits the aircraft through the ruptured fuselage.
