1. Report No. NTRD-ADB 76 01	2. Government Accession No.	3. Recipient's Catalog No.	
4. Title and Subtitle Aircraft Accident Report Alaska Airlines, Inc., Boeing 727-81, N124AS Ketchikan, Alaska, April 5, 1976		5. Report Date December 22, 1976

AIRCRAFT ACCIDENT REPORT

ALASKA AIRLINES, INC.
B-727-81, N124AS
KETCHIKAN INTERNATIONAL AIRPORT
KETCHIKAN, ALASKA
APRIL 5, 1976

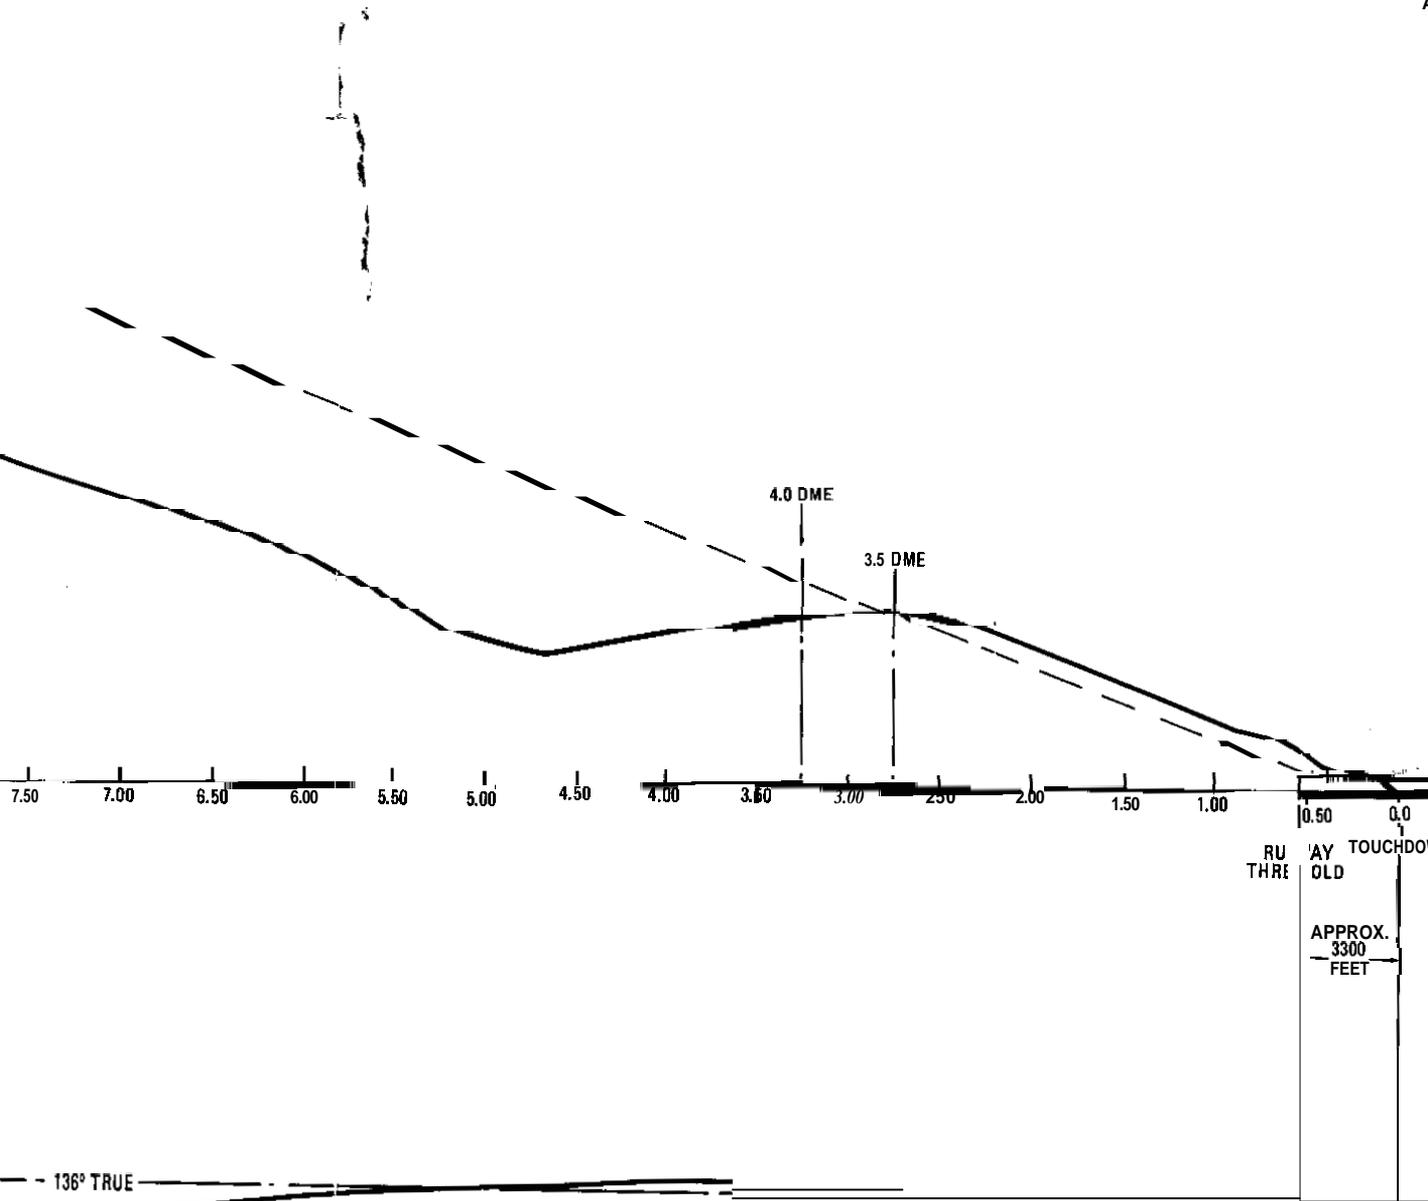
CALCULATED DESCENT PROFILE & GROUND
BASED ON FDR DATA FROM ALASKA AIRLINES

The indicated airspeed was consistently higher than normal throughout the approach. It varied from 240 kns at 5,000 ft to 145 kns at touchdown. The captain apparently intended to land with 30° flap extension. The reference airspeed based upon the aircraft's weight and the 30" flap configuration was 121 kns. Alaska Airlines, Inc., operating procedures allows an additive correction not to exceed 20 kns to provide a maneuverability margin when headwind and gusty conditions prevail. Although such conditions were not indicated by the reported weather, the captain explained that he added the full 20 kns on the expectation that turbulence would be encountered. Sometime before landing, the first officer extended the flaps to 40° . The reference speed for that configuration was 117 kns.
