Final Report of the Federal Aircraft Accidents Inquiry Board

concerning the Accident of the aircraft DC-9-32, ALITALIA, Flight No AZ 404, I-ATJA
on the Stadlerberg, Weiach/ZH, of 14 November 1990

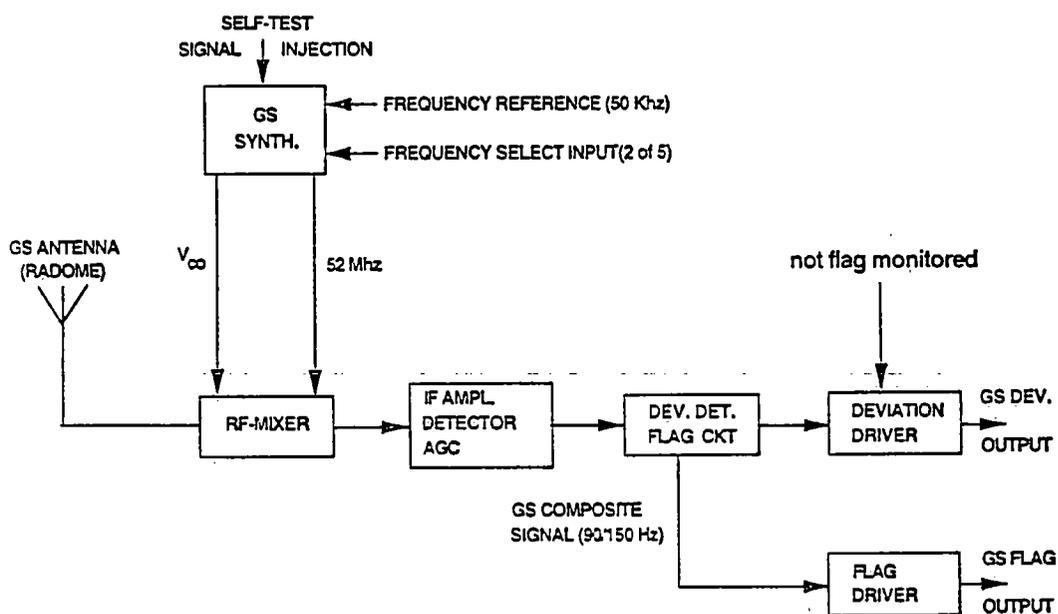
Block Diagram KING KNR 6030 GS Receiver

The IC I 2903 in the glide slope deviation driver was missing. The IC I 2904 in the VOR/LOC deviation driver was found loose in the unit. The Scientific Service specialists determined that both IC must have been pulled from their respective receptacles by acceleration forces.

A detailed examination of the interface-board was not possible due to the high degree of damage. It is noted however, that a fault in an electronic component on this board would tend to have caused a hard-over, rather than a centred indicator needle.

The examination of the NAV receiver KING KNR 6030 gave no firm indications of a pre-crash deficiency. It can not, however, be excluded that this unit could have accounted for a "frozen" centred glide slope indication.

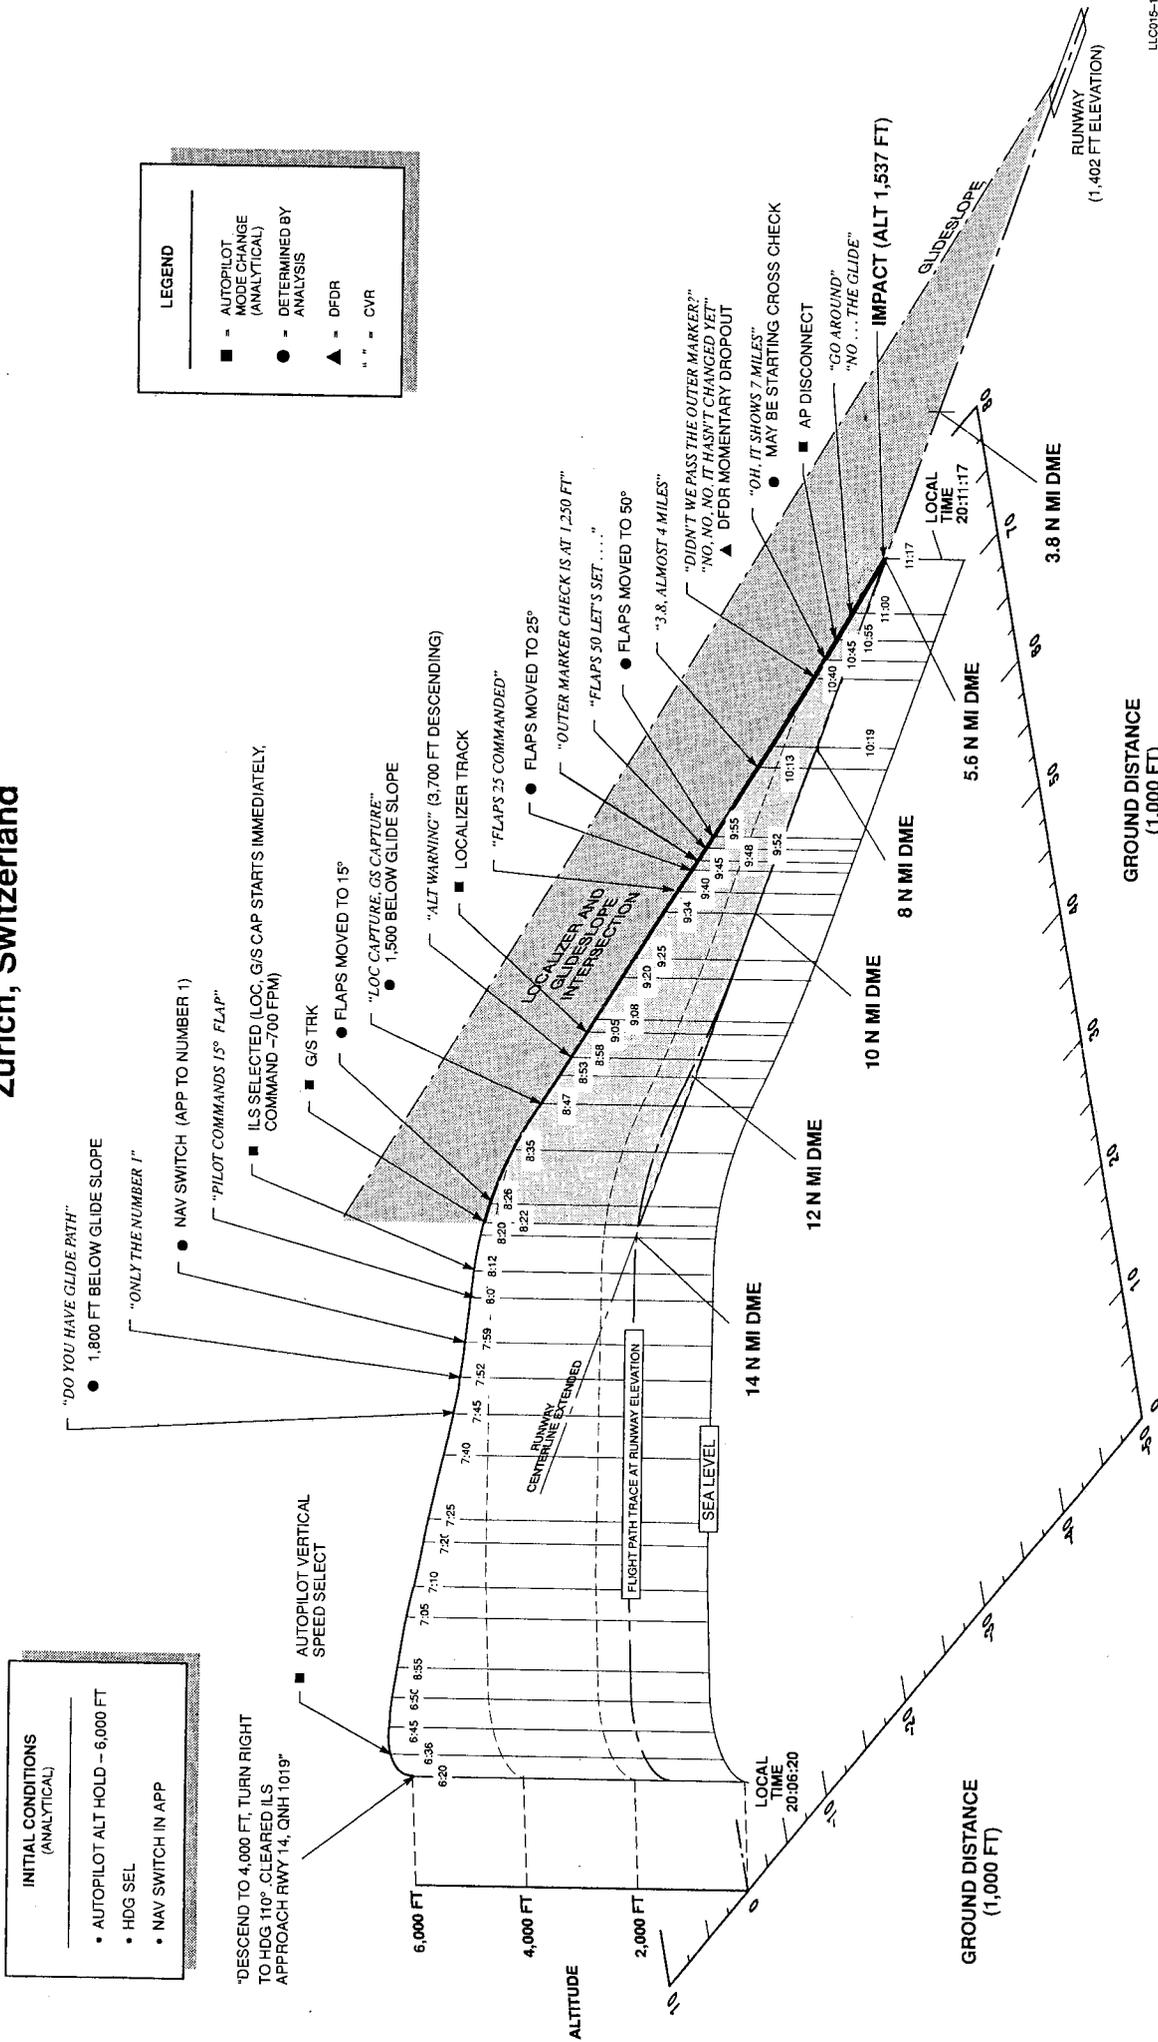
Beilage / Annesso / Annex 3

Anflugprofil der AZ 404 (ILS-Anflug)

Approach profile AZ 404 (ILS Approach)

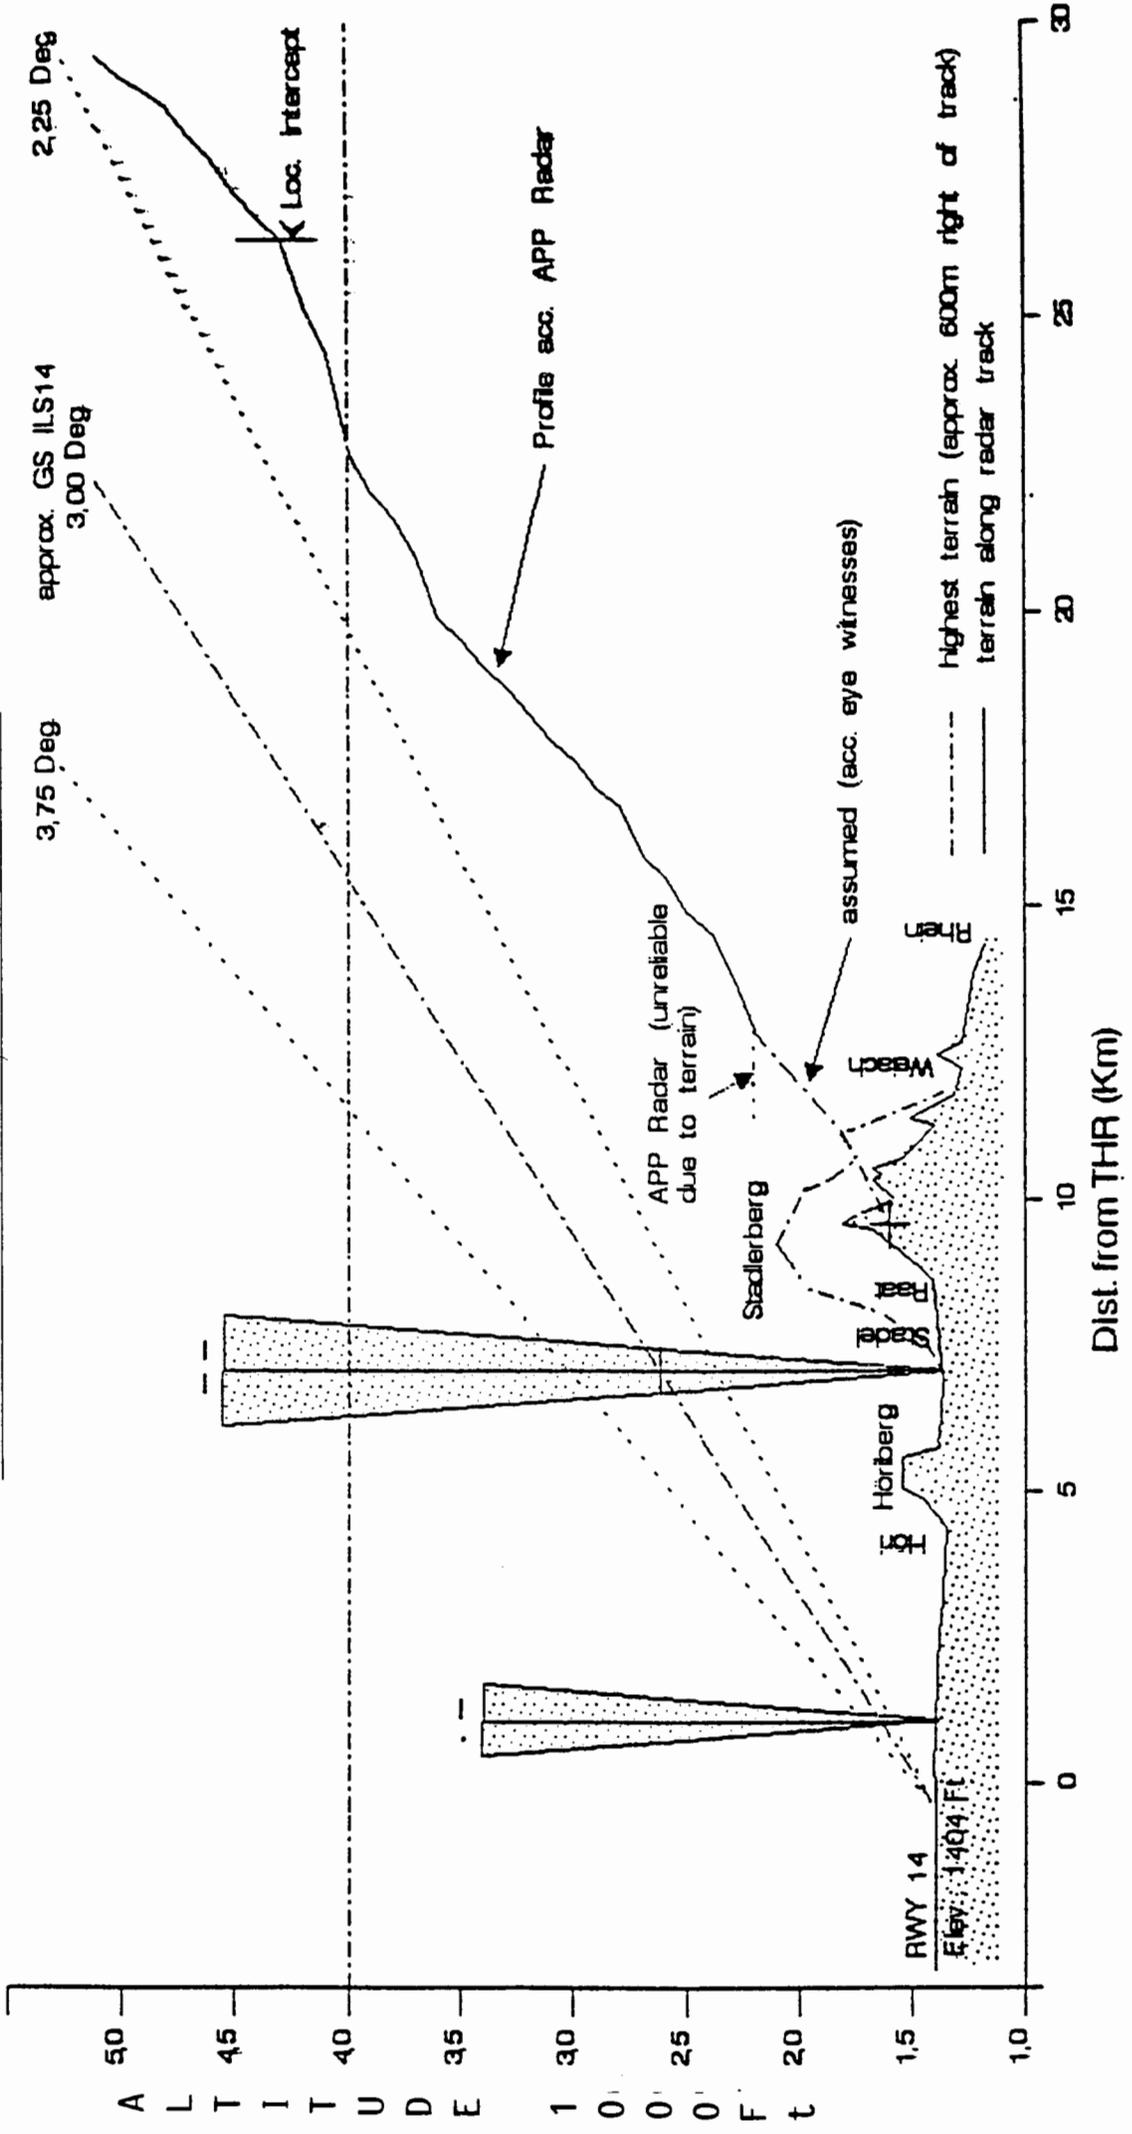
Beilage / Annesso / Annex 4

AZ 404: Radaraufzeichnung des Flugweges

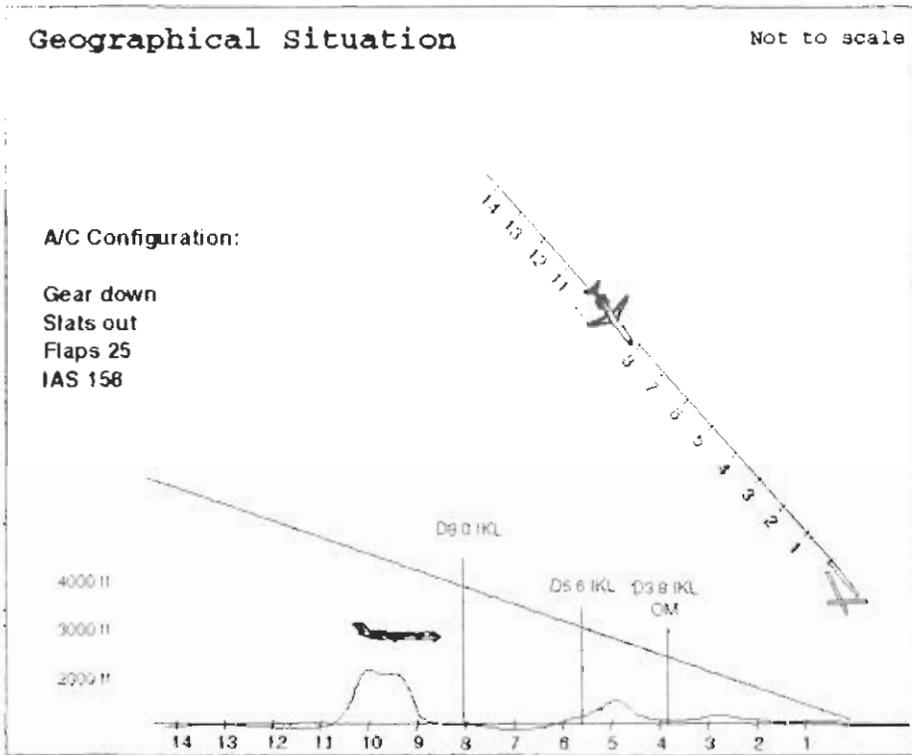
Figure 9

1908.58 - ALTITUDE ALERT SOUNDS (3700' descending) -

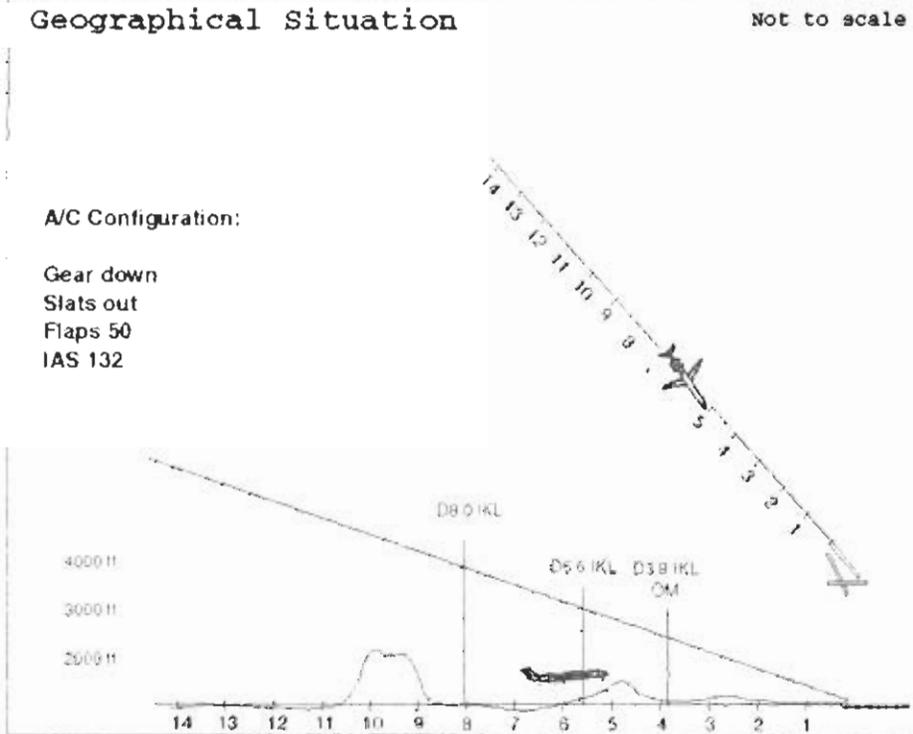
Figure 12

1910.56 F/P ...that doesn't make sense to me...
 A/P Not to me...

1910.57 A/P Pull, pull, pull, pull!
 - Click of Auto-pilot disengage is heard

1910.59 F/P ... AROUND

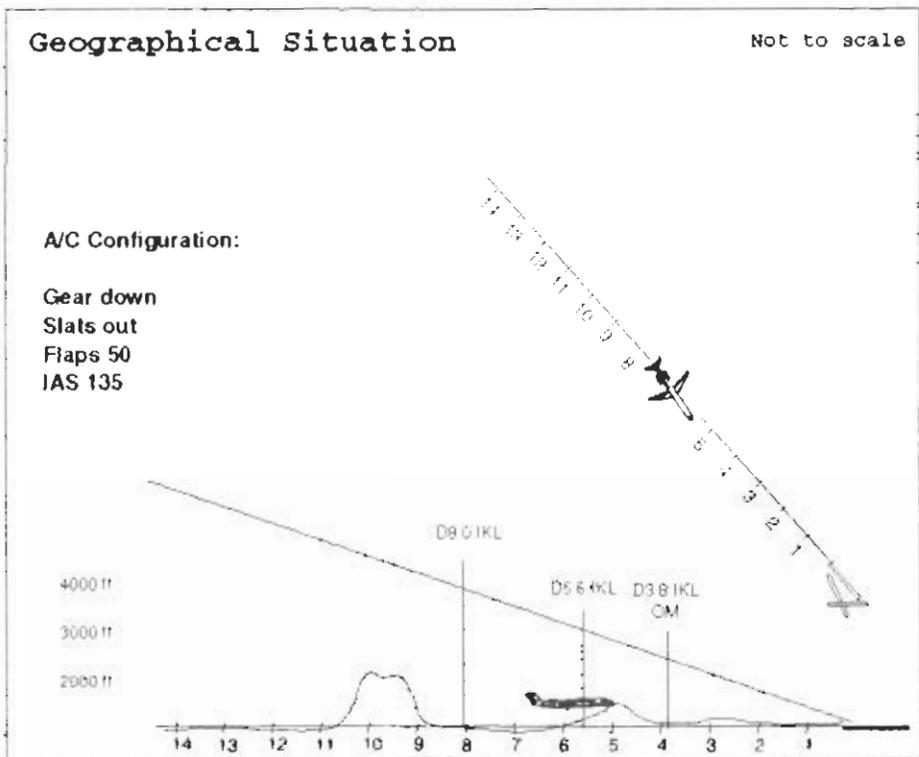
Figure 13

1911.16 A/P Hold on let's try to put on...

1911.18 - crash sounds heard -
