AIRCRAFT ACCIDENT REPORT

INADVERTENT IN-FLIGHT SLAT DEPLOYMENT
CHINA EASTERN AIRLINES FLIGHT 583
McDONNELL DOUGLAS MD-11, B-2171
950 NAUTICAL MILES SOUTH OF SHEMYA, ALASKA
APRIL 6, 1993

Abstract: This report explains the inadvertent deployment of the MD-11 airplane's leading edge wing slats while the airplane was in cruise flight, about 950 nautical miles south of Shemya, Alaska, on April 6, 1993. Safety issues in the report focused on the inadequate design of the flap/slat actuation handle, the inadvertent extension of the leading edge wing slats, the longitudinal stability of the airplane during the pitch upset, the pilot-induced oscillations that can occur during recovery, the premature deterioration of the seat cushion fire-blocking material, and the inability of the material to provide the required seat cushion fire protection on transport-category airplanes. Safety recommendations on these issues were made to the Federal Aviation Administration.

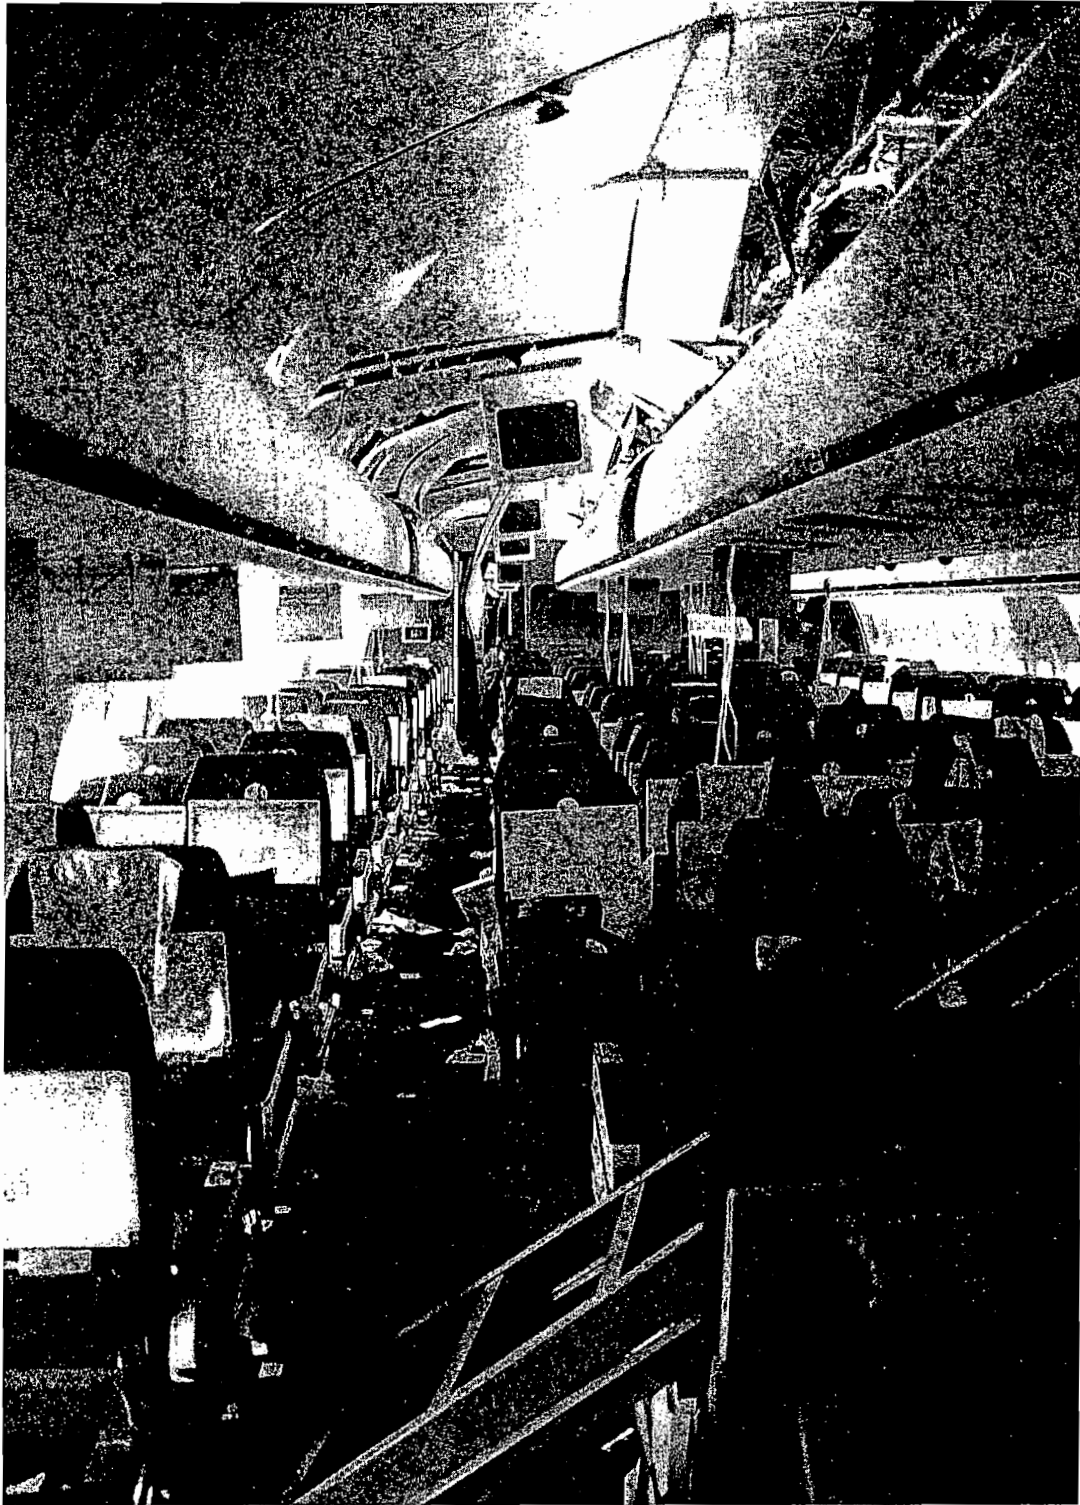
Figure 7.--Passenger cabin interior.

The primary damage occurred to the interior structure and seats in the coach class section. The damage to the passenger seats ranged from slight deformation to distortion and/or complete collapse of the seat arm rests and seat backs. (See figure 7).

Several passenger service units (PSUs) in the coach class section sustained impact damage when they were struck by passengers. The damaged PSUs had been displaced or pushed up into their mounting structure. Twenty oxygen masks, in various parts of this cabin section, were found deployed as a result of damage to the PSUs.

Numerous ceiling panels in the forward coach cabin and all of the ceiling panels in the aft cabin of the coach section were damaged, and some were displaced upward against their support frames. About 80 percent of the ceiling cross beams, which support the ceiling panels in the aft section of the airplane, were found crimped, separated or bent.
