# National Transportation Safety Board

## Aircraft Accident Brief

Accident No.:	DCA00MA052
Operator or Flight Number:	Executive Airlines
Aircraft and Registration:	British Aerospace J-3101, N16EJ
Location:	Bear Creek Township, Pennsylvania
Date:	May 21, 2000

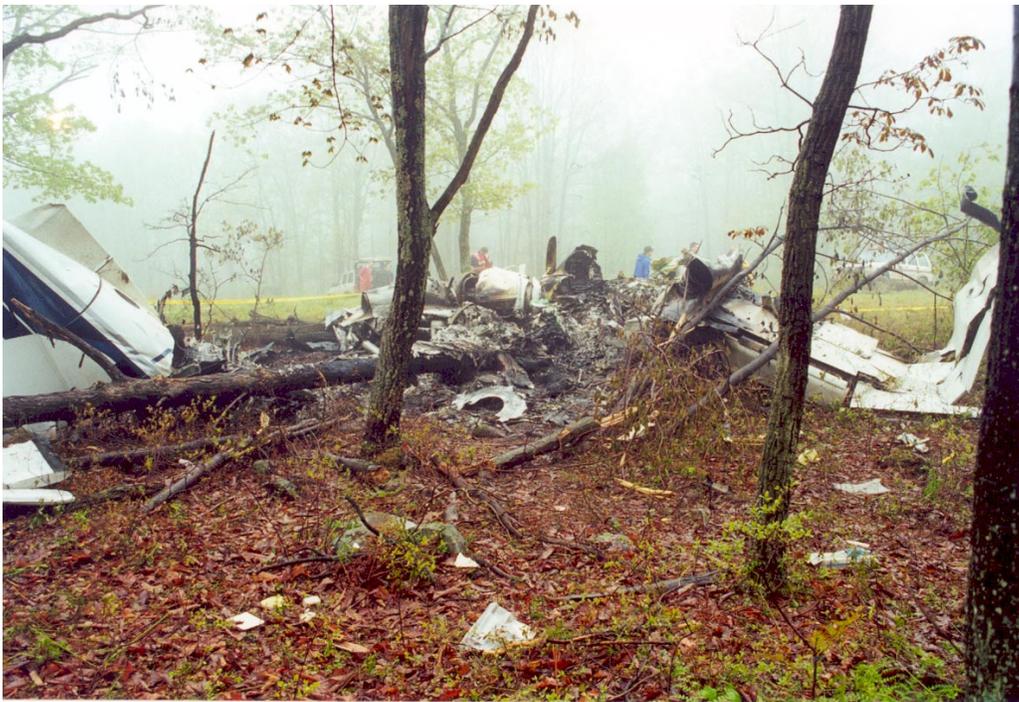
The airplane wreckage was found on the top of a mountain on the east side of a pipeline clearway on state-owned property. Ground and tree impact marks indicated that the airplane impacted terrain at a steep angle and in an extreme bank angle. Witness marks on the attitude indicator, ground witness marks, airplane crushing, and other damage indicated that the airplane impacted the ground at a 60° nose low attitude and in a 135° left bank. Ground scars indicated that the airplane impacted the ground on a 40° heading. All of the airplane's primary structure was located at the accident site. All recovered primary and secondary flight control surfaces were found at the accident site. As shown in figure 2, fire damage was confined to the immediate impact area, with little fire damage to surrounding trees and foliage.

**Figure 2.** Photo of the accident site illustrating the lack of fire damage to the surrounding area.

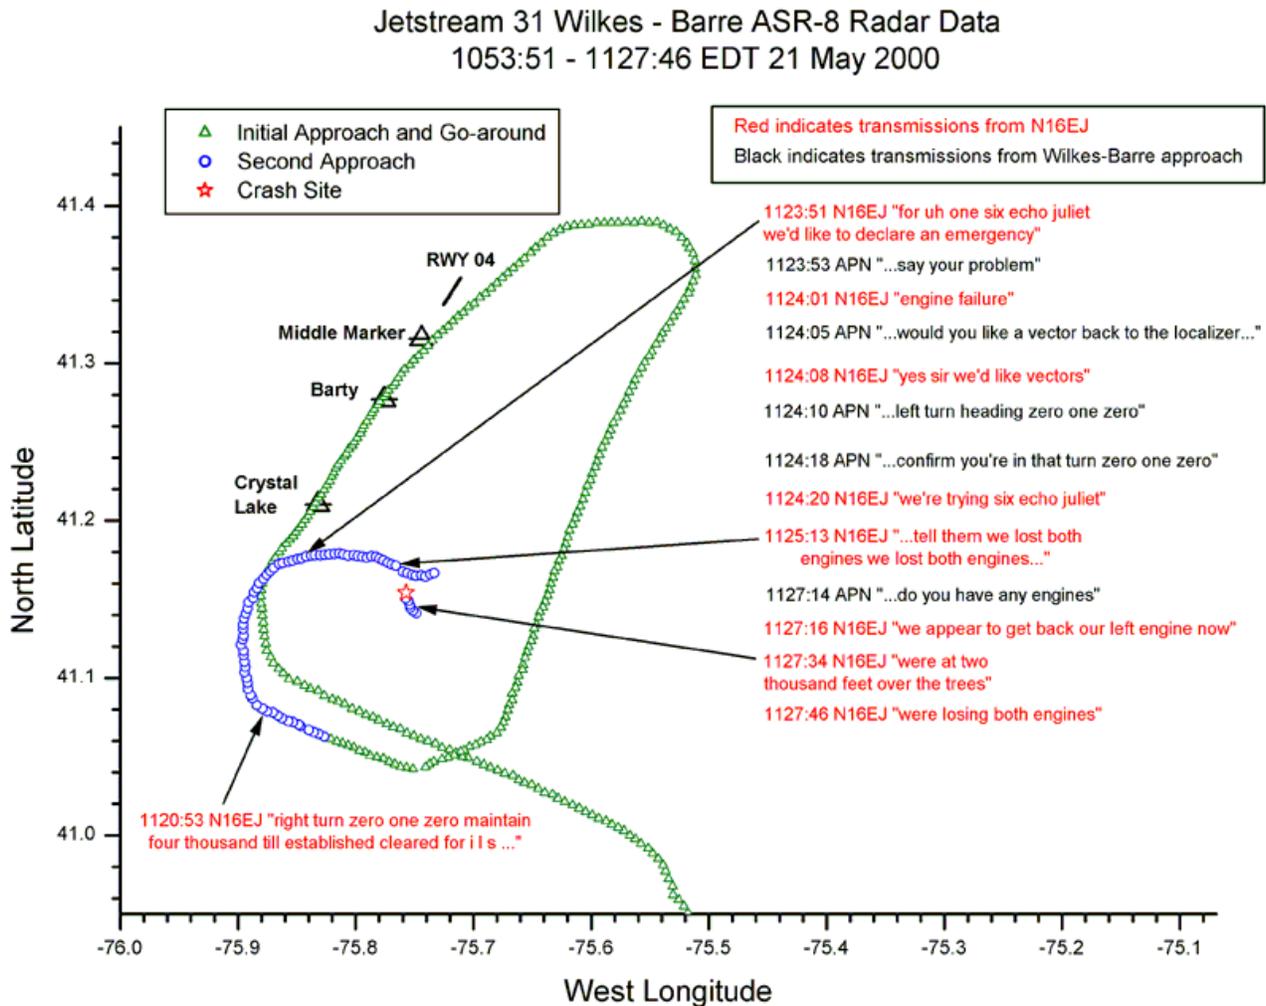
The accident airplane was at an altitude of 3,800 feet when the flight crew declared an emergency at 1123:51 (see figure 4). By this time, the airplane had deviated from the specified 45° approach course to about a 70° heading, had slowed to about 125 knots airspeed, and was about 12 nm from the runway threshold. The airplane continued to turn right. At 1124:14, when ATC instructed the flight crew to turn left, and a crewmember responded "we're trying," the airplane was on a 100° heading, or about 55° off of the desired heading and to the right of the specified approach course. About a minute later, when the crew radioed that it had lost both engines, the airplane was in a steeper descent, descending about 1,500 fpm at 130 knots airspeed. The airplane then turned to the left to a 90° heading and radar contact was temporarily lost. Airspeed increased to 140 knots as the airplane descended through 2,100 feet.

**Figure 4.** Plot of the accident airplane's initial and second approaches correlated with key ATC transmissions.
