# **Aviation Occurrence Report**

**TransAsia Airways Flight GE235**

**Loss of Control and Crashed into Keelung River**

**Report Number: ASC-AOR-16-06-001**

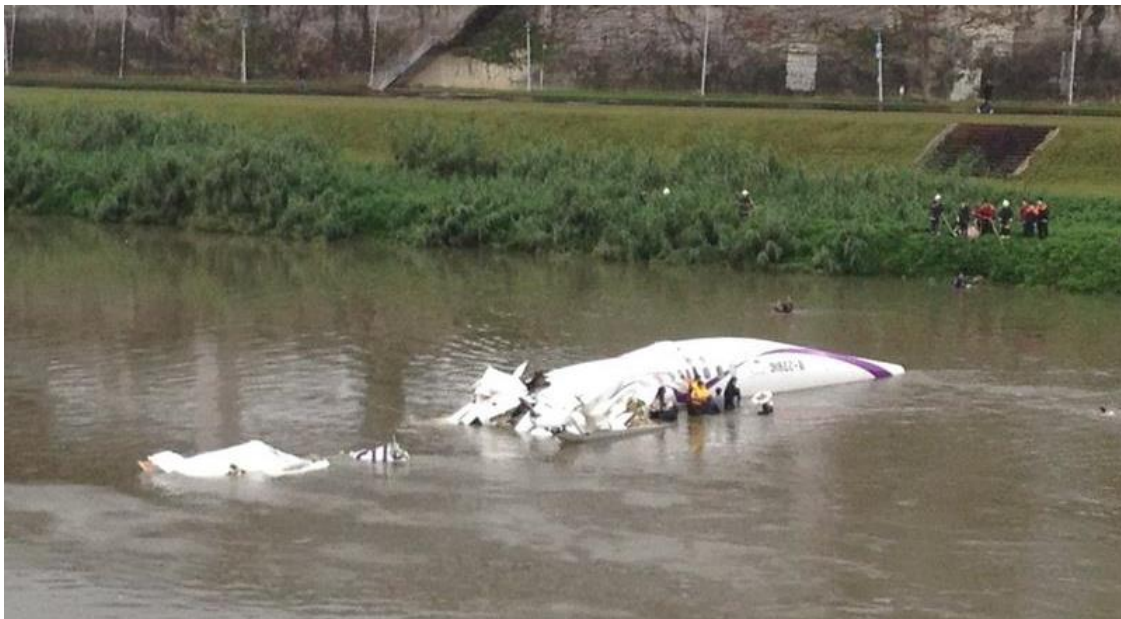
Figure 1.1-1 GE235 main wreckage

More than half of the main wreckage was submerged in the middle of the river (see Figure 1.1-1). As the aircraft flew over an overpass before impacting the water, its left wing collided with a taxi with two occupants. The taxi driver sustained serious injuries and the passenger sustained minor injuries.

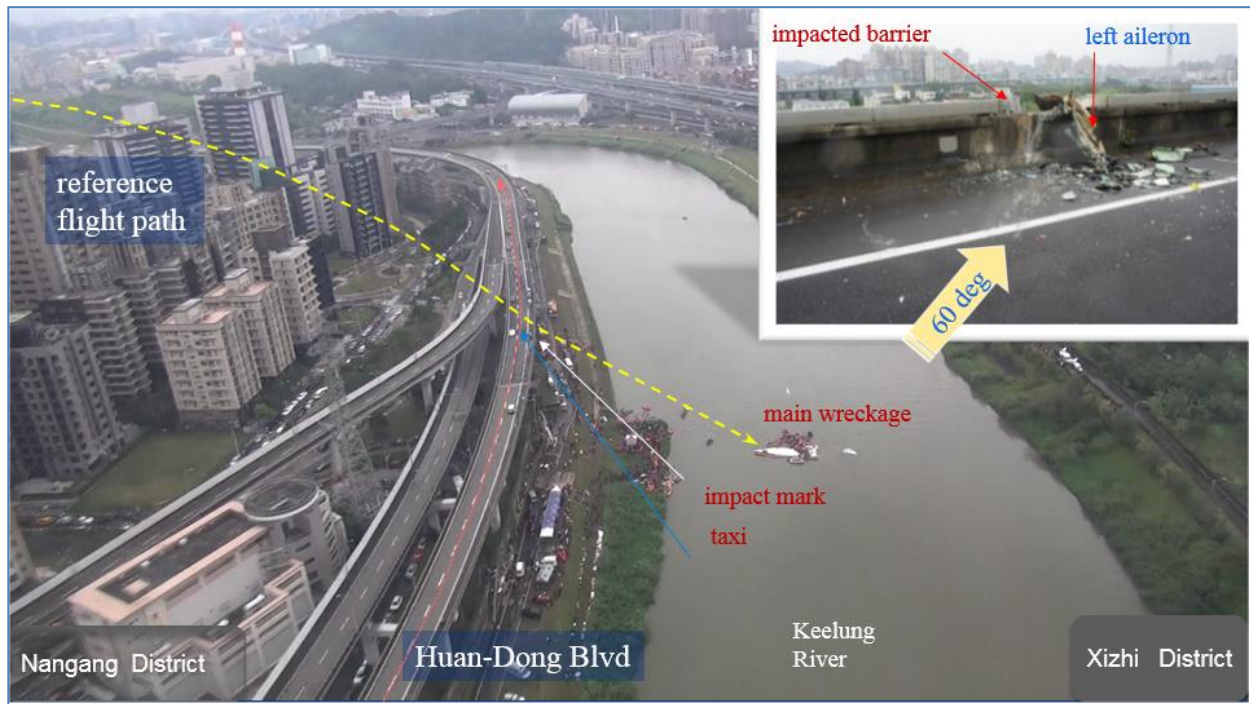
Figure 1.12-5 Aerial Photo of the GE235 crash site

Video footage and aircraft impact marks indicated that the aircraft had collided with a taxi, light pole and guard railing or barrier on the Huan-Dong overpass before impacting the Keelung River. Figure 1.12-5 presents an aerial photograph of the accident site. Keelung River is to the north side of the overpass. The depth of the river in this location is between one to two meters.

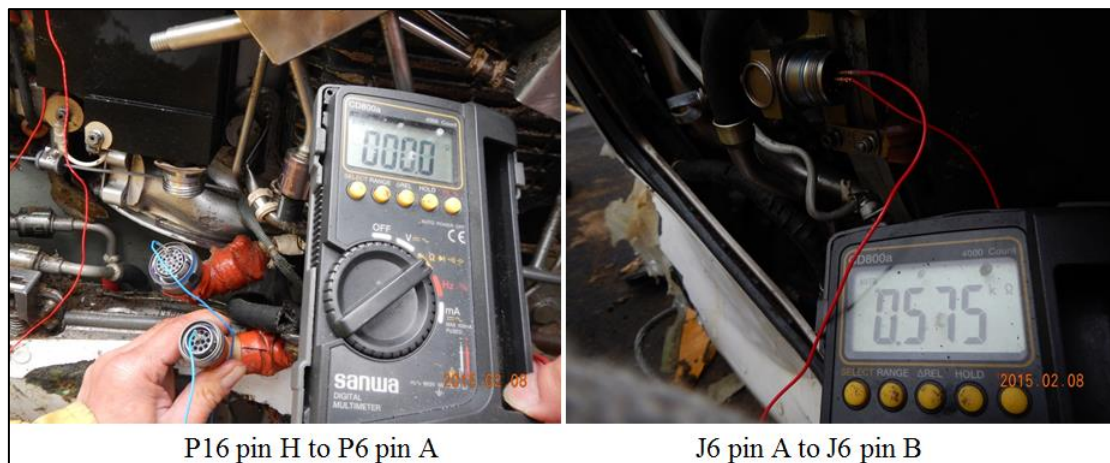
Figure 1.16-2 Continuity check of AFU No. 2 electrical circuit

Point-A	Point-B	Expected	Result
J6 pin A	J6 pin B	553-589 ohms	575 ohms
P16 pin H	P6 pin A	0-0.5 ohms	0 ohm
P16 pin J	P6 pin B	0-0.5 ohms	0 ohm
Insulation resistance (with reference to ground) of torque sensor No. 1 > 2 Mohms

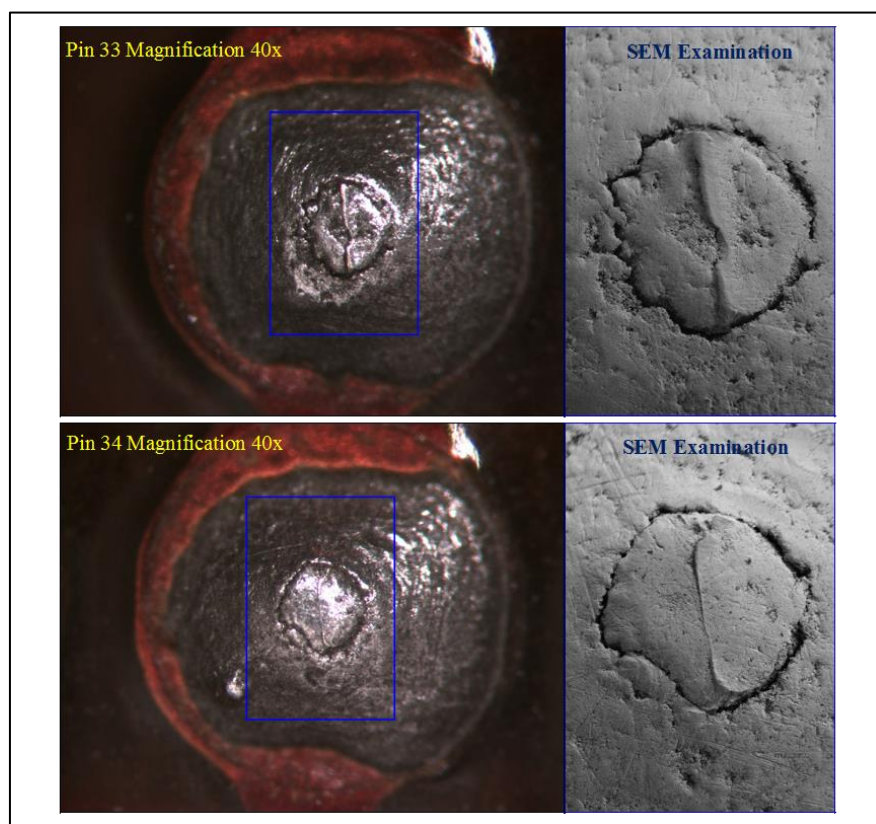
Figure 1.16-4 Microscope (40X magnification) and SEM images for Pins 33 and 34.

microscope and a scanning electron microscope (SEM). Figure 1.16-4 shows the microscope (40X magnification) and SEM images for Pins 33 and 34. The J2 flex circuit connector pins 33-42 were cross sectioned to the component centerline and examined. Figures 1.16-5 and 1.16-6 show the cross sectioned pin to flex solder joints of pins 33 and 34. In the optical cross-section images the lead-rich area was indicated by the grey particles dispersed within the white tin-rich area. In the SEM images the lead area is represented by white and tin by grey. The pin-flex solder joints displayed a coursing of the solder micro structure near the pin on each of the 10 pins in the strip. The condition was most advanced on pins near the end of the strip. The solder microstructure was consistent with enlargement, coarsening and cracking in a stress zone adjacent to the pin/solder interface. Away from this “stress zone” the solder microstructure was very fine.

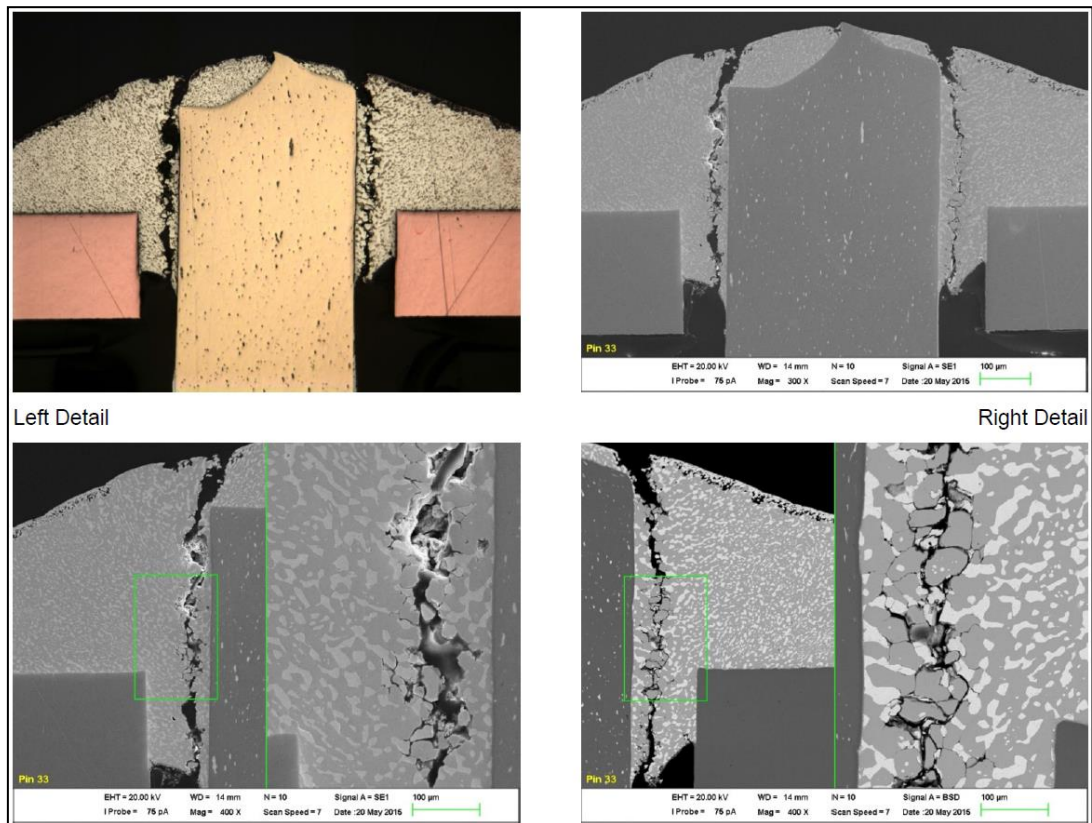
Figure 1.16-5 Cross sectioned pin to flex solder joints of pins 33

1. An intermittent signal discontinuity between the auto feather unit (AFU) number 2 and the torque sensor may have caused the automatic take off power control system (ATPCS):
  - Not being armed steadily during takeoff roll;
  - Being activated during initial climb which resulted in a complete ATPCS sequence including the engine number 2 autofeathering.
2. The available evidence indicated the intermittent discontinuity between torque sensor and auto feather unit (AFU) number 2 was probably caused by the compromised soldering joints inside the AFU number 2.

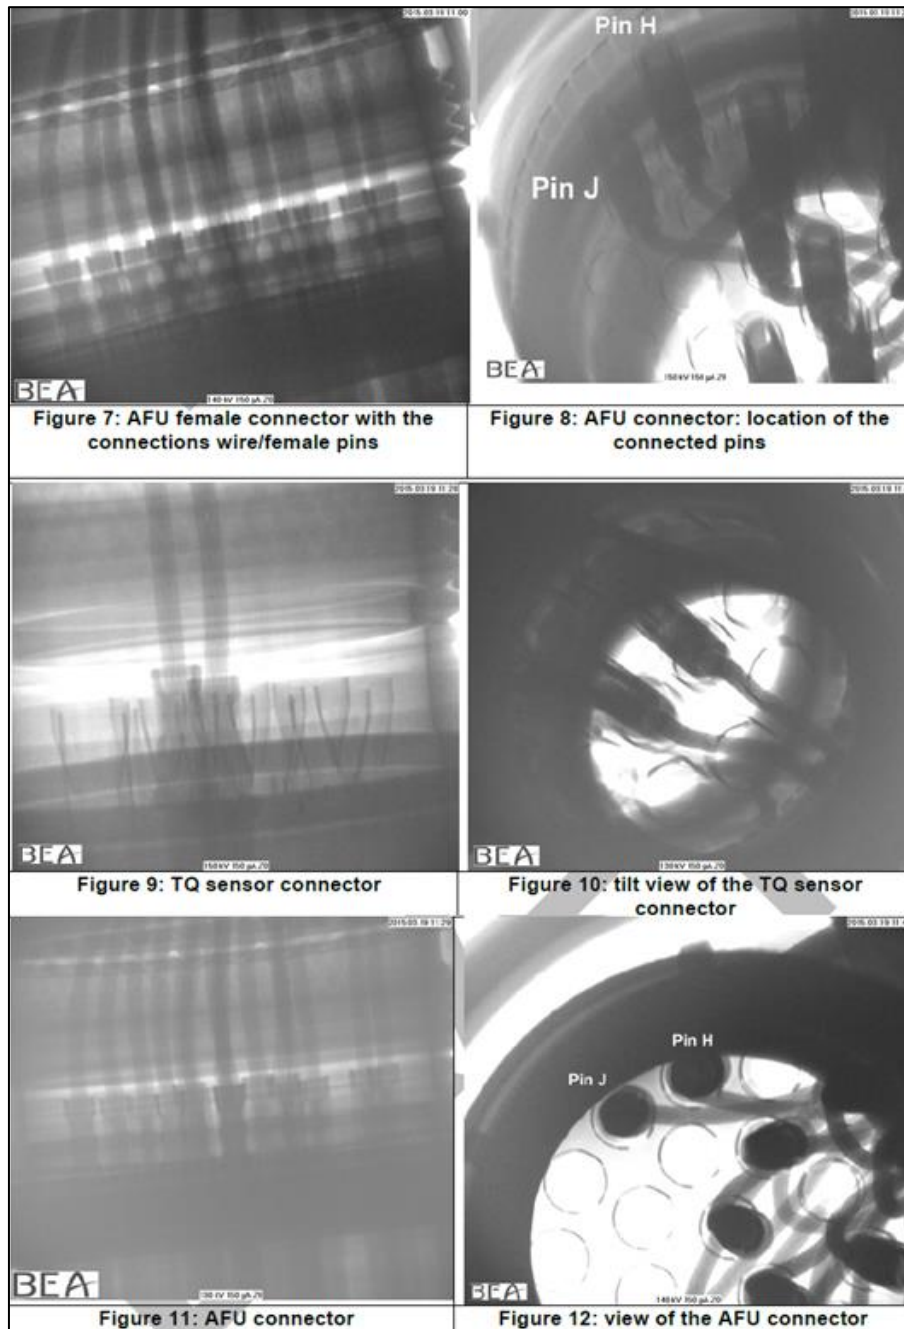
Figure 1.16-8 X-ray examination of AFU and torque sensor connectors

The X-ray examination of both harnesses showed no anomaly. The X-ray pictures of the connectors which connect AFU and the torque sensor of ENG 2 are shown in Figure 1.16-8.

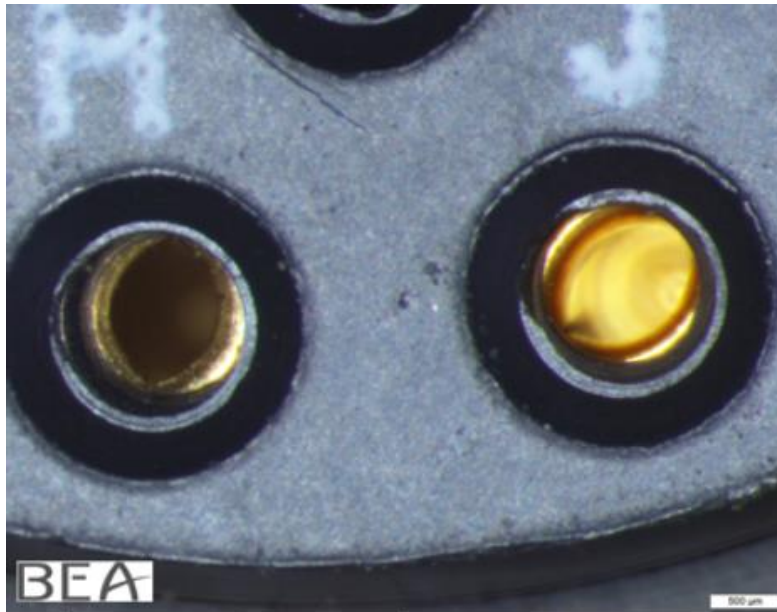
Figure 1.16-9 Connector pins H (left) and J (right) of AFU No. 2

The macroscopic examination identified a difference between pin H on ENG 2 AFU connector and the other pins on that connector. Figure 1.16-9 shows AFU No.2 connector pins H and J.
