Interim Report n°2

on the accident on **1st June 2009**
to the **Airbus A330-203**
registered **F-GZCP**
operated by **Air France**
flight AF 447 Rio de Janeiro – Paris

Bureau d'Enquêtes et d'Analyses
pour la sécurité de l'aviation civile

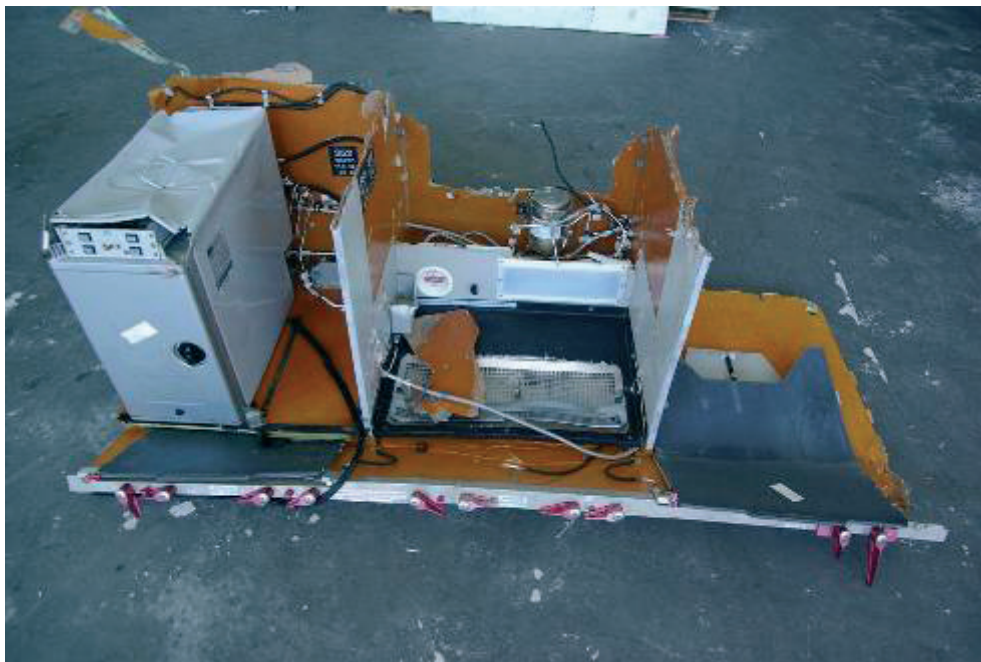
- ❑ A high degree of vertical compression can be seen on the cabin parts such as the galleys, stowage, partitions and toilet doors. This vertical compression is observable from the front (stowage and toilet at the level of door 1) to the rear of the aircraft (Galley G5), and from the right- to the left-hand sides.

Part of Galley G3: downwards deformation at the level of the galley's heavy parts

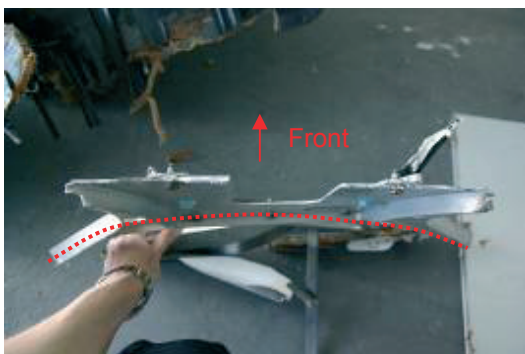
Certain overhead luggage racks were found with their fuselage attachment fittings. Besides the damage due to the vertical compression, these fittings have deformations that are due to a forward movement of the overhead luggage racks.

Luggage rack fitting deformed towards the front

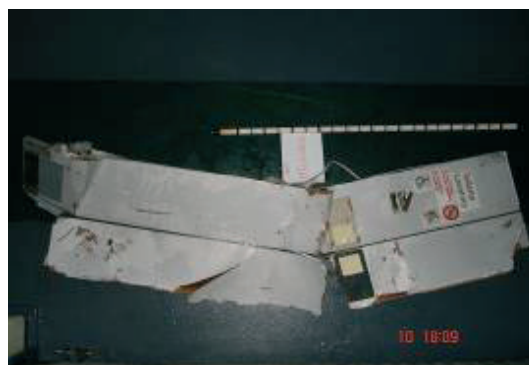
Toilet door (L54) metallic stiffeners deformed by buckling

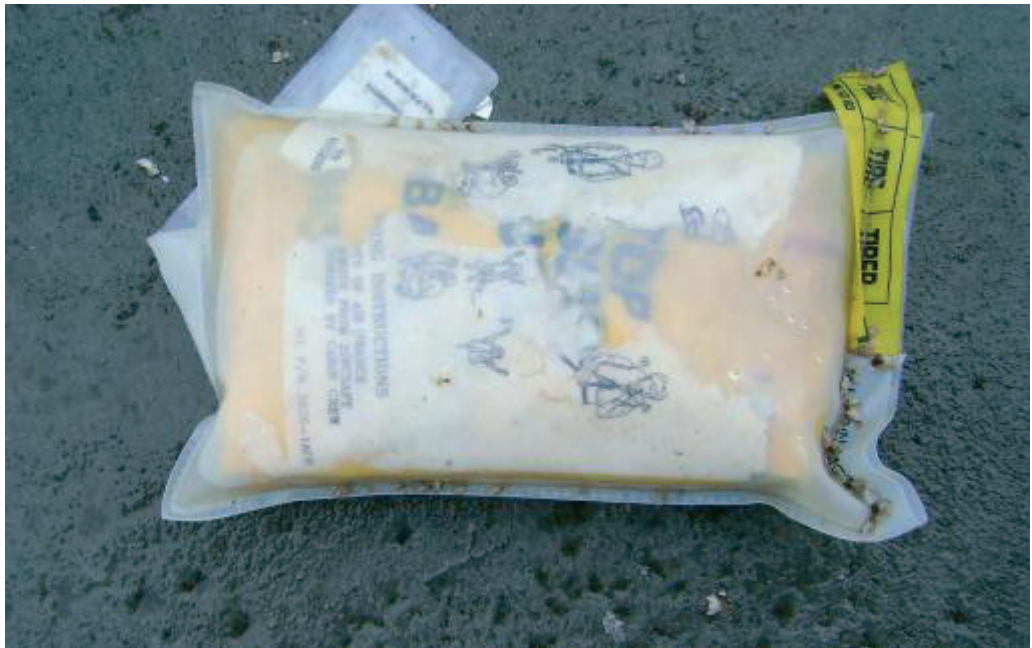
Lifejacket found in its packaging

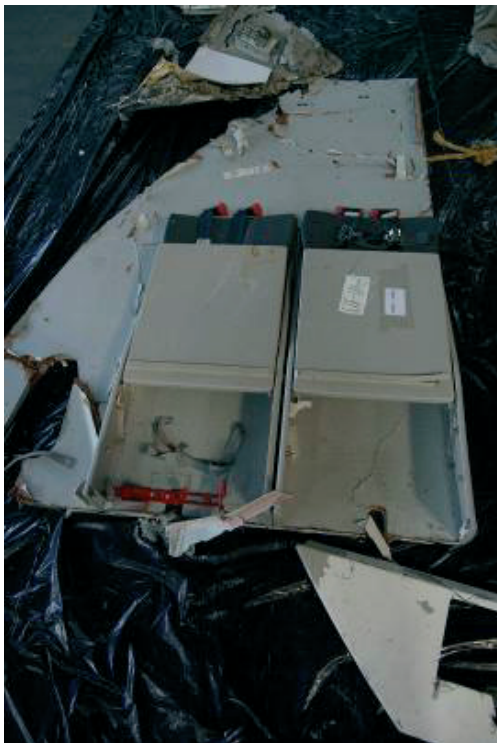
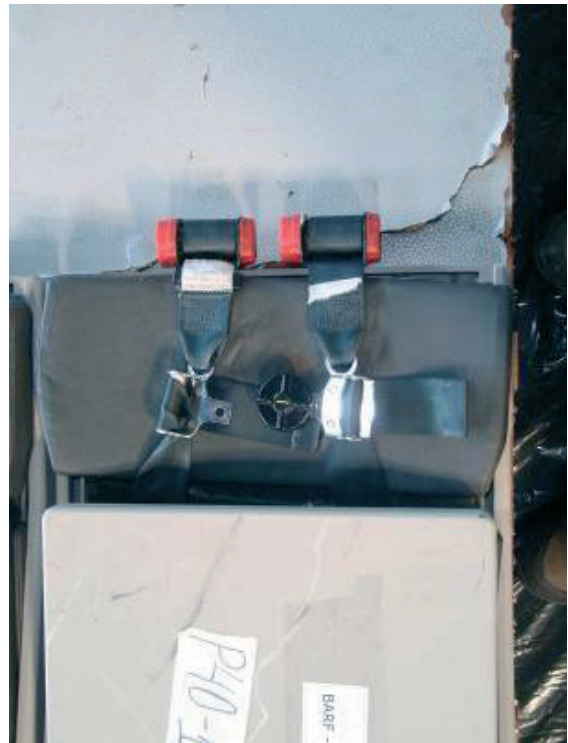
- Three Cabin Crew seats were recovered. The two seats located on the partition at the level of left-hand door 1 (photos below) were not deformed; which was also the case for the corresponding seat belt fasteners and attachments. The seat located at the level of right-hand door 2 was damaged due to the deformation of the partition on which it was attached.

Cabin crew seats located on the toilet L11 partition at the level of left-hand door 1

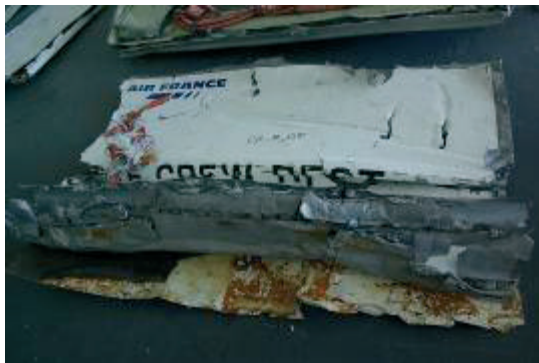
The wall fragments were crumpled. The reconstitution of the ceiling showed it was bent downwards and the floor bent upwards.

Part of the crumpled aft wall

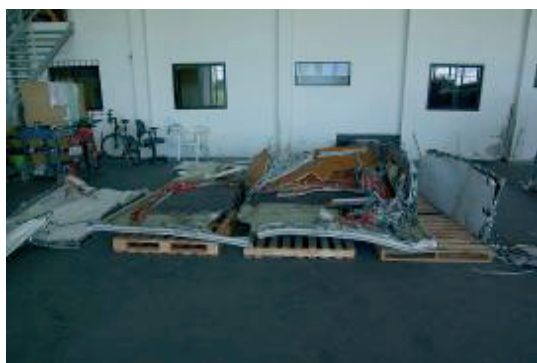
Floor of the LDMCR:
with bottom-upwards deformation

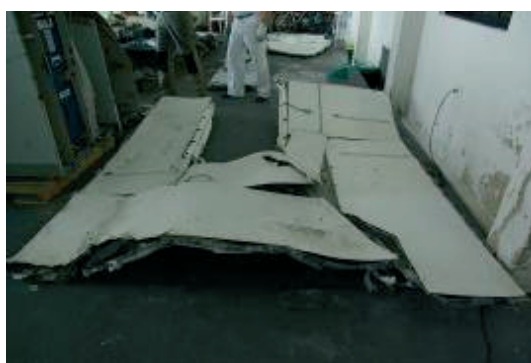
Ceiling of the LDMCR:
with top-downwards deformation

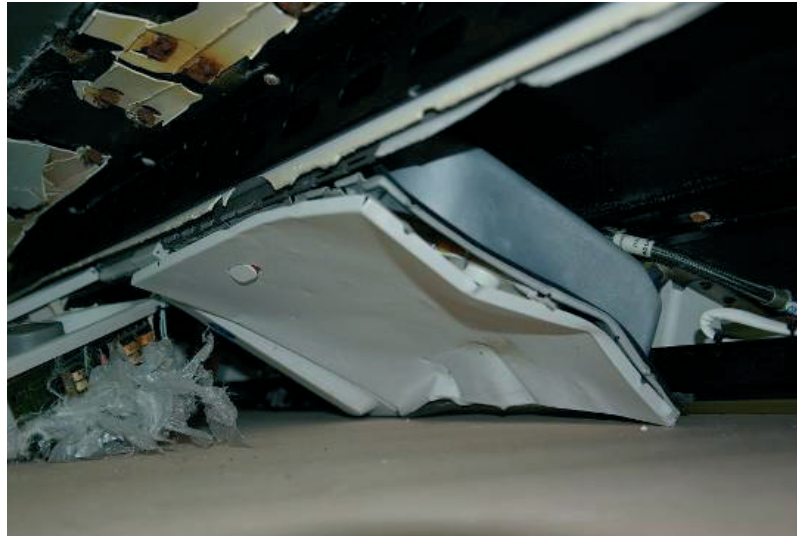
The deformations observed on three of them showed that they were in the closed position.

Passenger oxygen container recovered closed: the deformations on the cover and box match

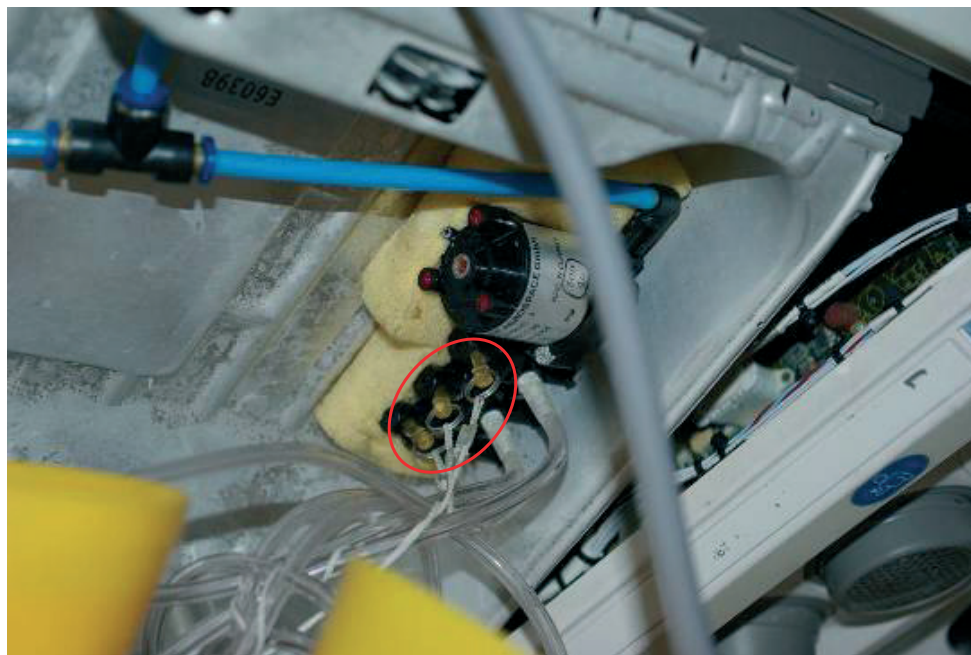
On the less damaged containers, the pins were found in place, closing the oxygen circuit.

Passenger oxygen container recovered open: the three pins are in place

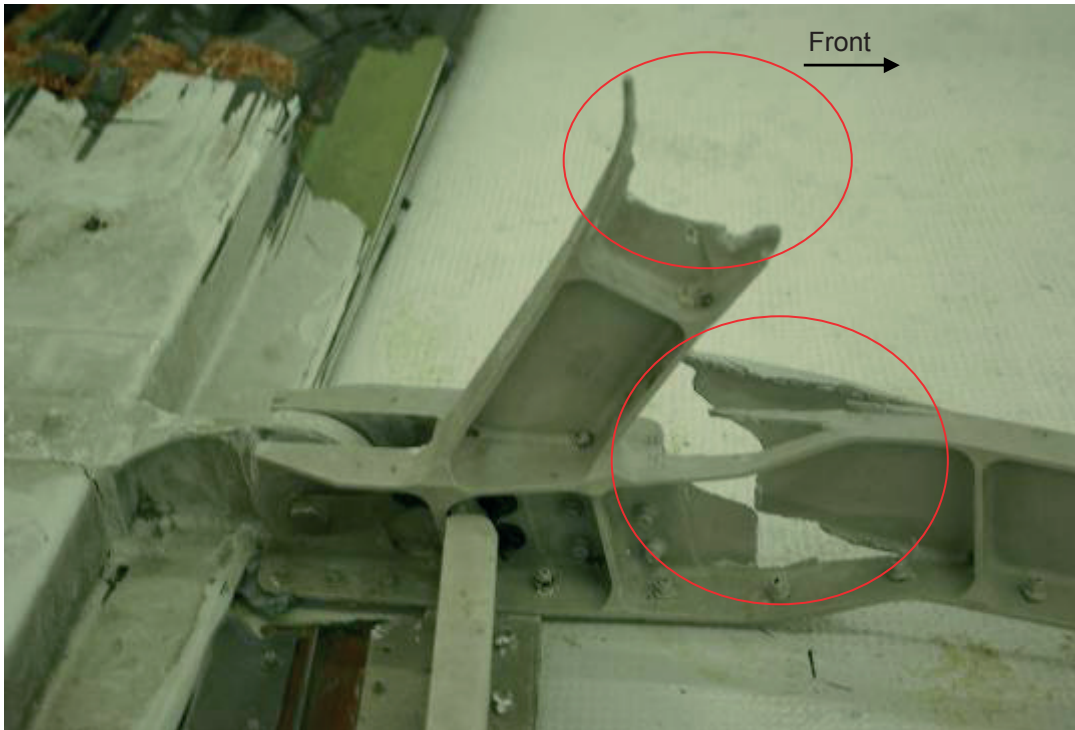
On the left-hand spoiler No. 1 and left-hand inboard aileron, certain fittings attaching the moving part to the wing aft spar were still present. The failures observed on these fittings were the result of the bottom-upwards loads applied on the spoiler or aileron.

Lower surface of left-hand spoiler No. 1 with a piece of the fitting attaching spoiler No. 5 to the wing aft spar: failures due to the bottom-upward loads on the spoiler

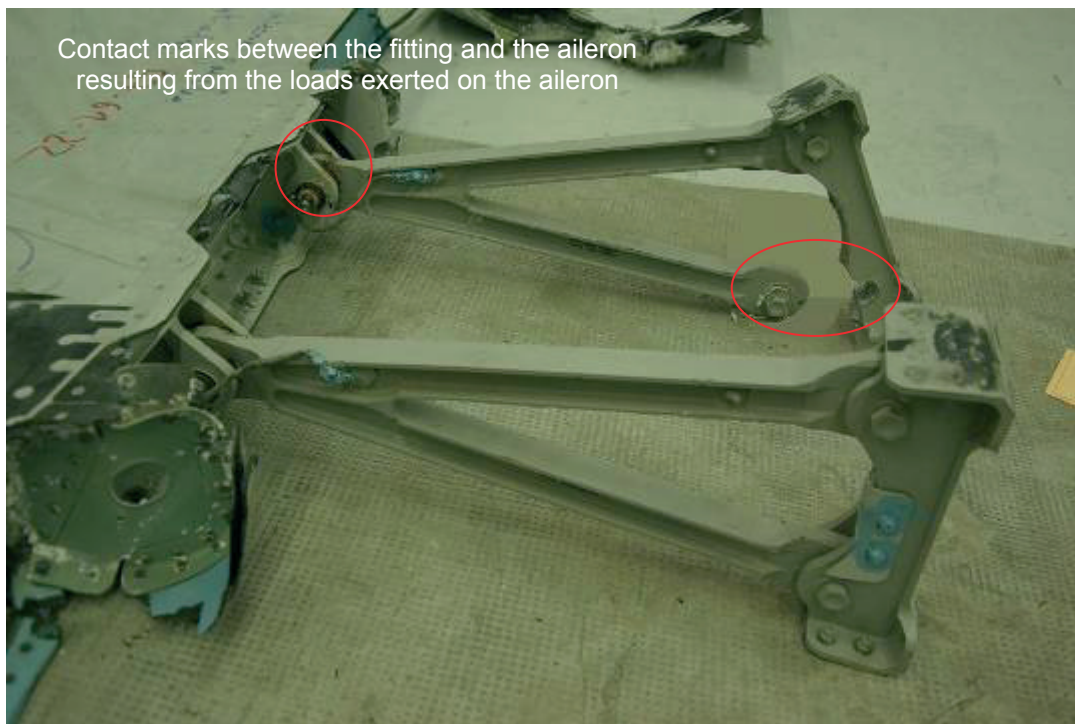
Contact marks between the fitting and the aileron resulting from the loads exerted on the aileron

Upper surface of the left-hand inboard aileron with the fittings attaching it to the wing aft spar: failure due to the bottom-upward loads applied on the aileron

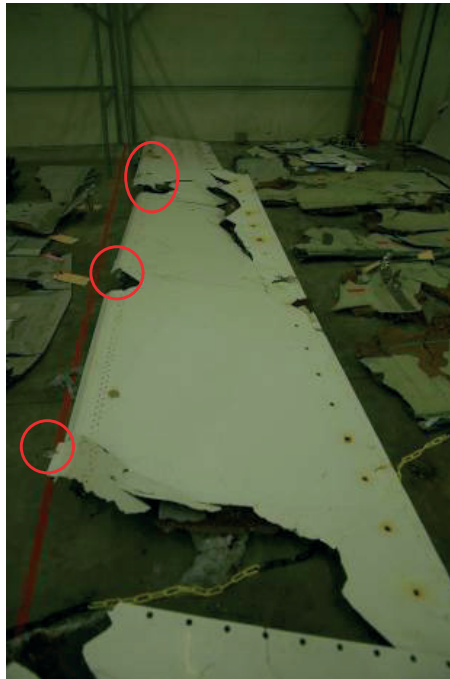
On the right-hand half elevator, four of the seven fittings attaching the elevator to the trimmable horizontal stabiliser were present. They had bottom-upwards deformations.

Outboard half of the right-hand elevator: the four attachments that can be seen were deformed bottom-upwards

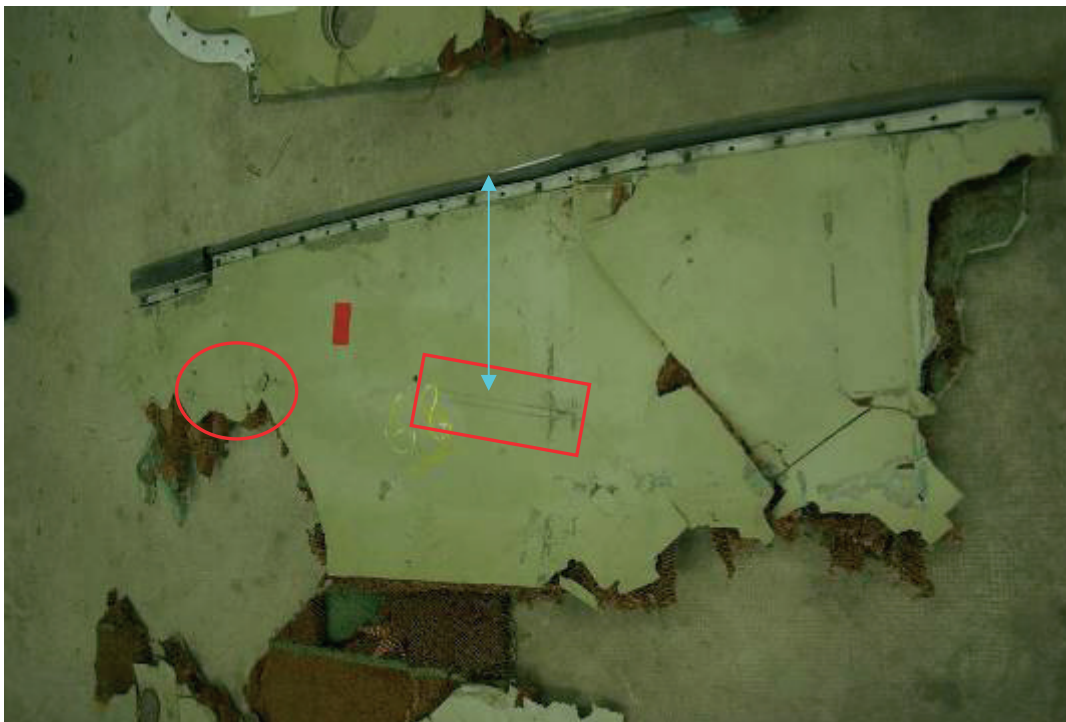
Several parts of the flap extension mechanism fairing were found. There were marks on two of them (positioned at the level of flap track No. 3), made by the flap extension track on impact. Analysis of these marks (morphological and dimensional examinations) and comparison with an identical aircraft made it possible to determine that the flaps were in the "retracted" position at the time of impact with the water (measurement of the distance between the track and the lower surface of the flap, position of the carriage on the track).

Part of the No. 3 flap track fairing on the left wing

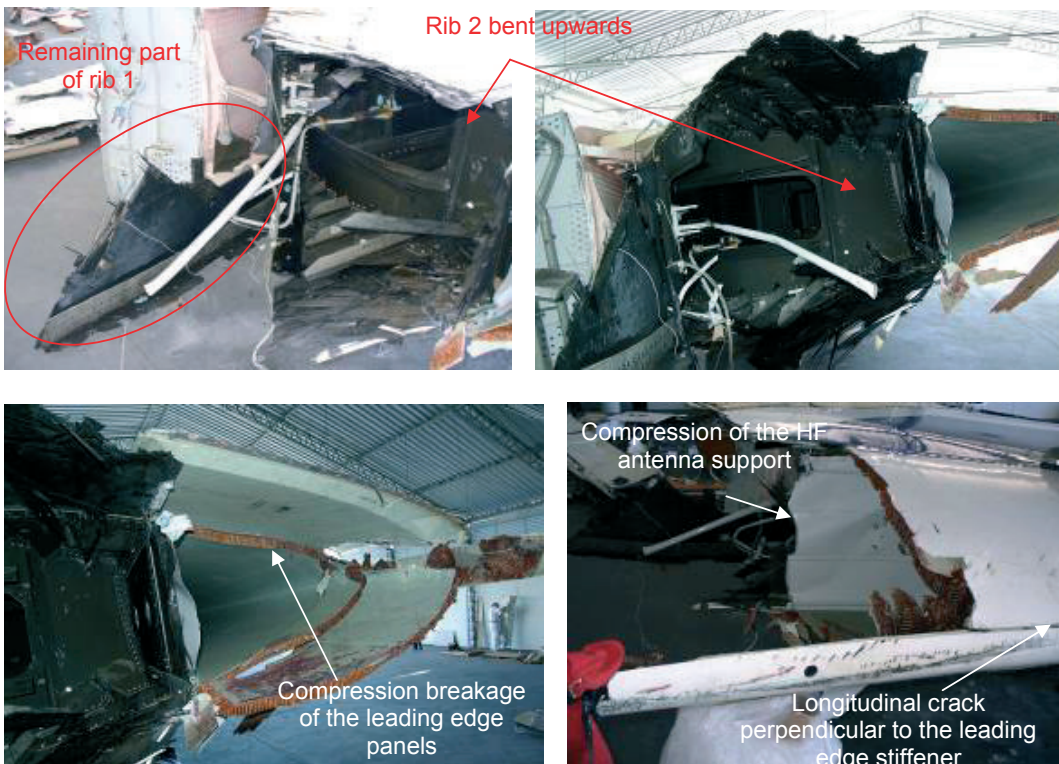
The front of the fin showed signs of symmetrical compression damage:

- ❑ failure of the leading edge right- and left-hand panels
- ❑ longitudinal cracking of the leading edge stiffener
- ❑ HF antenna support (attached to the forward spar): failure of the lower part, crumpling indicating bottom-upwards compression loads

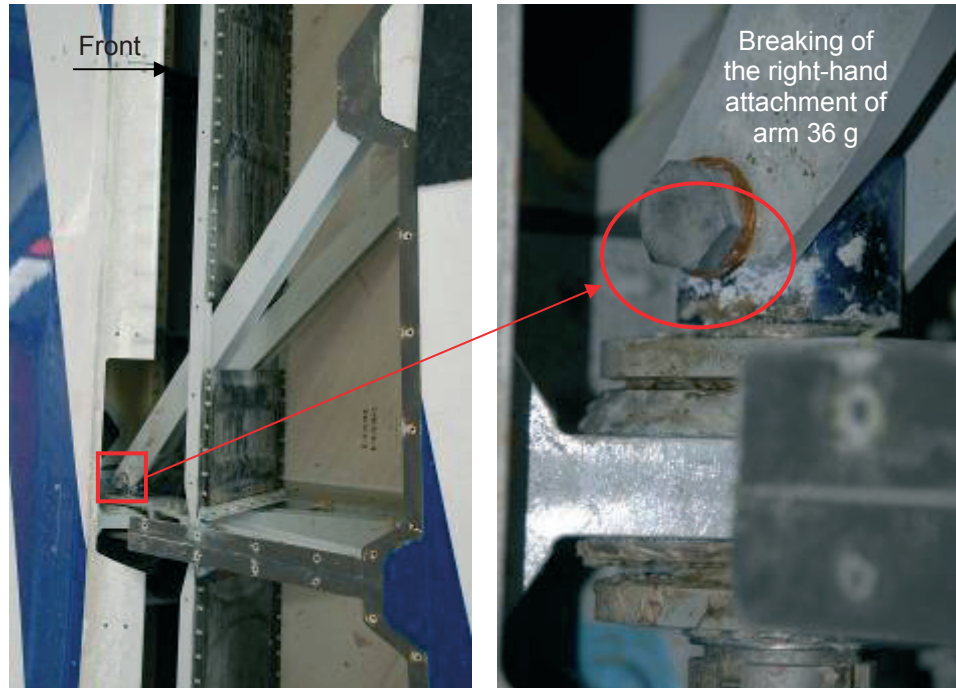
The vertical load pick-up arm in the rudder's hinge axis (arm 36 g) broke at the level of the attachment lug on the rudder side.

The size of this arm is calculated to withstand a maximum load of 120,000 N, corresponding to a relative acceleration of 36 g of the rudder in relation to the vertical stabilizer.

Arm 36 g, right view: failure of the rudder attachments

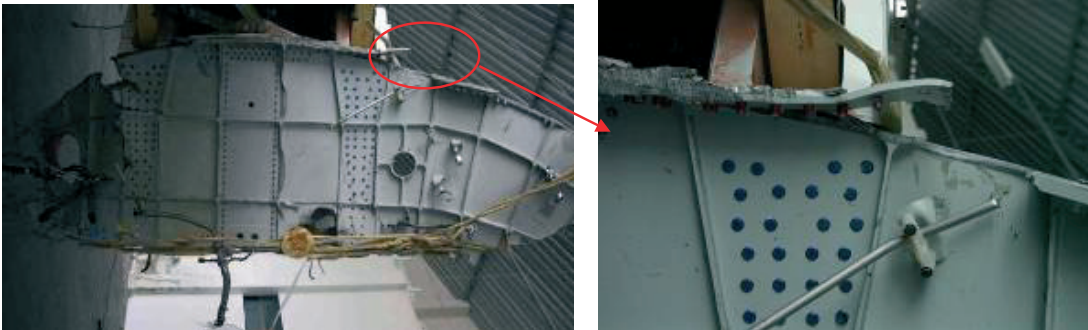
The fuselage was sheared along the frames and centre and aft attachment lugs by loads applied bottom-upwards.

Frame 87: shearing of the frame and fuselage skin along the frame

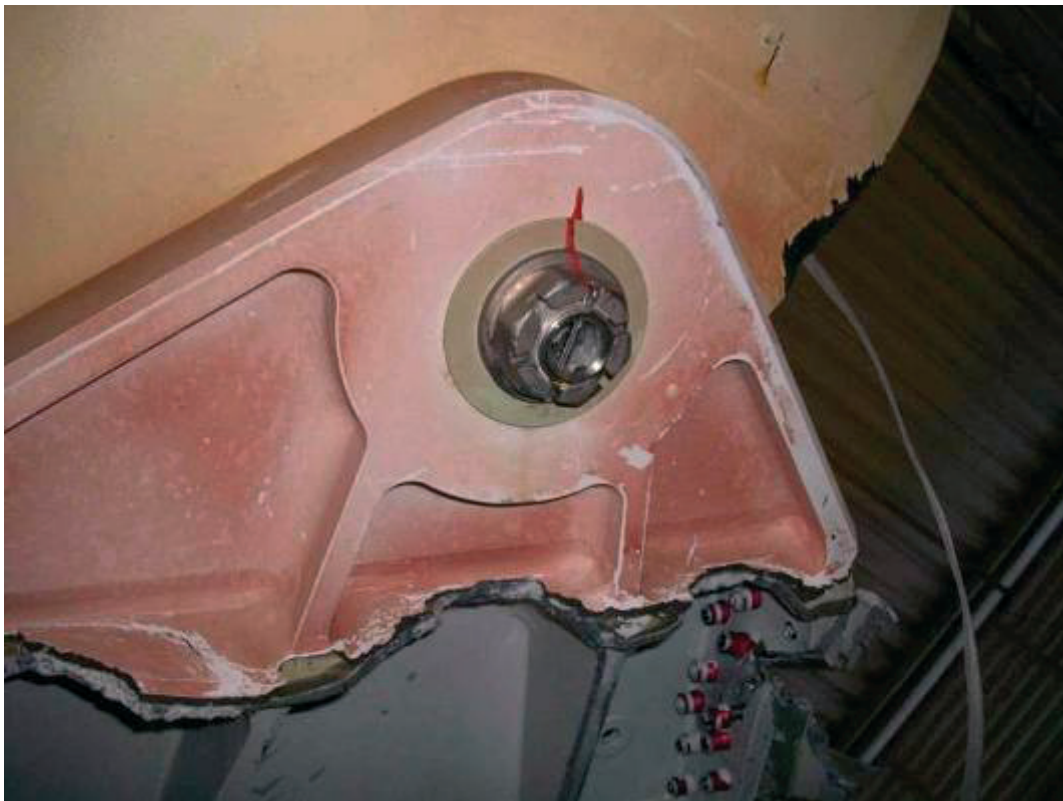
Right-hand aft lug: shearing of the fuselage along main frames 86-87

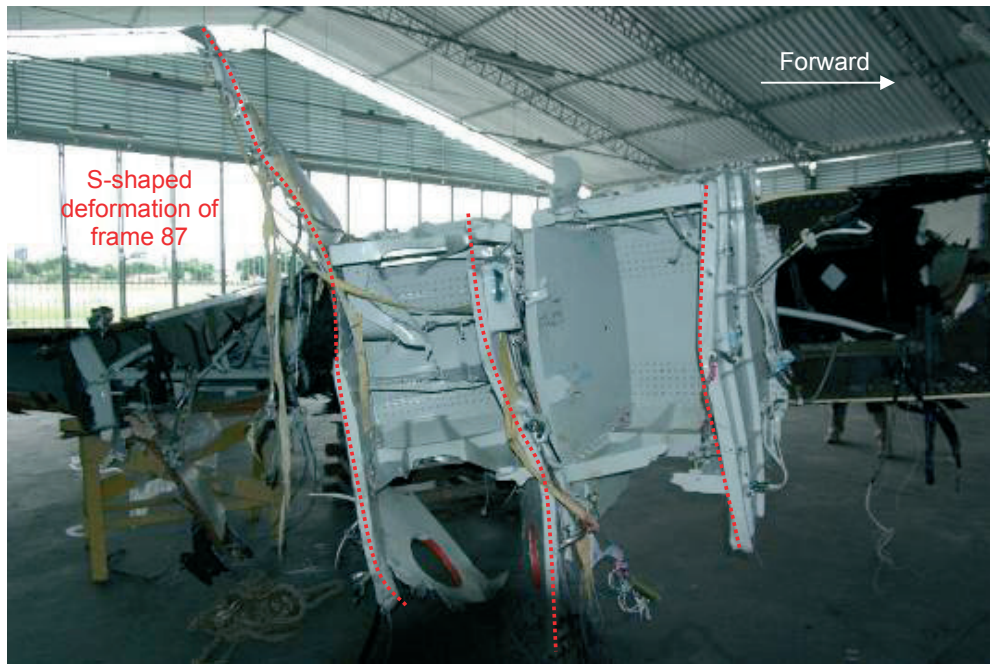
The part of frame 87 that can be seen had undergone S-shaped deformation: the left-hand side forwards, and the right-hand side backwards. The horizontal stabiliser actuator supports were deformed and broke in a backwards movement from the front. These observations indicate a backwards movement of the trimmable horizontal stabiliser.

Frames 84 to 87: S-shaped deformation of frame 87, with frames 84 and 85 pushed in backwards

Frames 84 and 85 were pushed in backwards in the middle. The deformations observed on the rudder control rod are consistent with this indentation.

The deformations of the frames were probably the consequence of the water braking the aircraft's forward movement.

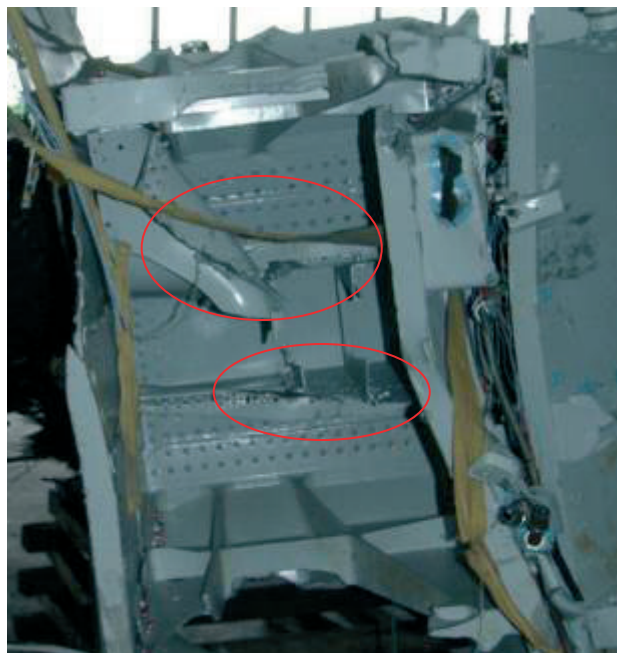
Frames 86 and 87: failure of the horizontal stabiliser actuator supports

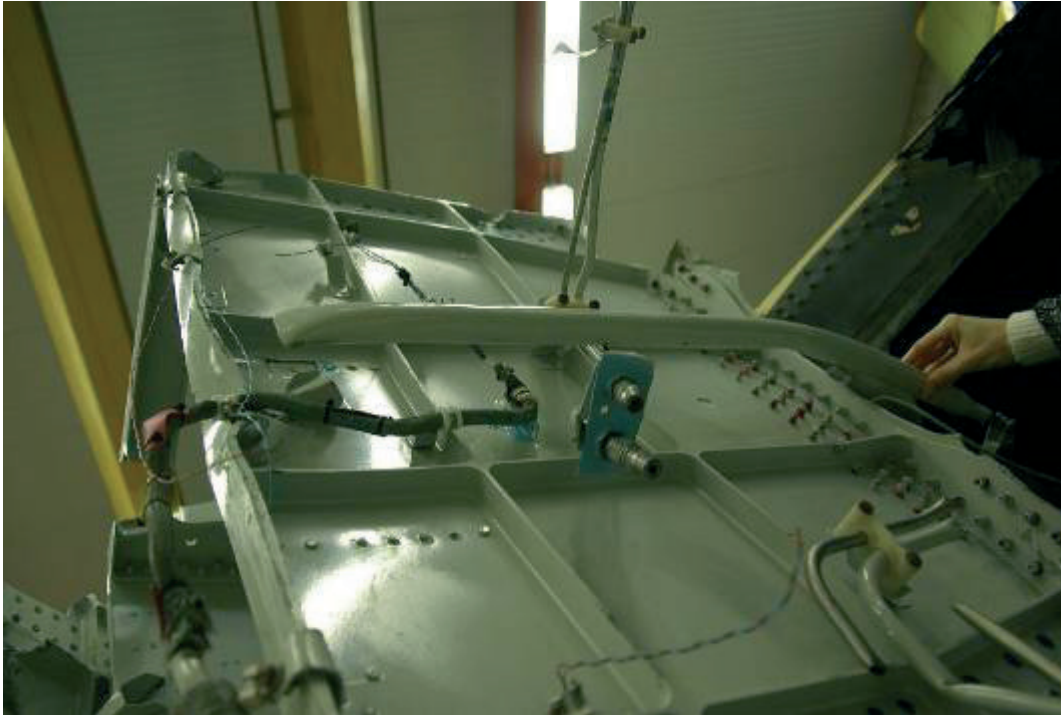
Deformations of the rudder control rod consistent with the backwards indentation of frame 84

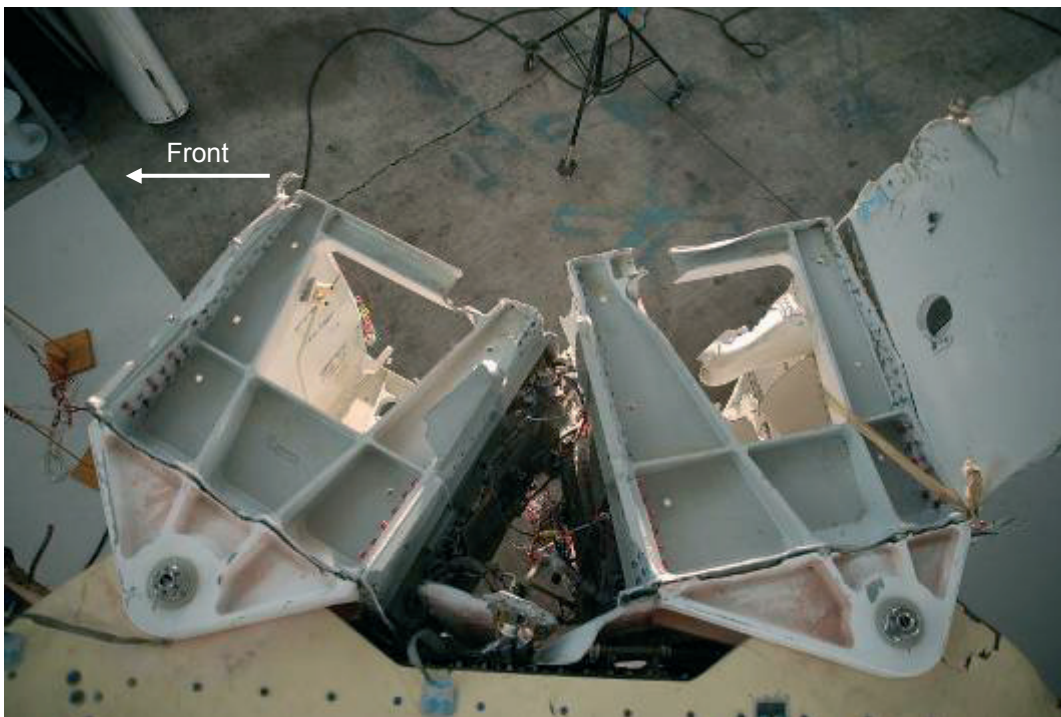
The centre attachment had pivoted backwards with the parts of the frames and web frames that were attached to it. The aft attachment had pivoted forwards with the parts of the frames and web frames that were attached to it.

Fin centre and aft attachments

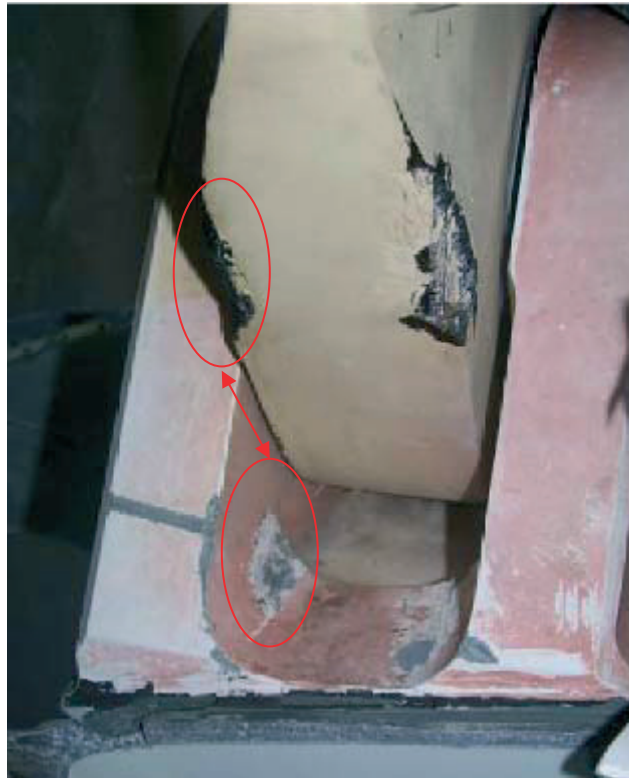
The aft attachment lugs (male on the fin and female on the airframe) had marks indicating a backwards movement of frames 86 and 87 as a whole.

Rear view of the left-hand aft lug: there were marks showing a backwards pivoting of frames 86 and 87

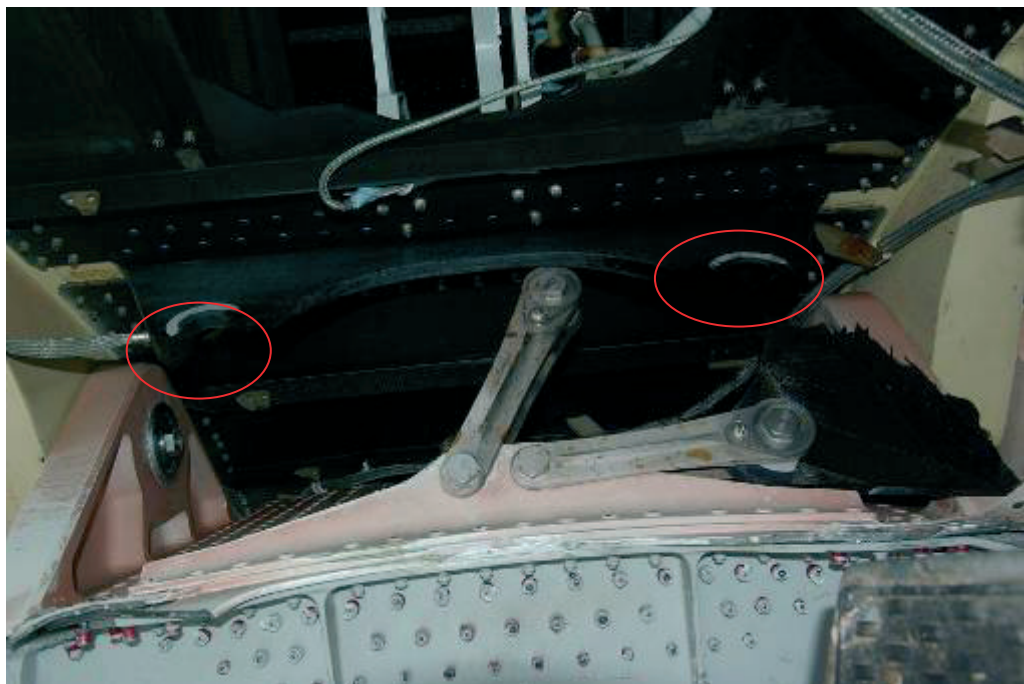
- ❑ tensile failure of the centre spar at the level of the centre rod attachments;
- ❑ compression failure of the aft spar at the level of the aft rod attachments and failure of the left-hand rod by buckling.

Tensile failure of the centre spar at the level of the attachment of the lateral load pick-up rods

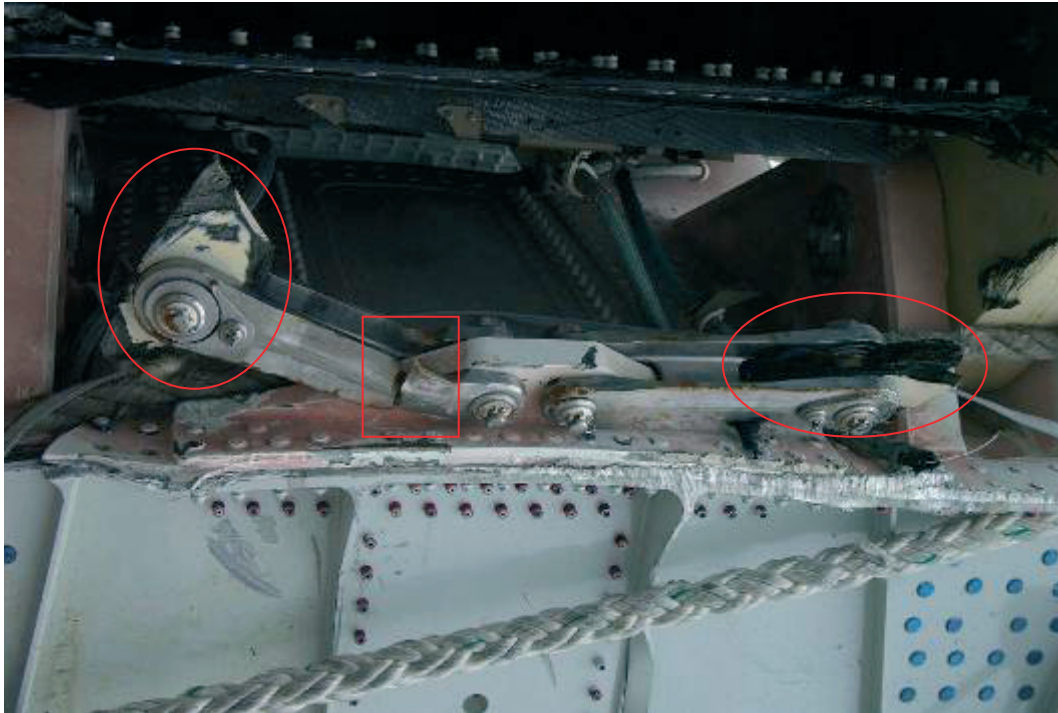
Compression failure of the aft spar at the level of the attachments of the lateral load pick-up rods and failure of the left-hand rod by buckling
