Interim Report n°3

On the accident on **1st June 2009**
to the **Airbus A330-203**
registered **F-GZCP**
operated by **Air France**
flight AF 447 Rio de Janeiro - Paris

Bureau d'Enquêtes et d'Analyses
pour la sécurité de l'aviation civile

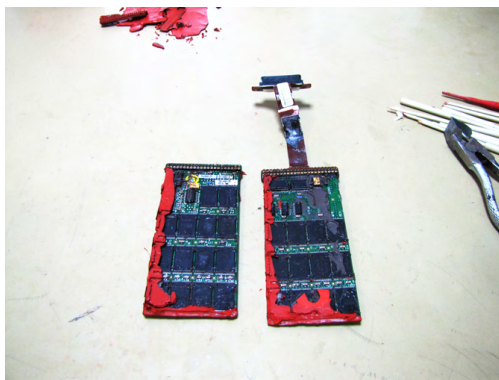
CVR memory boards after cleaning

Visual inspection of the boards revealed damage: a capacitor and a resistor were cracked on one of the boards; two decoder-type components were damaged on the other board.

The boards were placed in an oven for 42 hours. The damaged components were unsoldered and replaced. The impedance value measured at the input connector complied with the measurements made on reference boards.

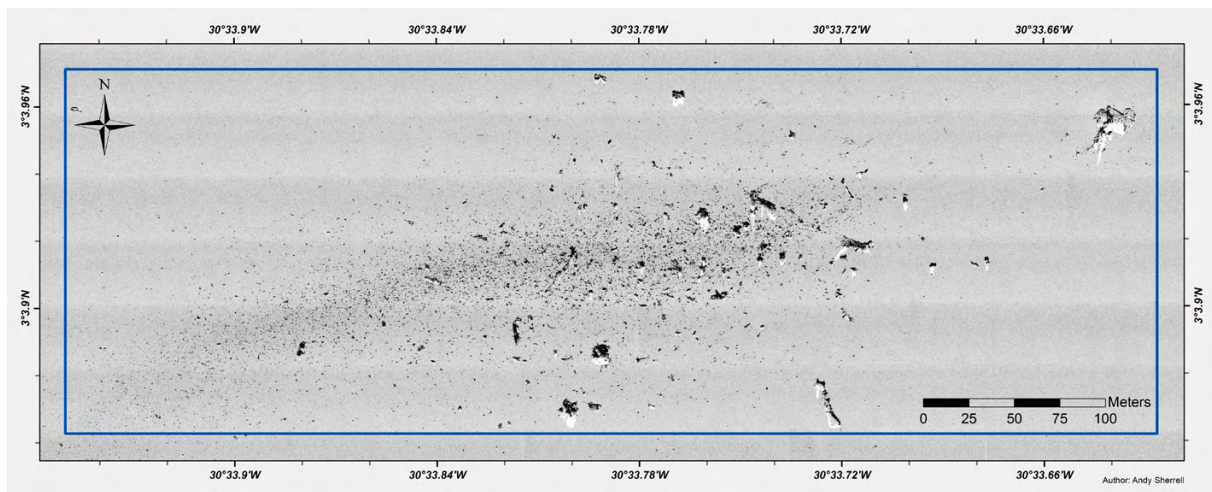
The densest debris (central section, engines, APU, landing gear) was found to the east of the site and the lighter debris to the west.

Outside the main area of 600 metres by 200 metres, a rear left fuselage panel containing eleven windows and around seven metres long was found approximately two kilometres south-west of the area. Part of the lower surface of the trimmable horizontal stabiliser was also found slightly to the south-west of this area.

Sonar images of debris field

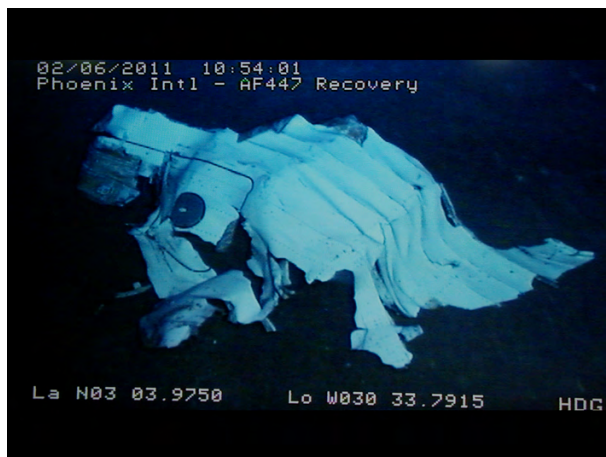
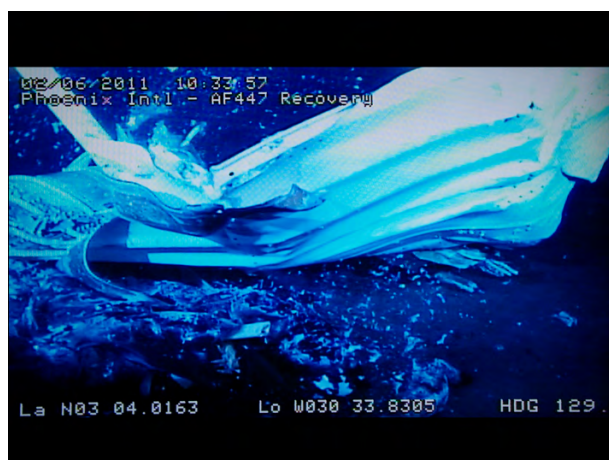
The lower elements of the fuselage were badly broken up and deformed. In these areas, crushing of the sheet-metal between the ribbing was noted, which indicates a vertical component at the time of impact.

Parts of the fuselage

The upper elements of the fuselage are generally larger. They often had significant lengthwise folding.

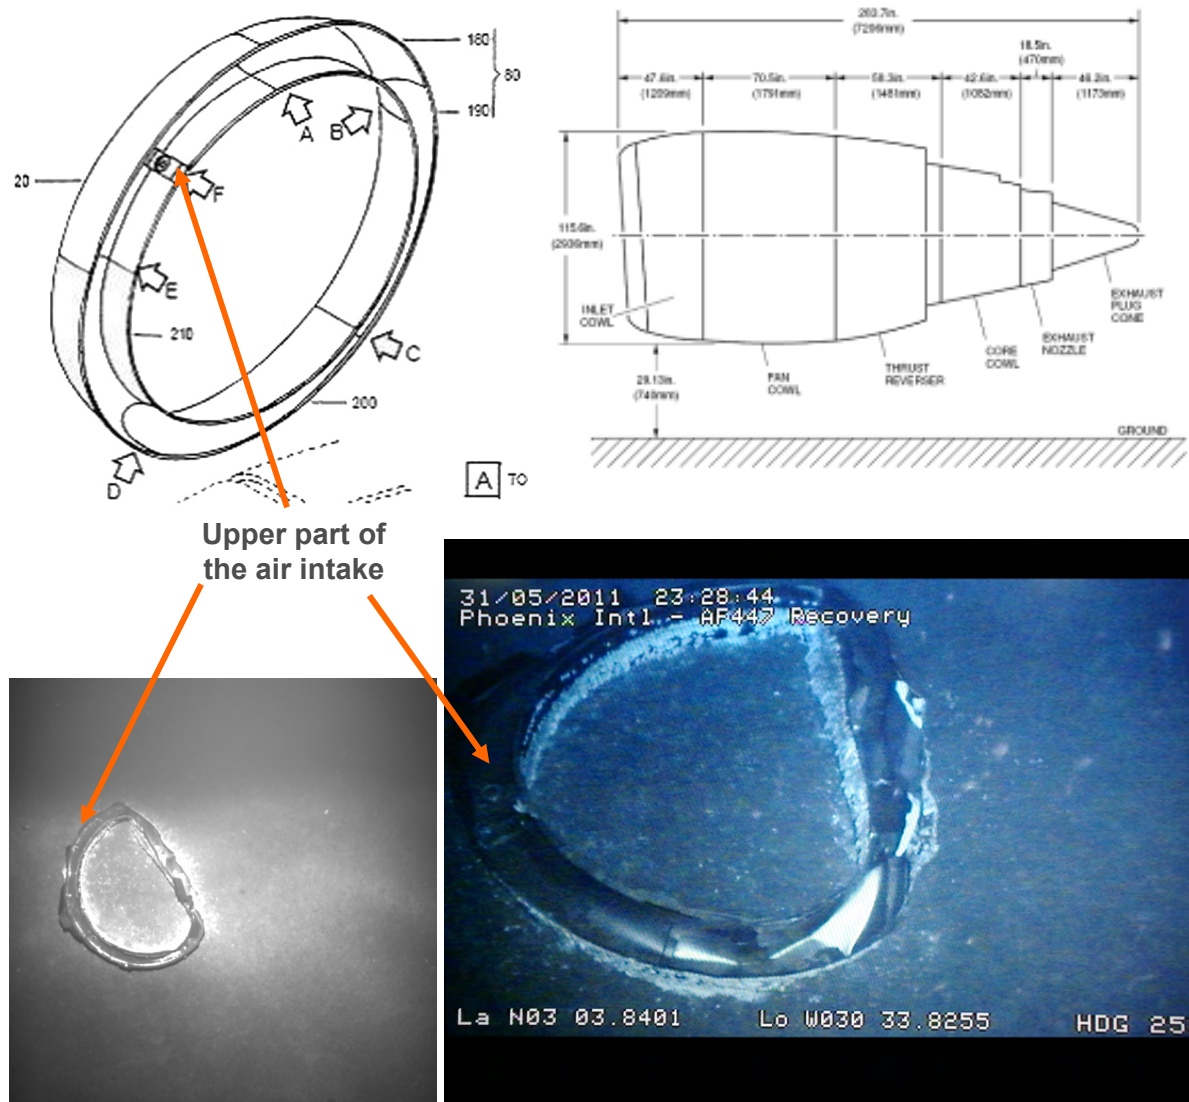
From the images supplied by the AUV REMUS and by the ROV, the leading edge of the left engine air intake showed a significant rectilinear deformation on its lower part.

Left engine air intake

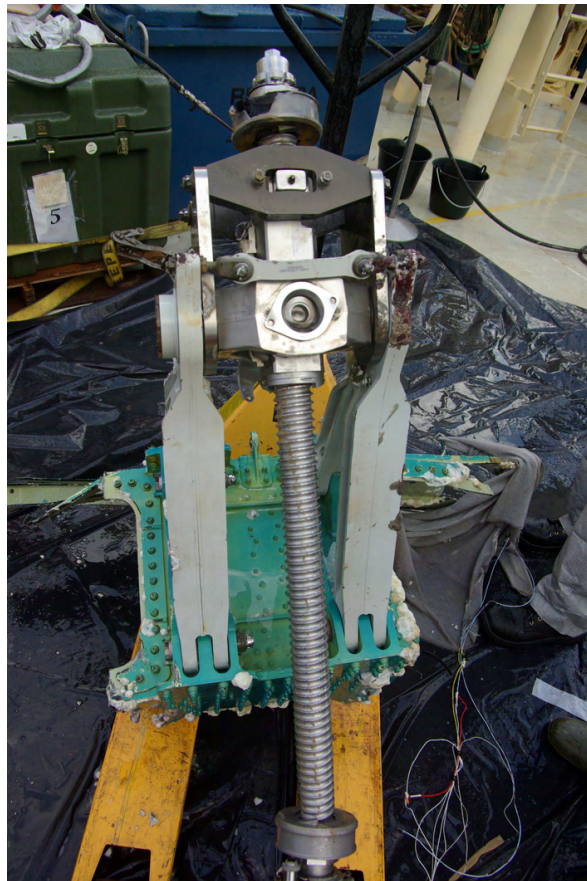
According to the manufacturer's technical documentation, the relative position of the actuator and the THS screwjack corresponded to a THS position of between 13° and 13.5° nose-up.

Trimmable horizontal stabiliser screwjack after being raised on board

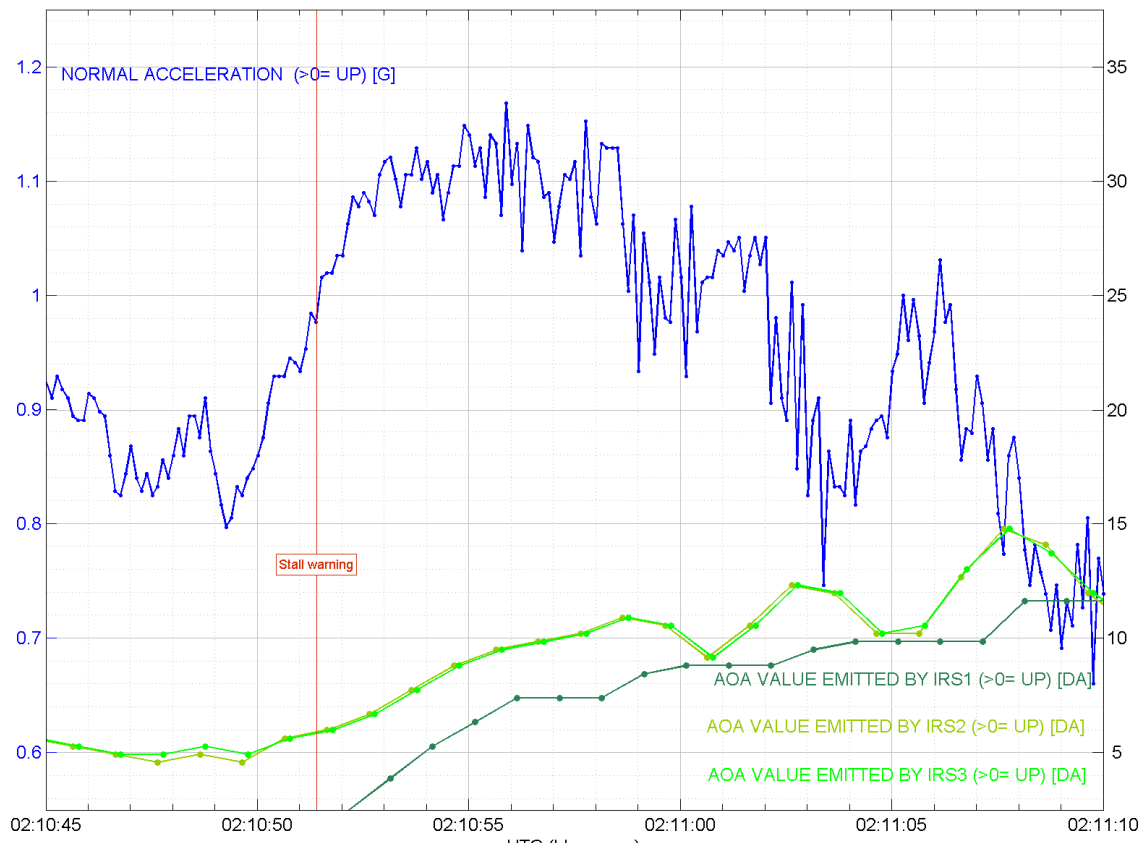
At 2 h 10 min 51, when the aircraft was at about 37,500 ft and still climbing, the stall warning was activated (refer to 1.6.3). A change in the recorded normal acceleration behaviour was revealed from 2 h 10 min 53, at an angle of attack about 1 to 2 degrees greater than the warning activation threshold.

*Evolution in the normal acceleration
recorded at the time of the triggering of the stall warning*
