# **Directorate of Aircraft Accident Investigations**

Accident Reference: ACCID/112913/1-12

# Aircraft Accident Investigation Interim Report

11/29/2013 Embrear 190 C9-EMC Bwabwata National park. NAMIBIA

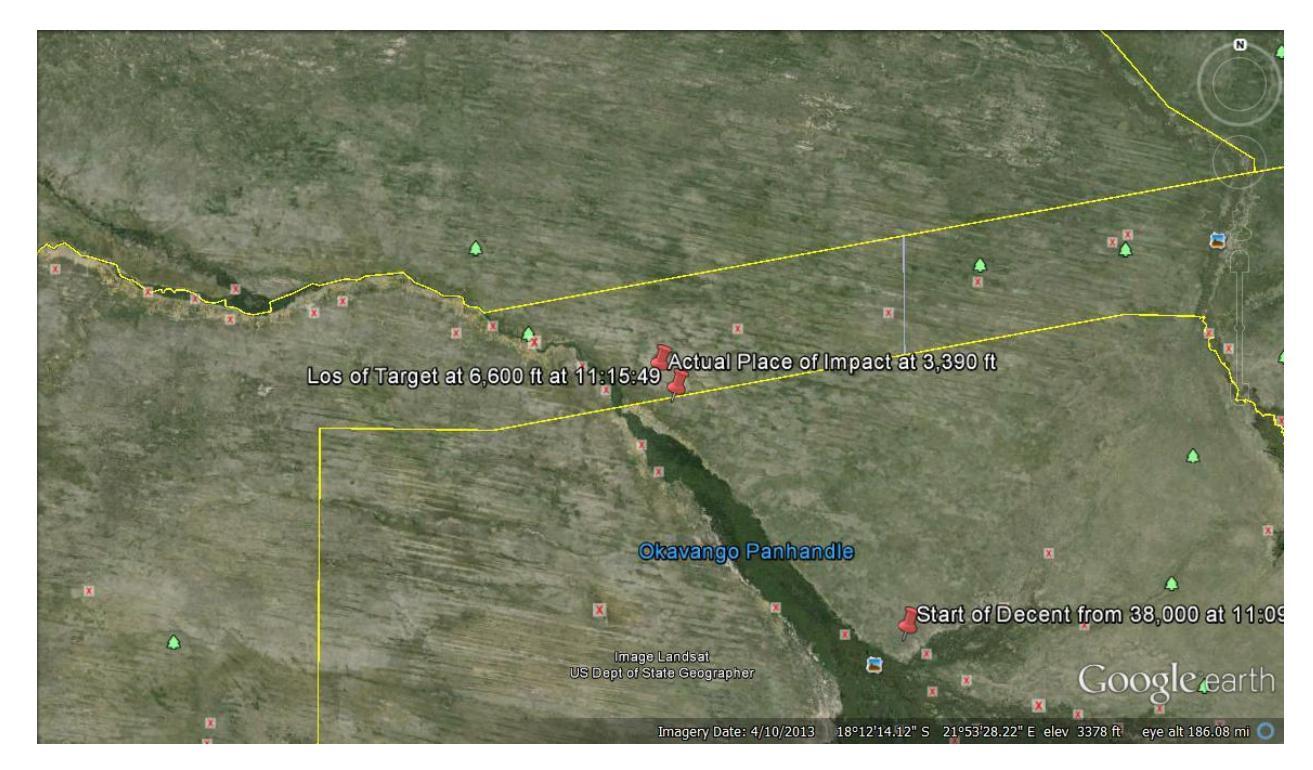
Map1 : Estimates from descent point to Radar loss Gaborone Airspace by the Namibian radar

Horizontal distance from top of descent to loss of radar 87.4 Km Vertical distance from top of descent to radar loss 9 571m Time taken from the descent till loss of Radar 6 min 43 sec

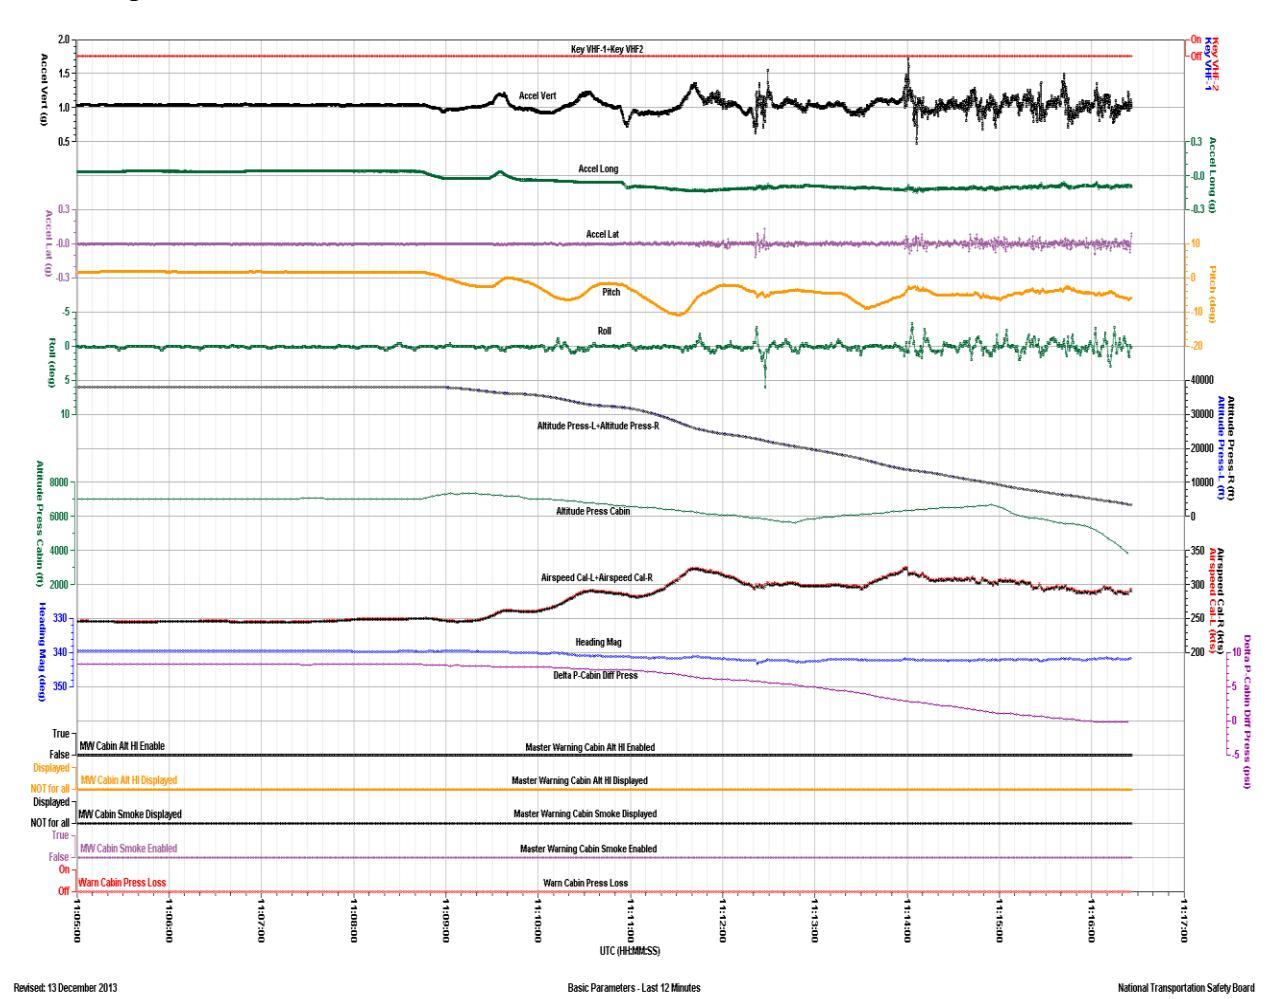
### GRAPH 1 Basic parameter of the last 12 minutes of descent.

1.16.1 The FDR/CVR recorders were sent to the National Transport Safety Board (NTSB) laboratories in Washington DC, USA (NTSB) for readout. Engineering Data taken from the FDR analysis at NTSB containing various commands inputs of the flights controls as well as Auto-Pilot were plotted against the time frame analysis of the last 12 minutes of the flight.

The last 12 minutes of the flight was replicated on a simulator as from **11:04:04** UTC to **11:16:25** UTC.

The behaviour of the simulator was very close to the parameters recorded of the occurrence on the FDR.

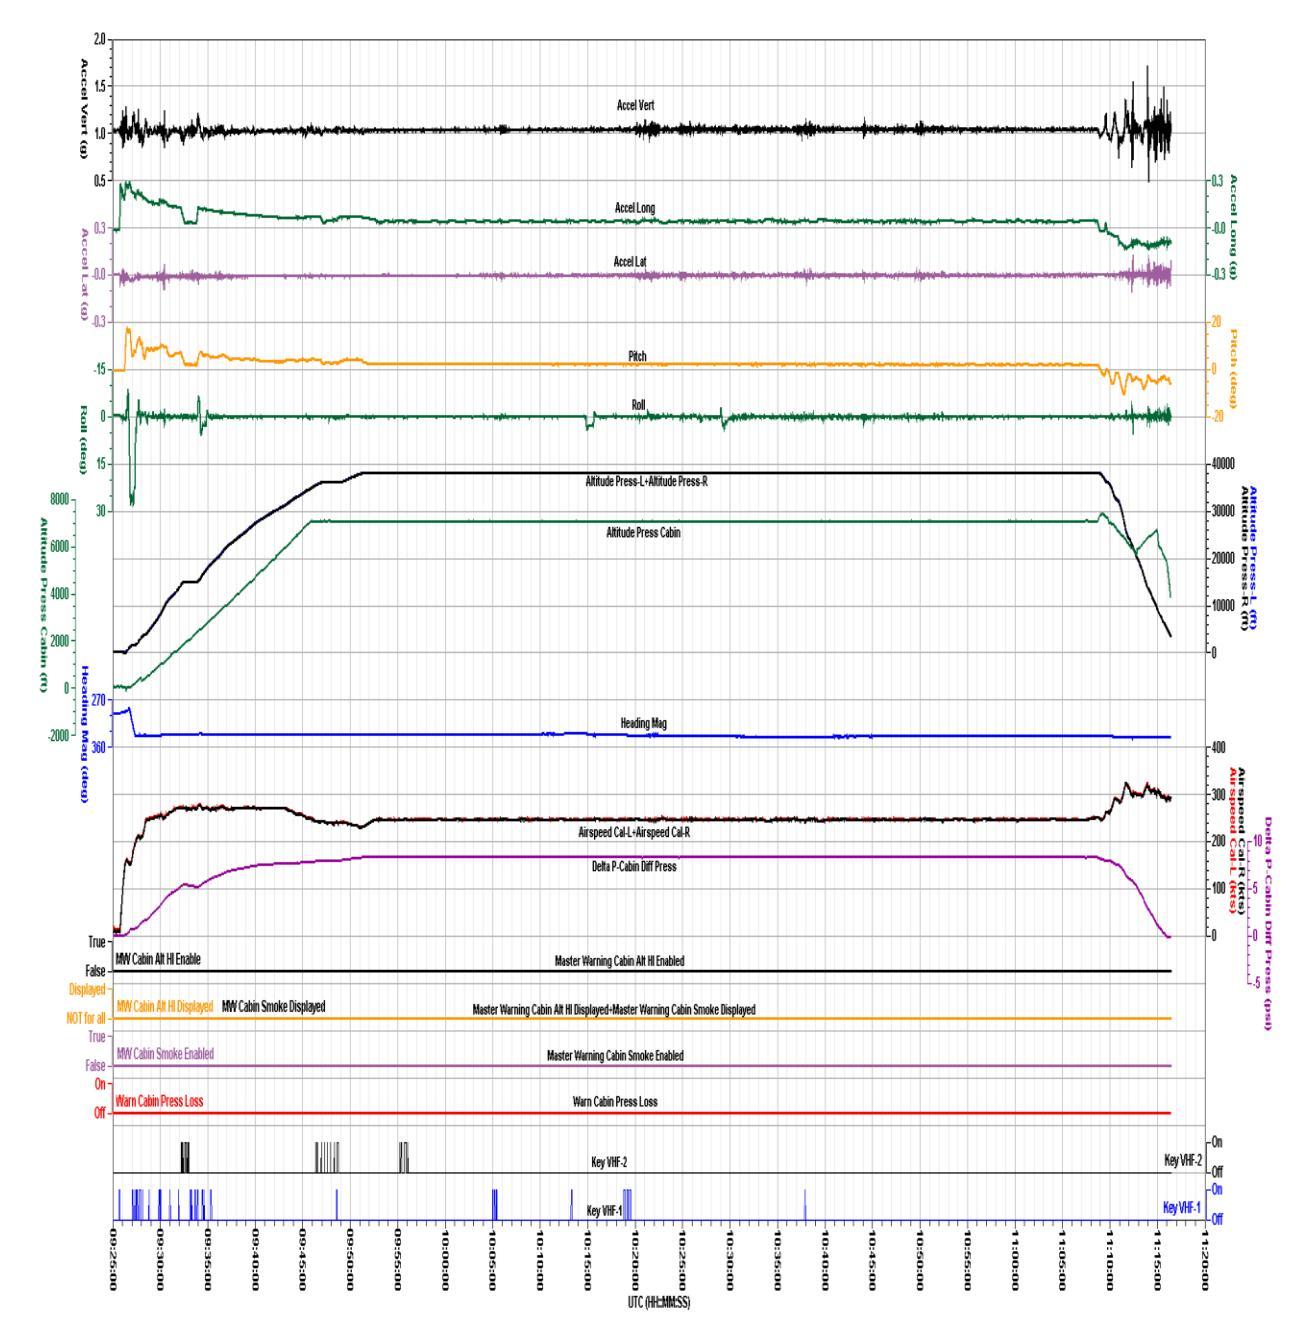
## Graph 2 Basic parameters of the entire flight

DFDR Data show the aircraft performing a normal take-off, climb and cruise. Only after approximately 1h 39m was there any anomaly as per flight plan. At this time 11:04 UTC The aircraft was flying at FL380, with ALTITUDE PRESELECTOR set to 38000 ft. Autopilot was engaged (and remained engaged until the end of recording) with flight director vertical mode VALT (FMS altitude hold).
