MH370 - Definition of Underwater Search Areas

ATSB Transport Safety Report

External Aviation Investigation AE-2014-054 26 June 2014 *(updated 18 August 2014)*

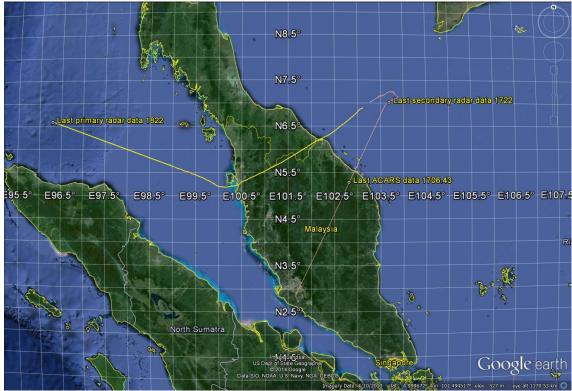
Figure 2: MH370 flight path derived from primary and secondary radar data

- The final primary radar fix occurred at 1822 (Figure 2)
- The satellite communications log indicated the aircraft continued to fly for another 6 hours until 8 March 0019
- No confirmed eye-witness reports were received
- No Emergency Locator Transmissions were received
- The search in the Australian search and rescue zone commenced on 18 March (10 days after the aircraft went missing)

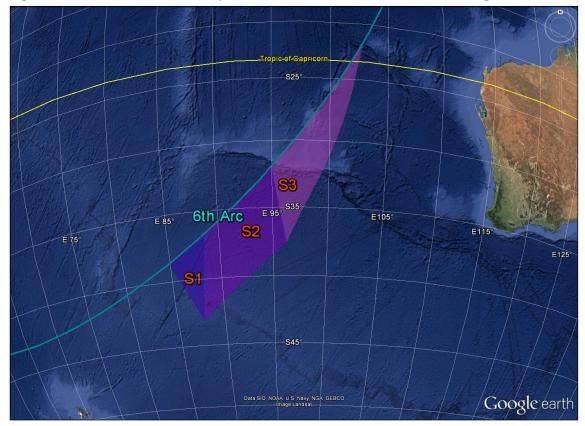
Figure 3: Possible southern final positions S1-S3 based on MH370 max range and time

Areas in the Southern Indian Ocean designated S1 $-S3^6$ were defined from the aircraft's predicted performance and endurance (Figure 3). Two speeds resulted in the longest, straightest tracks to the 6th arc⁷ and were used to define possible impact locations within areas S1 and S2.

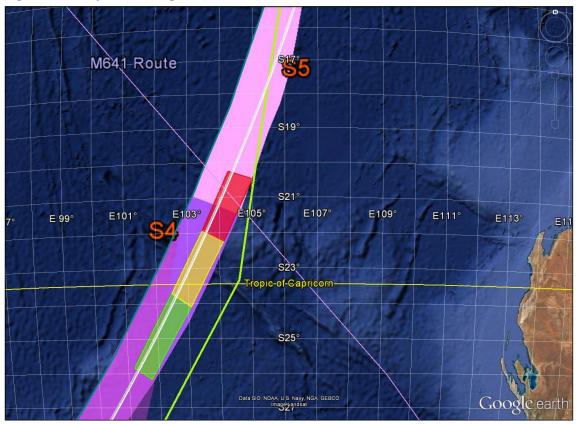
Figure 5: Red, yellow and green boxes within S4-S5 and M641 route

On 1 April (D25) the JIT advised AMSA/ ATSB of further aircraft performance and path analysis starting at a distance further NW of Sumatra that had the effect of shifting the most probable area NE within S4 and into S5. Probable impact areas red, yellow and green were defined within S4/S5 (Figure 5).

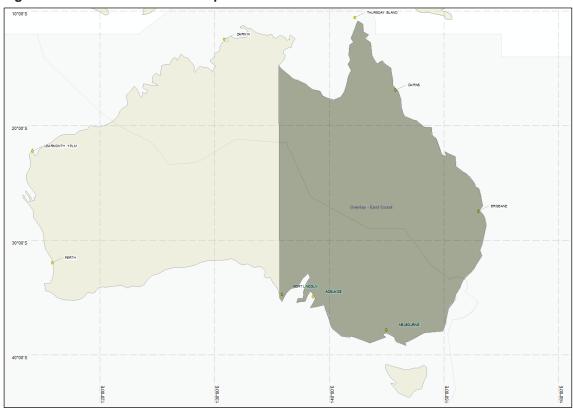
Figure 7: D21-52 drifted area comparison – East Coast Australia

For one month from 28 March (D21), areas along the 7th arc in the S3, S4 and S5 areas were drifted to guide the conduct of the surface search. The original and drifted areas are shown in Figure 6, comparison to other regions shown in Figure 7 - Figure 10.

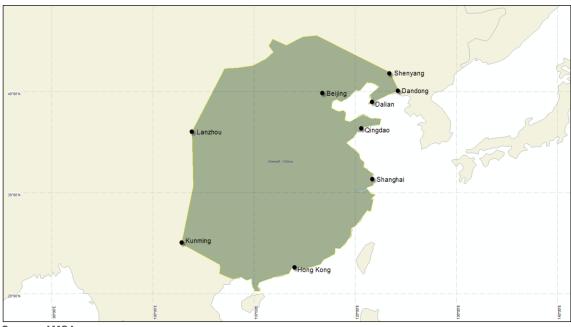
Figure 10: D21-52 drifted area comparison – China

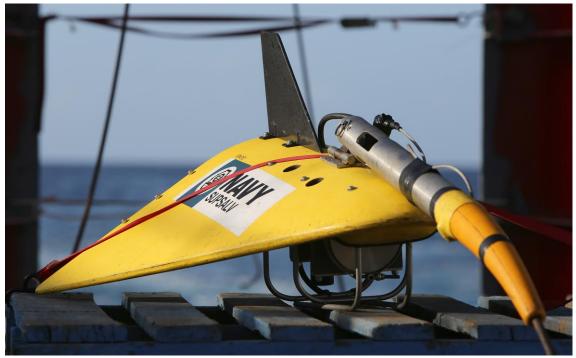
- Detectable frequency range: 3.5 kHz 50 kHz
- Maximum operating depth: 6,000 m

Figure 11: TPL towfish

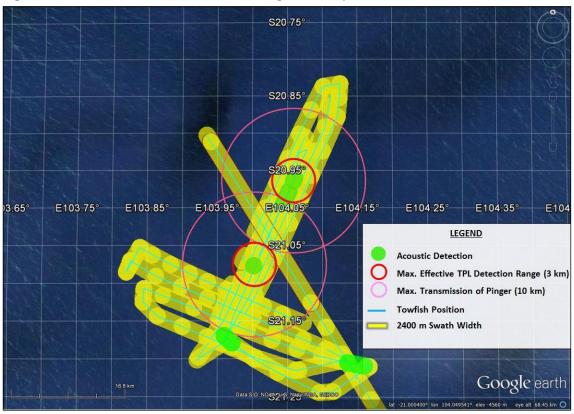
Figure 12: Ocean Shield TPL search coverage 04-14 April

The ADV-OS deployed the first towfish on 4 April 2014. The first towfish exhibited acoustic noise and was required to be changed out with the second towfish. The second towfish was deployed on 5 April 2014 and shortly after, whilst descending, detected an acoustic signal at a frequency of approximately 33 kHz. Further detections were made on 5 April 2014 and on 8 April; however, none were able to be repeated when following an opposing track. The first towfish was redeployed with no detections.

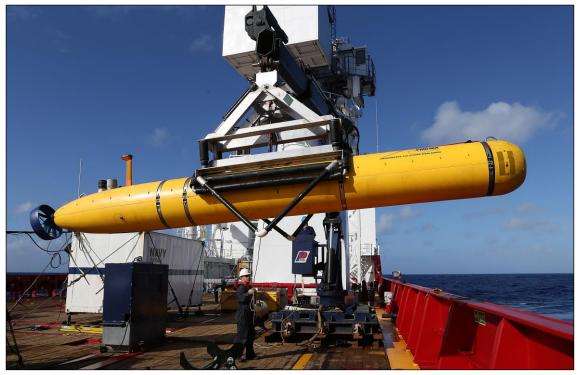
Figure 13: Ocean Shield AUV

Based on the analysis of the acoustic detections on ADV-OS, an underwater sonar survey using an autonomous underwater vehicle (AUV) commenced on 14 April 2014. 30 missions to depths between 3,800 - 5,000 m were completed. The side scan sonar tasking comprising a 10 km radius area around the most promising detection and a 3 km radius area around the other three detections was completed on 28 May. The total area searched during this time was 860 km² with nil debris or wreckage detected. The ATSB considers that the search in the vicinity of the ADV-OS acoustic detections is complete and the area can now be discounted as the final resting place of MH370.

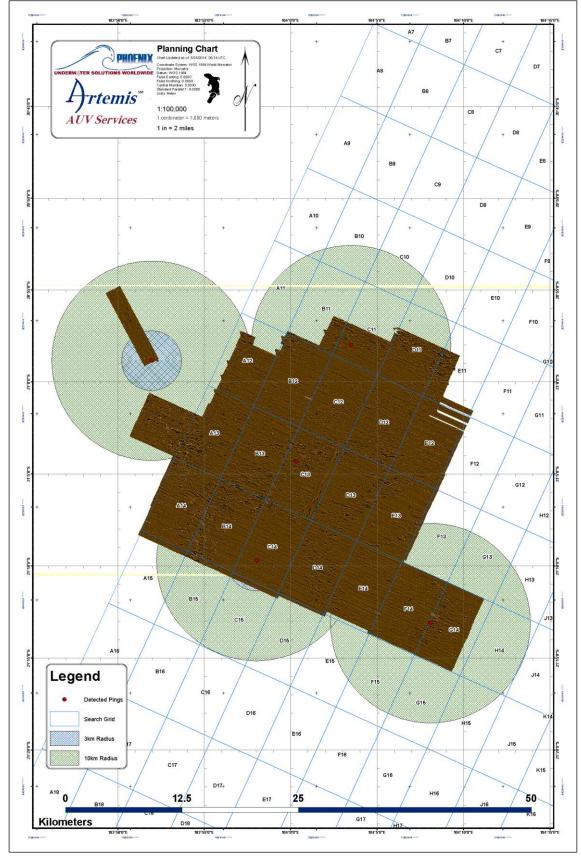
Figure 14: *Ocean Shield* AUV coverage 14 April-28 May 2014 (Note Western detection was a sonobuoy detection of different frequency)

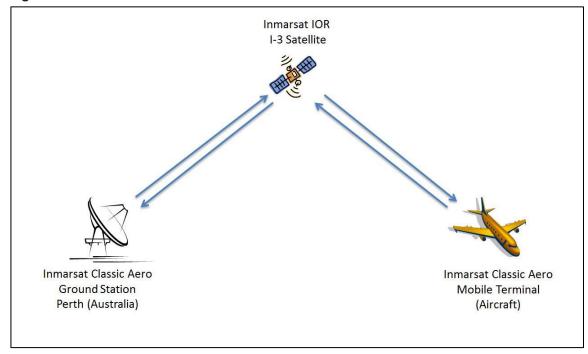
Figure 15: Schematic of basic satellite communications

The system used during flight MH370 consisted of the Inmarsat Classic Aero ground station located at Perth, Western Australia and the Inmarsat Indian Ocean Region (IOR) I-3 satellite. The Classic Aero service uses a single global communication beam per satellite, and contains no <u>explicit</u> information relating to the mobile terminal location being available.

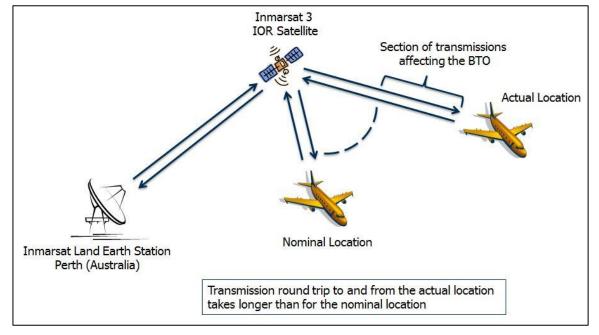
Figure 16: Difference in time delays between nominal and actual locations

For system efficiency and for the satellite communication to remain reliable, aircraft R-Channel transmissions are in time slots referenced to the P-Channel as received by the aircraft. The BTO is a measure of how long from the start of that time slot the transmission is received. This is essentially the delay between when the transmission was expected (given a nominal position of the aircraft) and when it actually arrives and is caused by the distance of the aircraft from the satellite (Figure 16).

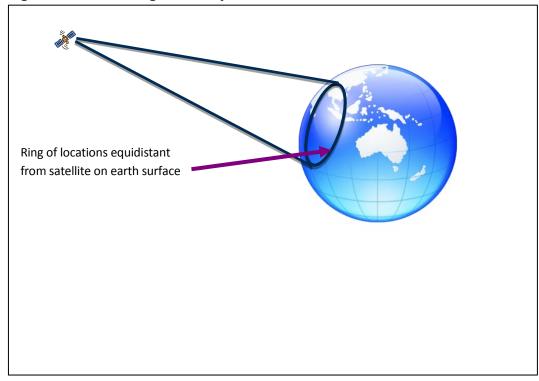
Figure 17: Position ring defined by BTO measurement

A set of locations can be plotted on the surface of the earth at the calculated distance from the satellite. The result is a ring of locations equidistant from the satellite (Figure 17).

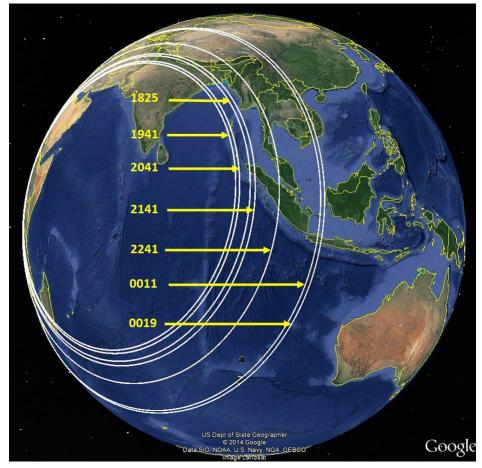
Figure 18: BTO ring solutions for 9M-MRO

For each completed handshake during flight MH370, the ground station recorded a BTO value which defined a location ring solution (Figure 18).

An analysis of the SATCOM system parameters, and empirical comparison between the BTO rings calculated for the time period when the aircraft was on the ground in Kuala Lumpur showed that the tolerance was ±10 km. Figure 19 shows a section of the BTO solution for the transmissions associated with the ACARS message overlaid on the flight track from flight MH370. The distance between the transmission location and the BTO arc is approximately 5 km.

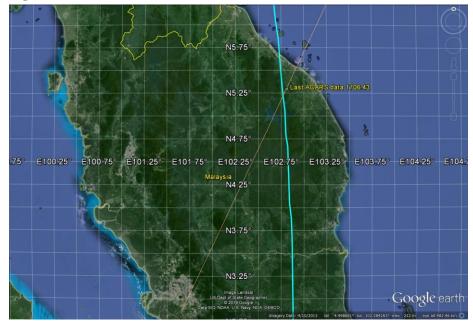
Figure 19: BTO solution arc for transmissions related to last ACARS data

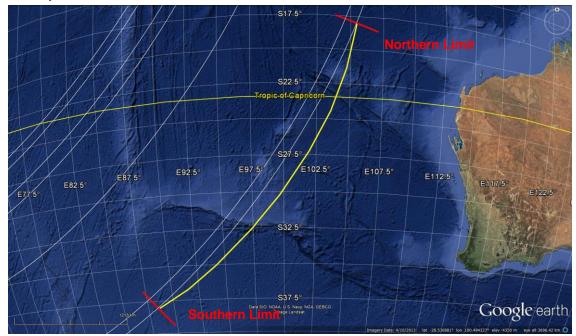
Figure 20: Performance limit of the aircraft in yellow - red lines indicate the intersection of the performance limit and the 7th arc.

- The aircraft was flown at a constant altitude
- The speed selected was operationally achievable for the given altitude
- Aircraft required to cross the arcs at the times defined by the BTO values
- Before the 1941 arc various path estimates were used including an immediate turn south after the last radar point at 1822 and a turn at the north western limit at 1912
- After the 1941 arc straight line segments between the arcs were flown
- Wind effects were modelled
- Modelling did not include individual engine efficiency

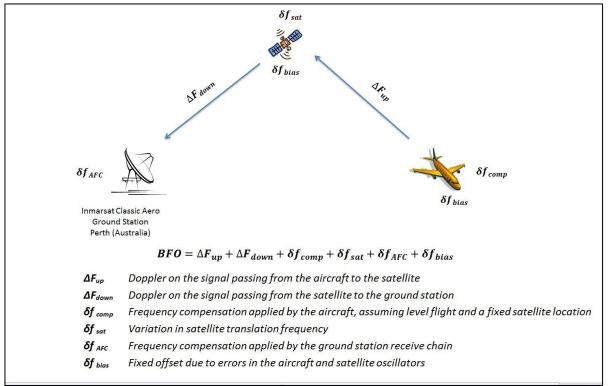
Figure 21: Total of BFO contributions

The total contributions to the BFO of the transmissions from MH370 are shown in Figure 21.

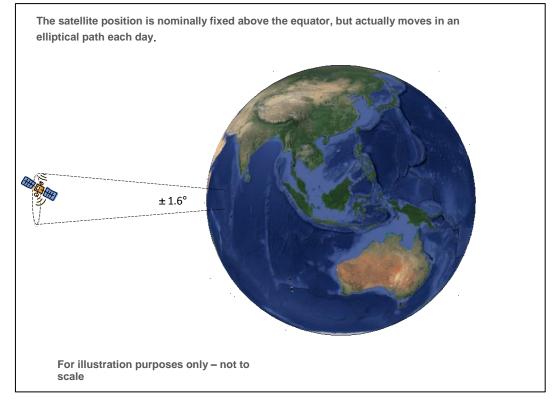
Figure 22: Satellite motion during geosynchronous orbit

- The compensation applied by the terminal is calculated along an incorrect direction as the satellite is not at the fixed location.
- No compensation is applied for the relative speed of the satellite in the direction of the terminal.

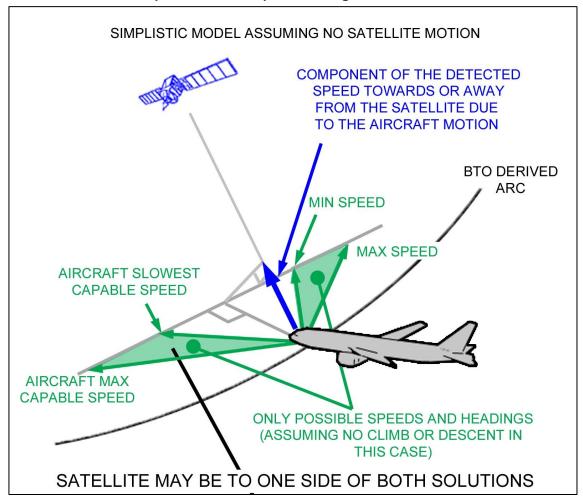
Figure 23: Simplistic model of velocity component affecting BFO measurements showing directions for various speeds within the possible range

Once the known error associated with the BFO is removed, the remainder is the Doppler Effect associated with the relative motion of the aircraft to the satellite (ΔF_{up}). For a given relative motion, there are many combinations of aircraft speed and heading that will produce the correct frequency change (BFO). There is however a limited range of speeds at which an aircraft can operate and therefore the number of feasible speed/direction solutions is limited (Figure 23).

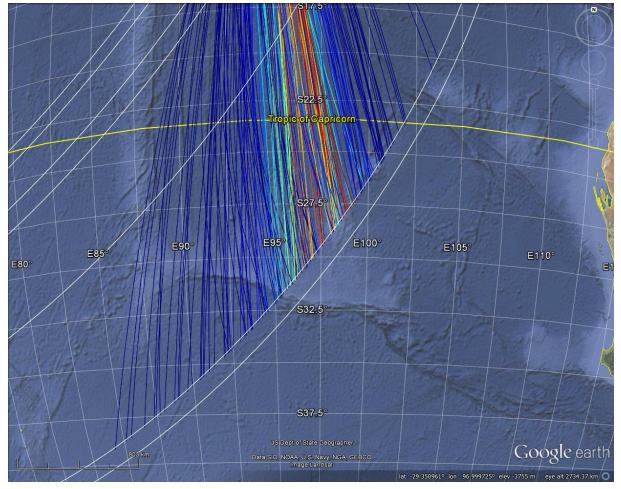
Figure 24: Analysis A results - red / orange/ green paths represent the highest correlation with satellite data

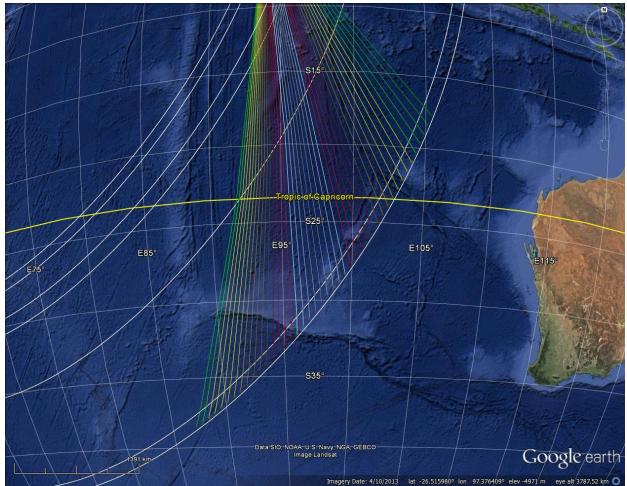
Figure 25: Analysis B results - white paths represent highest correlation with satellite data

• Straight line segments between arcs

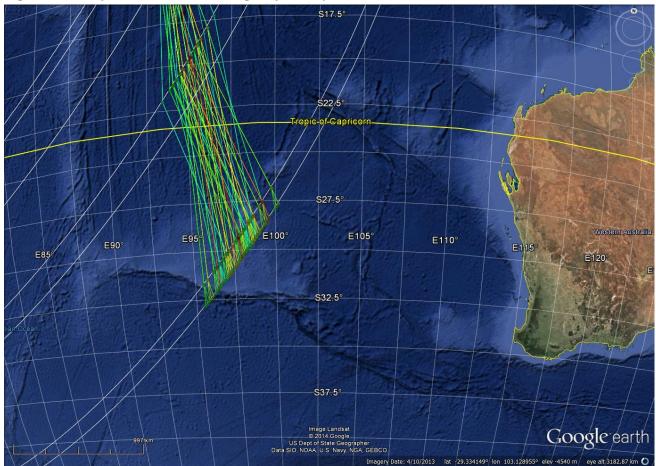
Figure 26: Analysis C results: Showing only the top 100 ranked tracks of 5000 candidates

- Initial track takes a northern hook around the tip of Sumatra
- Constant altitude
- Groundspeed can change at each arc crossing
- Heading changes allowed at each arc crossing
- Straight line segments between arcs

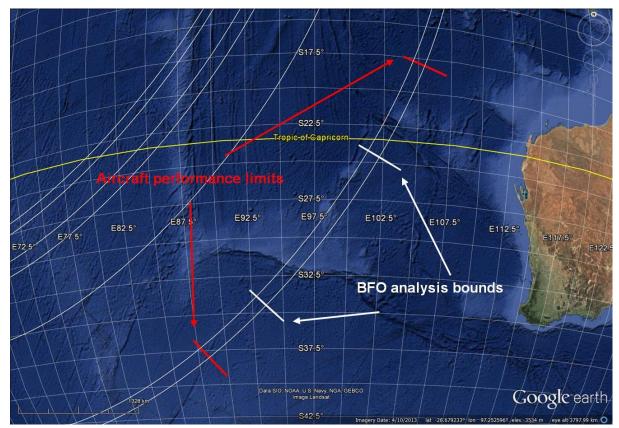
Figure 27: Aircraft performance bounds and narrower limits based on the higher correlation area from the BFO analyses with 5 Hz tolerance on fixed frequency bias

From each of the different analyses, the highest correlation paths were compared and each crossed the 7th arc within 450 km of each other. The greatest effect on the paths was from changing the value of the fixed frequency bias. A sensitivity study determined that a change of 1 Hz in the fixed frequency bias was approximately equal to 100 km along the 7th arc. In order to appropriately bound the results, the most northern and southern solutions were used and an error margin of 5 Hz (observed tolerance of the FFB) or 500 km was applied (Figure 27).

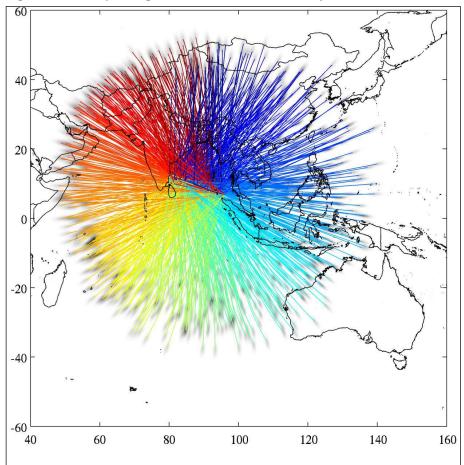
Figure 28: 1000 paths generated, unconstrained by the BTO and BFO values.

- An independent recreation of the satellite communication system model. This simulation was able to prove definitively that the BFO value is influenced by the location, speed and heading of the aircraft.
- Paths were generated starting from the last radar point assuming a single turn followed by a predominantly straight track. These paths were propagated in all directions, unconstrained by the BTO data locations (Figure 28). The BFO, at the times of the handshakes, was predicted for all the paths. In the paths that intersect the measured BFO values (red dots) are cyan and yellow coloured paths ending in the southern Indian Ocean (Figure 29). This was able to confirm that the southern corridor was the only valid solution.

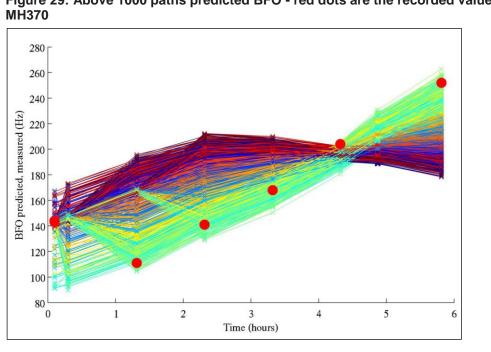
Figure 29: Above 1000 paths predicted BFO - red dots are the recorded values from

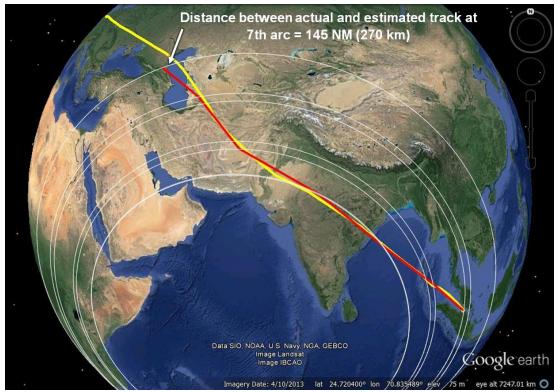
Figure 30: MH021 07 March 2014 - The red path is predicted path from BTO/BFO values; yellow track is the actual aircraft track

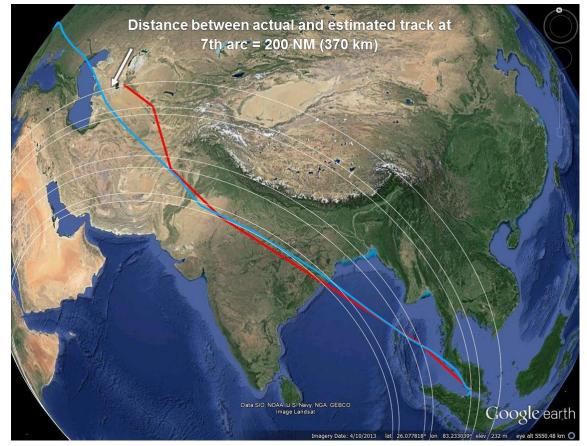
Figure 31: MH009 07 March 2014 - The red path is predicted path from BTO/BFO values; blue track is the actual aircraft track.

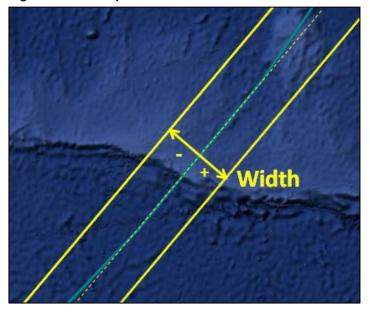
Figure 32: Description of the width of the search area

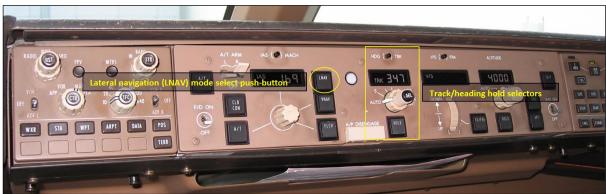
Figure 33: B777 LNAV mode and track/ heading hold selectors

²⁶ In the case of MH370, for any possible track, fuel exhaustion would have occurred prior to reaching a latitude at which the aircraft would have automatically selected a true North reference.

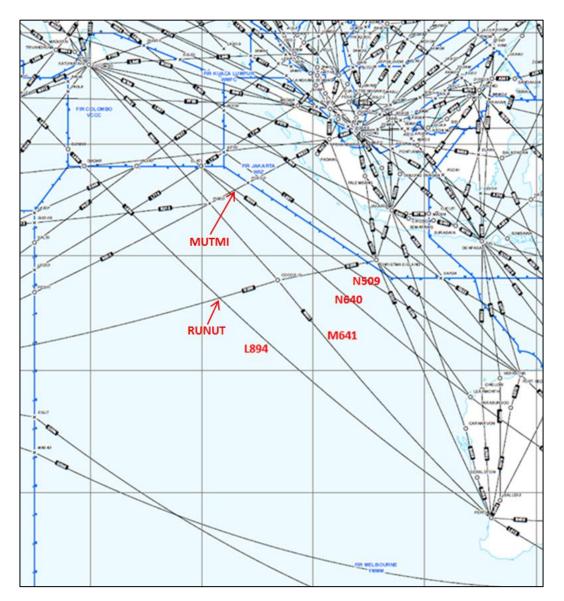
Figure 34: Southern Indian Ocean air routes and selected waypoints

The waypoints at MUTMI and RUNUT were also considered as possible points that MH370 may have crossed. However ground tracks through these points did not correlate well with the most favoured paths generated through the analysis of the BFO and BTO data.

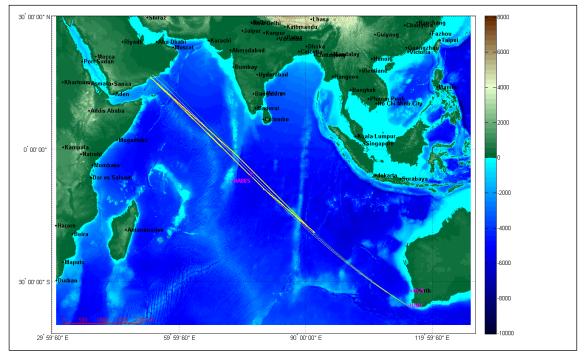
Figure 35: Map showing most probable location for the source of the received sound signals (magenta asterisk) and the uncertainty region (yellow polygon) based on an uncertainty of +/- 0.75° in the bearing from HA01 and a +/- 4s uncertainty in the difference between signal arrival times at RCS and HA01

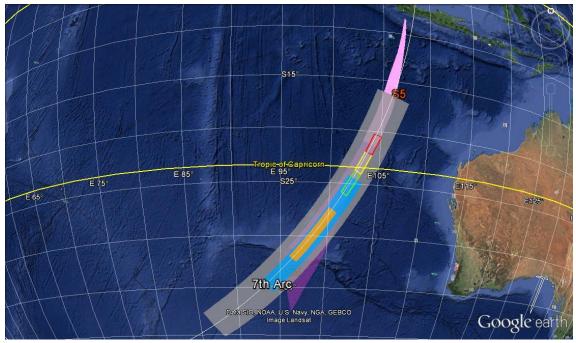
Figure 36: Underwater Search Areas - Wide (Grey), Medium (Blue) and Priority (Orange) shown in comparison to S3/S5 and red, yellow, green search areas

The limited data resulted in a large wide area (grey) needed to represent a high confidence in localising the aircraft. The medium area (blue) was calculated by using the ranking of candidate tracks contained within several of the analysis. Although still of reasonably high confidence, and relatively large, this reduced area does not contain all the possible derived paths.
