AAIB Reference Number: EW/C2008/01/01

Aircraft Type and Registration: Boeing 777-236, G-YMMM

Date & Time: 17 January 2008 at 1243 hrs

Title: Accident to Boeing 777-236, G-YMMM at London Heathrow Airport on 17 January 2008

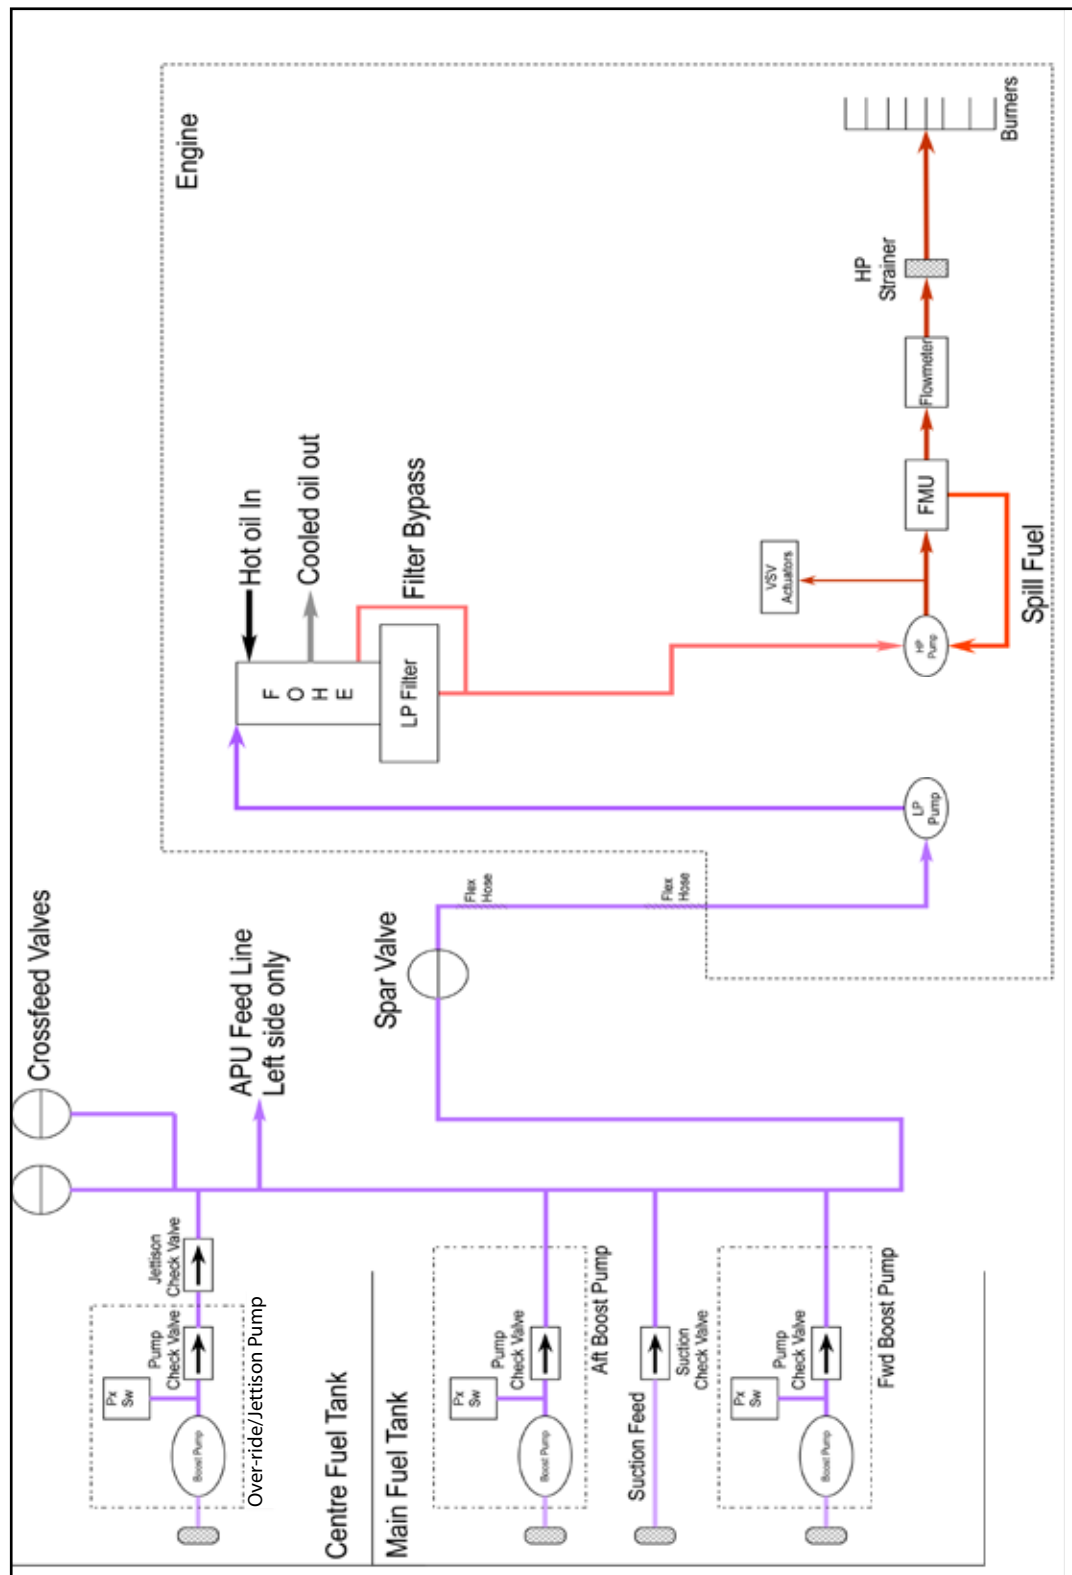
Figure 3

The fuel on the Boeing 777-200ER is stored in three fuel tanks: a centre tank, a left main tank and a right main tank; see Figure 3. The centre tank contains two override / jettison pumps (OJ) and each main fuel tank contains two boost pumps, identified as forward (fwd) and aft. Each of the pump inlets is protected by a mesh screen and the pumps are also equipped with a check valve fitted in the discharge port, to prevent fuel in the fuel feed manifold flowing back through the pump. A pressure switch, mounted between the pump's impeller and check valve, monitors the fuel pressure and triggers a warning in the flight deck if the pressure rise across the pump drops to a value between 4 and 7 psi.

Boeing 777 / Rolls-Royce Trent 800 Fuel System
