**ATSB TRANSPORT SAFETY REPORT**

Aviation Occurrence Investigation – AO-2009-012

Preliminary

**Tail Strike  
Melbourne Airport, Vic.  
20 March 2009  
A6-ERG  
Airbus A340-500**

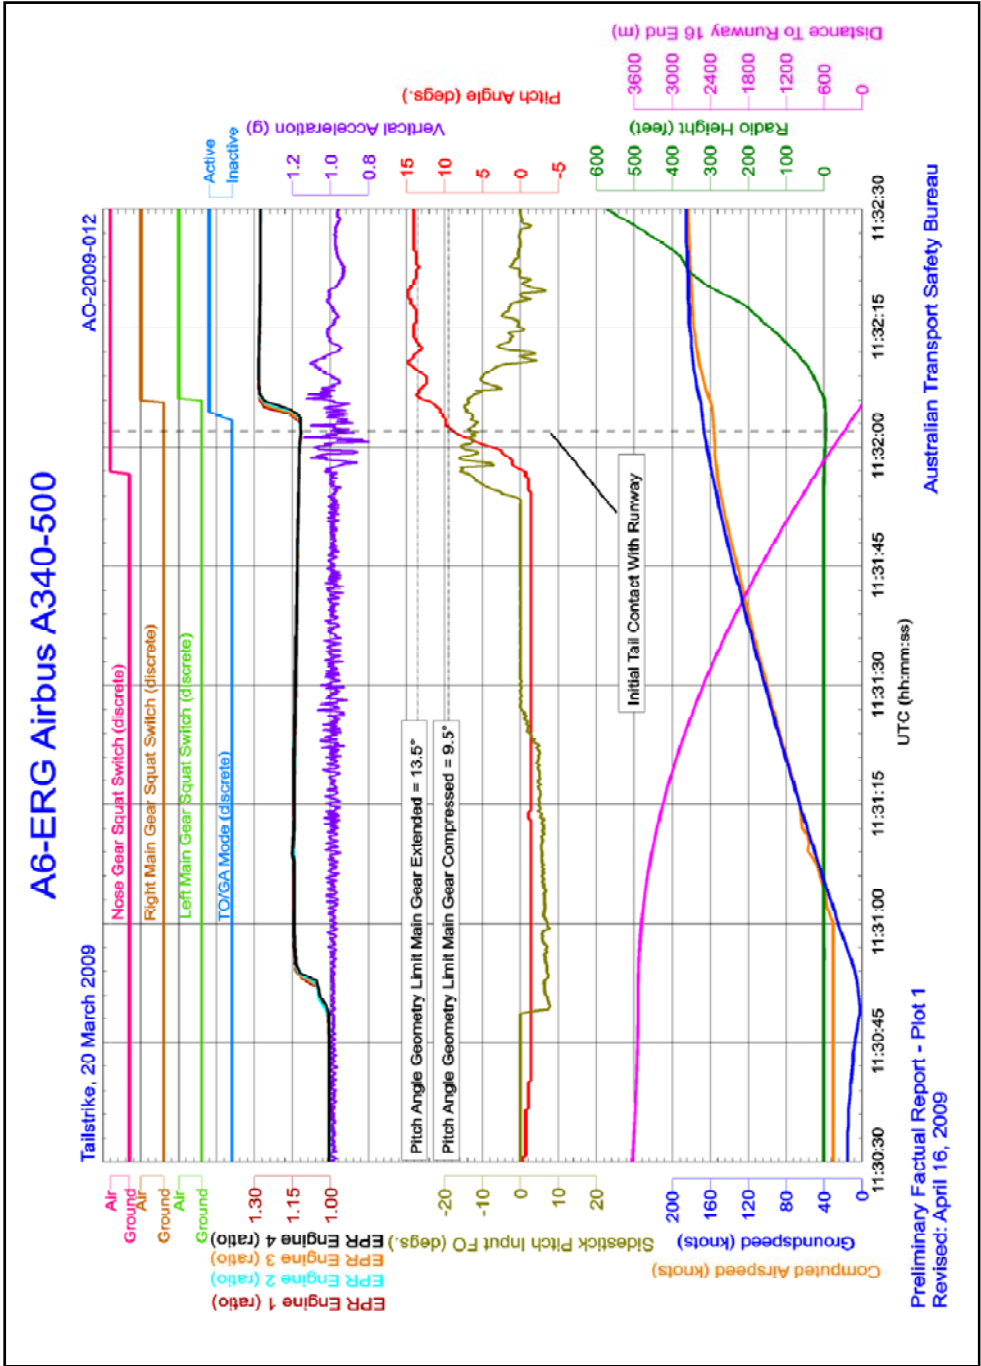
Figure A1: Selected DAR parameters for entire take-off roll

The DAR PC-card was found to contain flight data from three previous flights and the entire accident flight. The DAR parameters and FDR data compared favourably up to the point of FDR data stoppage. The DAR flight data was consequently used in the preparation of a sequence of events for the accident flight. A graphical representation of the DAR data during the takeoff is presented in Appendix A.
