ATSB TRANSPORT SAFETY REPORT

Aviation Occurrence Investigation AO-2008-053

Preliminary

**Depressurisation
475 km north-west of Manila, Philippines
25 July 2008
Boeing Company 747-438, VH-OJK**

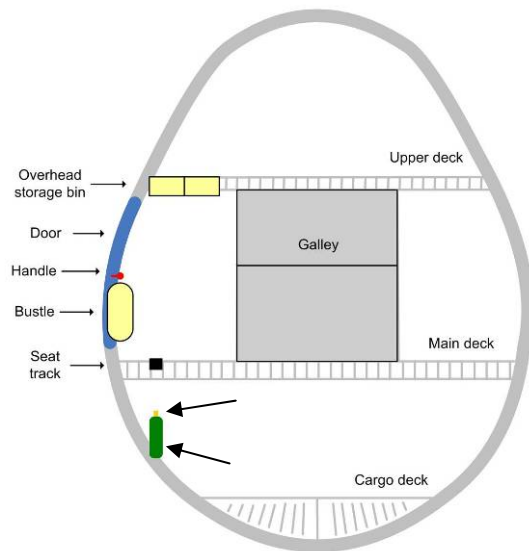
Figures D1 – D7: Cross-sectional view through aircraft fuselage at the R2 cabin door location

1. Normal arrangement (Oxygen cylinder and valve arrowed)
