Final Report of the Federal Aircraft Accidents Inquiry Board

concerning the Accident of the aircraft DC-9-32, ALITALIA, Flight No AZ 404, I-ATJA
on the Stadlerberg, Weiach/ZH, of 14 November 1990

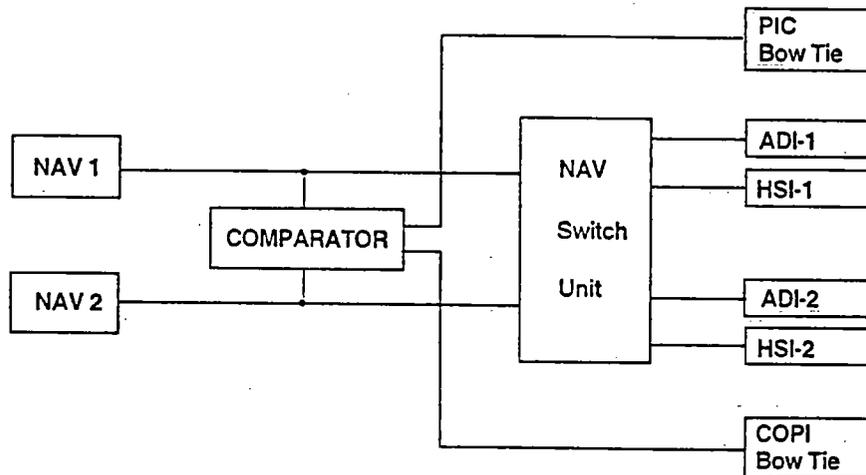
Block Diagram of the NAV System

The NSU consists of a number of rotary switches which are positioned by a motor. The motor receives its control signals from a RADIO switch which is located on the Flight Director Control Panel.

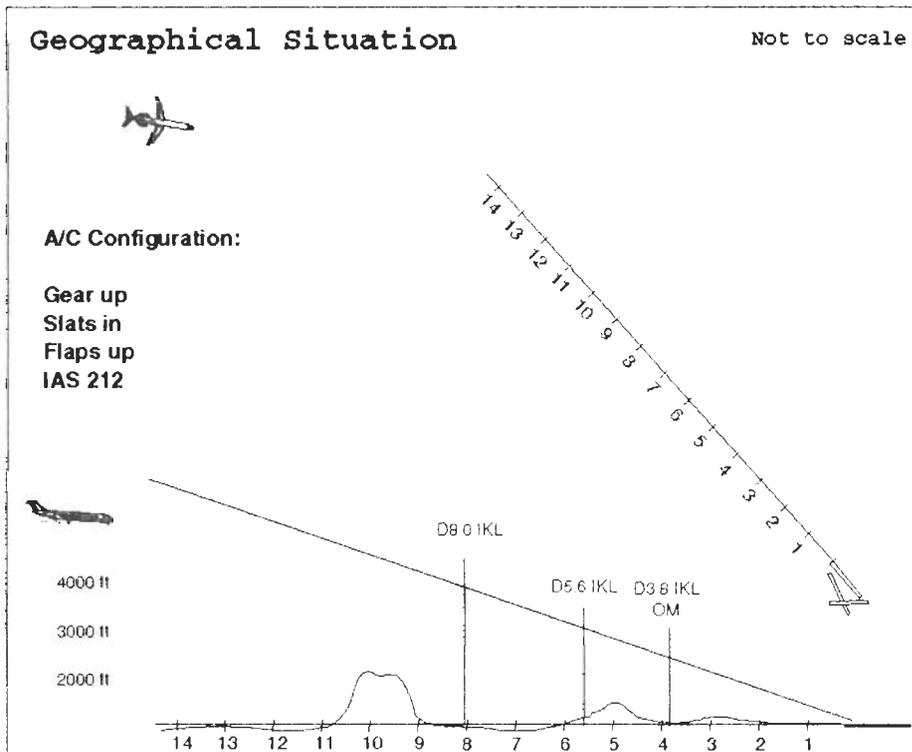
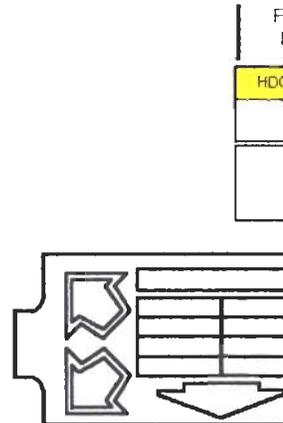
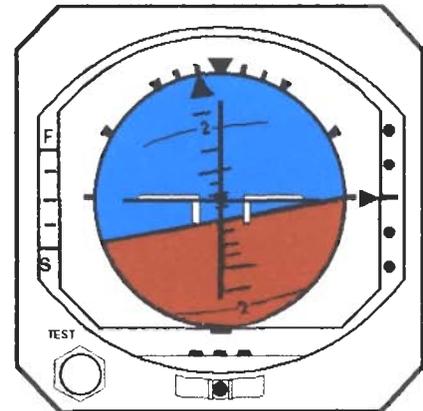
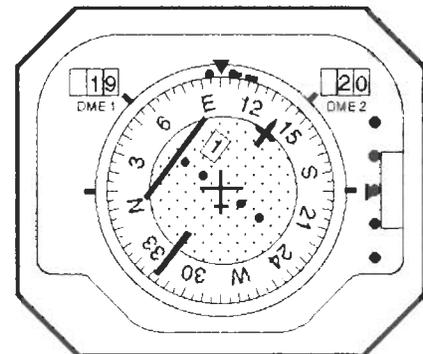
Figure 1

- 19.06.45: Figure 1: Starting point RADIO 1
Figure 2: Starting point RADIO 2
Both versions are possible.

Fig. 1: In the Radio Selector position 1 the relative position to the localiser (LOC) and glidepath (GP) is shown on all four instruments (ADI 1 and 2, HSI 1 and 2), supplied by VHF- NAV 1 (108.30 MHz/ILS 14).

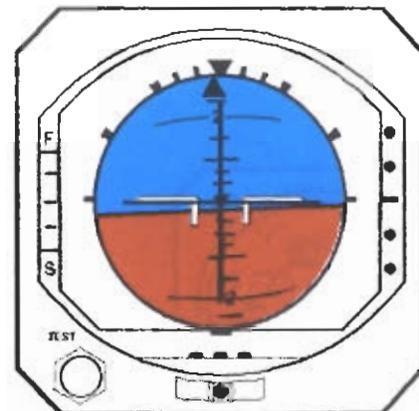
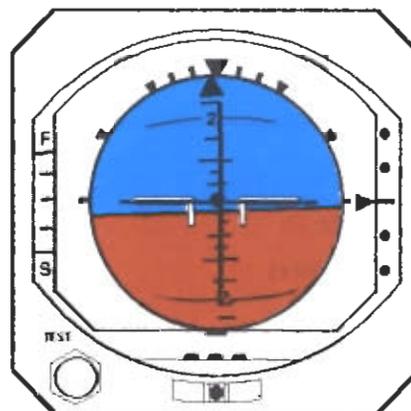
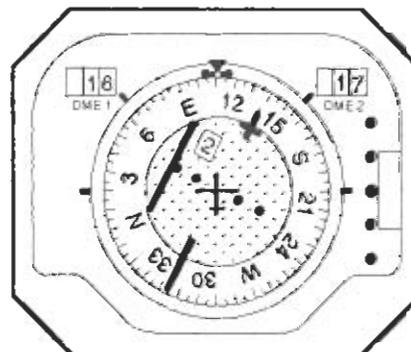
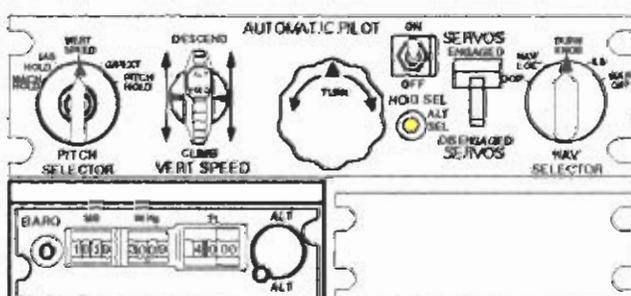
Figure 3

- 19.07.25: Fig. 3: The crew selected RADIO APP on the Radio Selector. By switching to RADIO APP, VHF-NAV 2 internally automatically tuned the ILS frequency 108.30 MHz of VHF-NAV 1. The selected frequency of 116.40 MHz on VHF-NAV 2 remained visible and available for DME 2 receiver. Accordingly, DME 2 showed the distance to KLO-DME. DME 1 showed the value from ILS-DME 14. The signal from VHF-NAV 1 receiver was displayed on HSI 1. Due to the fault in the GP receiver 1 a Null (zero) Signal was sent which led to an apparently correct centred GP indication on HSI 1. ADI 2 takes the LOC and GP information of HSI 1. HSI 2 received information from VHF-NAV 2 receiver which was functioning correctly. ADI 1 received the LOC and GP information of HSI 2. The actual position was way below the nominal glidepath. Accordingly the pointers in HSI 2 and ADI 1 were in the upper limit position and as designed not in view. The OFF FLAG was not in view because the GP signal was being received.

Comparator LOC on,
then off
Comparator GP on

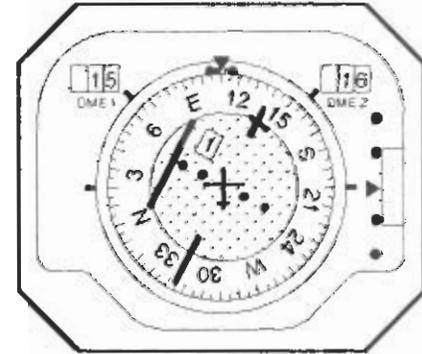
Figure 4

- 19.07.40: Fig. 4: In the meantime, the Flight Director Mode Selector was switched to the position NORM, confirmed by "N-L ARM" in the Mode Annunciator Panel. Due to the disparity of the GP indications, the GP Comparator warning light came on. The Copilot (FP) asked: "Do you have the Glide?". The Captain replied "On 1...". Five seconds later the Copilot said: "I don't have it". The Captain's comment "On 1" referred to the indication on HSI 1 which was centred. The Copilot, with the words "I don't have it" was referring to the indication on HSI 2.

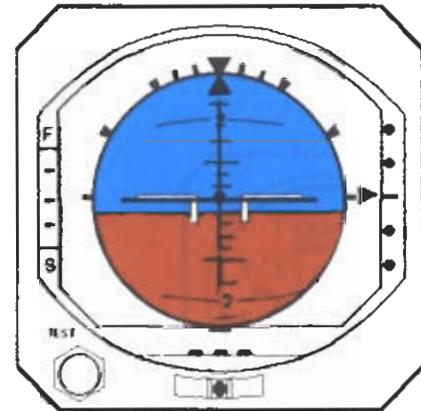
Figure 5

- 19.08.00: Fig. 5: At 19.07.59 hrs the PIC decided: "Good, let's do it on 1", whereby the COPI ordered "RADIO 1".

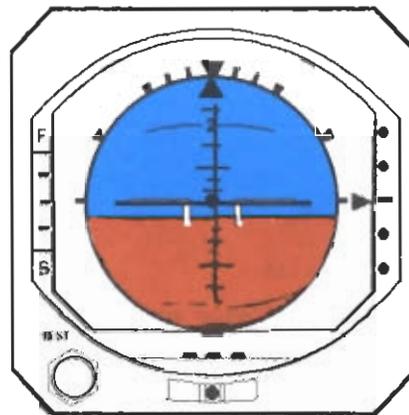
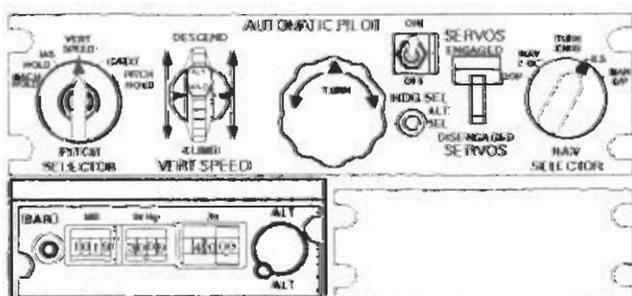
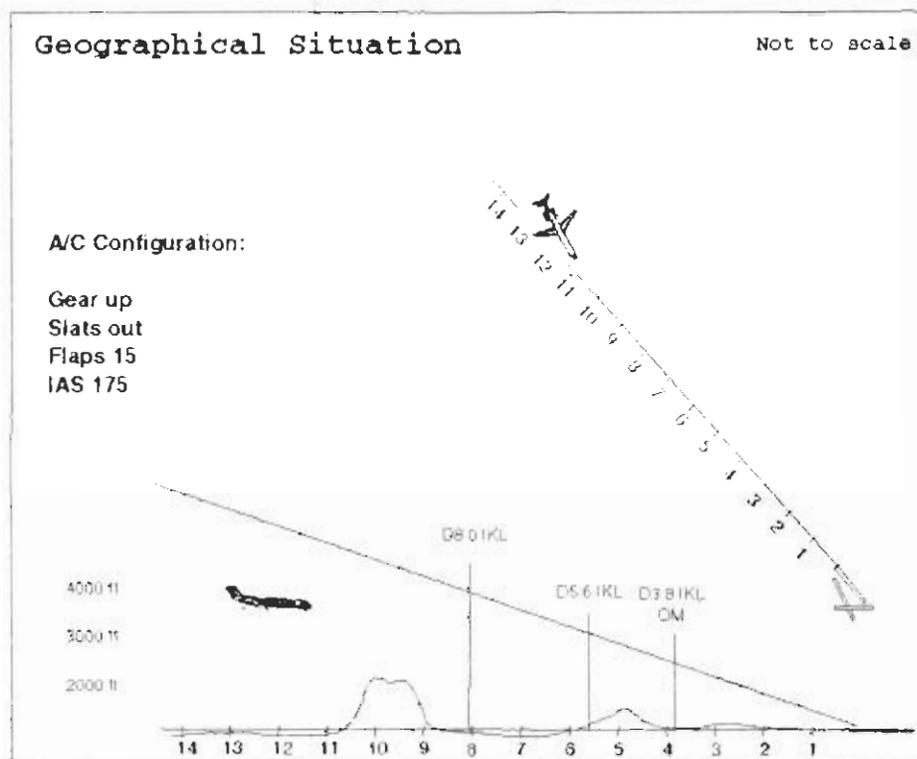
Figure 6

- 19.08.47: Fig. 6: The aircraft was slightly East of the LOC at about 4000 ft QNH where, although both Flight Directors and the Autopilot were following the LOC and GP. In the case of the GP it was the Null Signal from VHF-NAV 1 receiver. Here the aircraft was already 1200 ft below the nominal glidepath and still 12 NM from touch-down. This finding is supported because at 19.08.47 hrs the PIC confirmed "... capture LOC capture Glide path capture, so we are on the beam a little off track but ...".

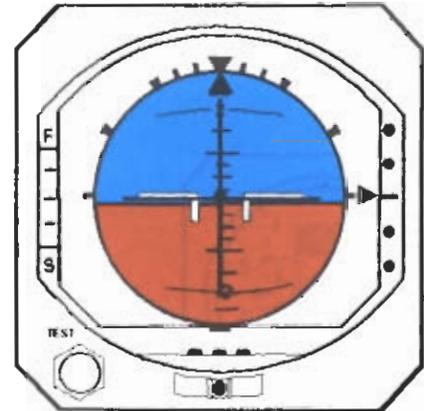
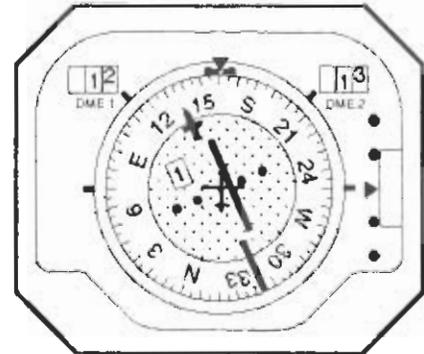
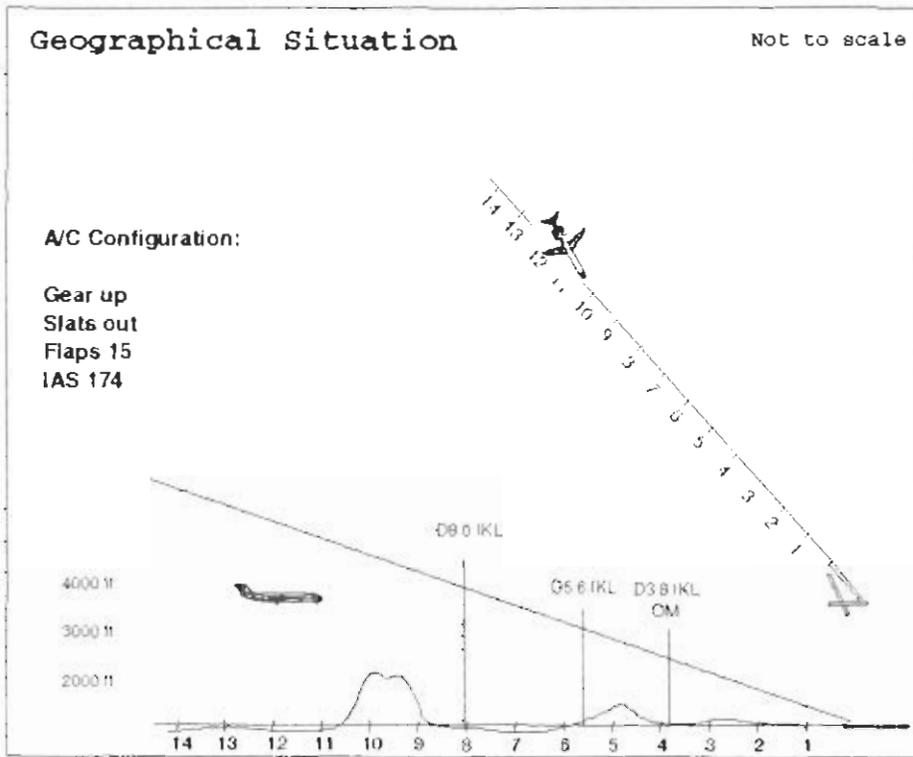
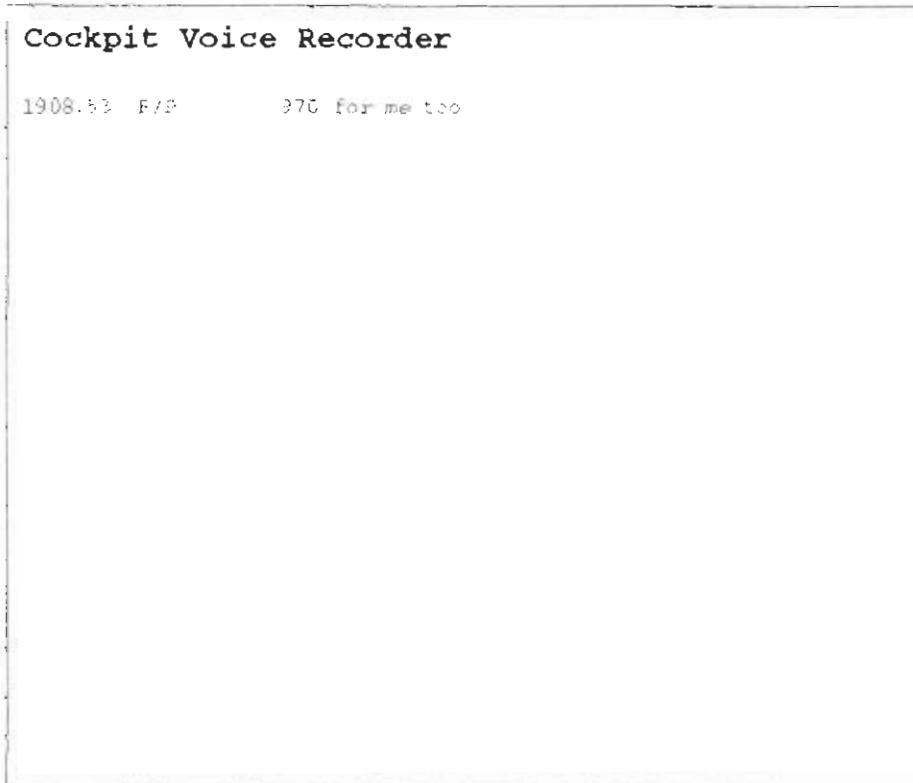
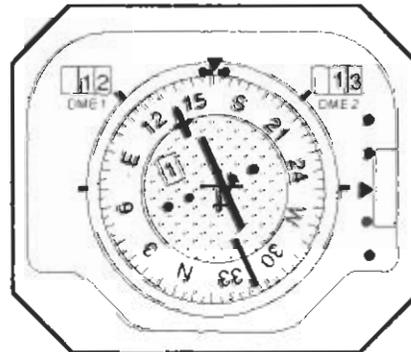
Figure 7

- 19.08.53: Fig. 7: Descent through 4000 ft is confirmed by the COPI "970 for me too", as he also set his altimeter to 970 hPa QFE.
- 19.08.57: Fig. 8: The aircraft passed 3700 ft as the Altitude Exit Warning sounded. This was armed to the selected altitude of 4000 ft QNH on the Altitude Preselect System.

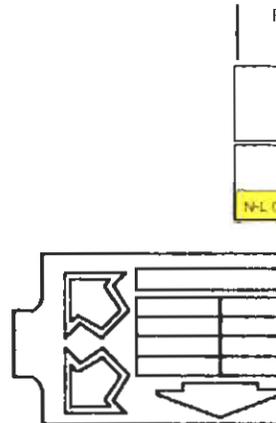
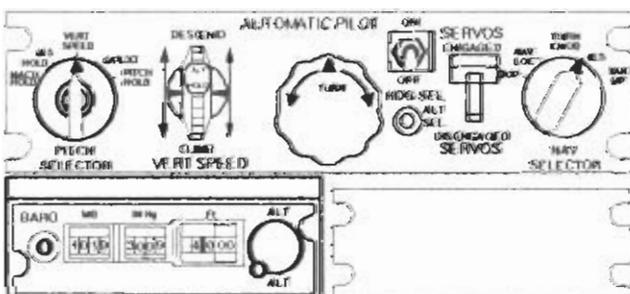
Figure 9

- 19.09.43: Fig. 9: Convinced that he was established on the ILS, the PIC said at 19.09.09 hrs: " I cancel and set 5000", referring to Altitude Preselect System. At this point the Landing Gear was probably extended, as during setting of the Flaps to 25 (19.09.41 hrs) no Gear Warning Horn was heard. At 19.09.18 hrs the PIC urged the COPI to reduce the speed further as he feared they were closing too near to the preceding aircraft. At 19.09.47 hrs the PIC stated "The outer marker check is at 1250 ft (QFE)". The altitude was now 1600 ft QFE and the distance from touchdown about 9 NM. As before, the aircraft was about 1200 ft below the the nominal GP.

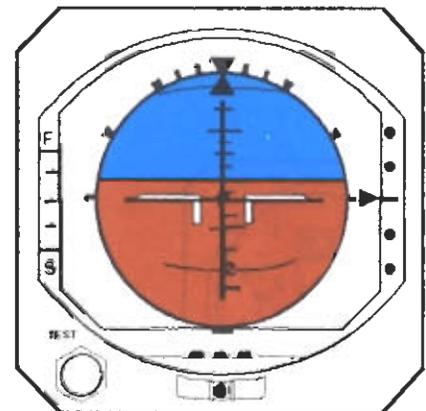
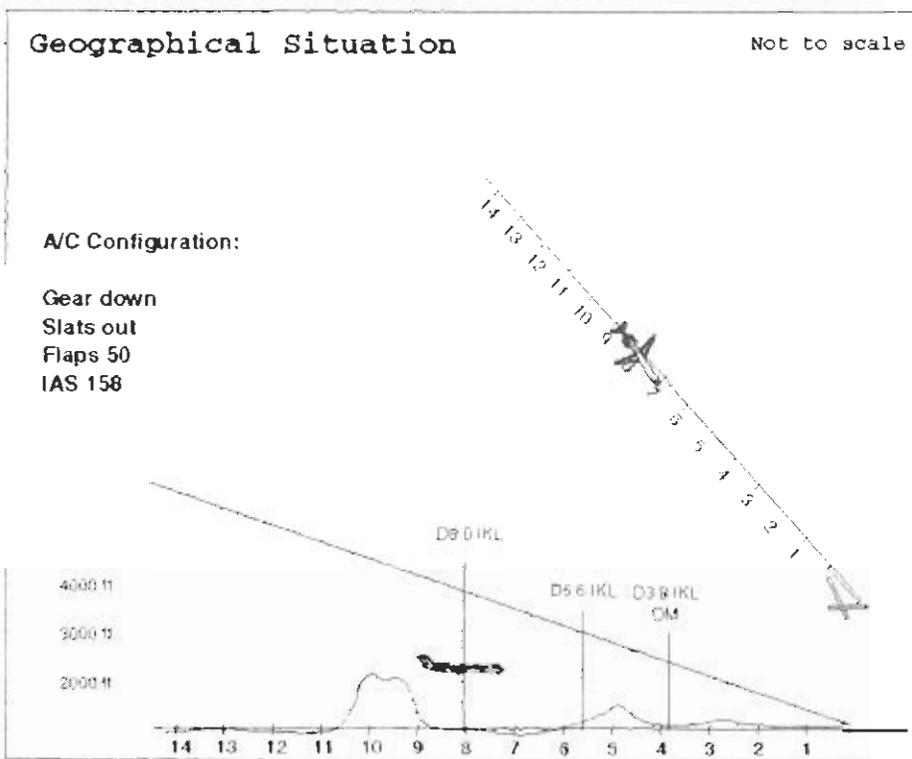
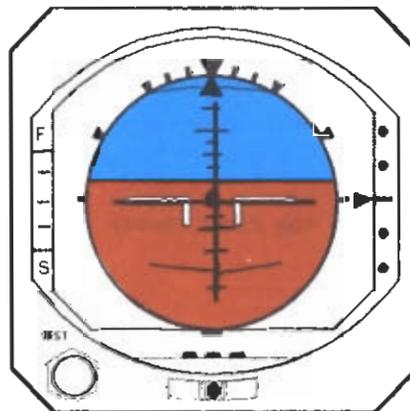
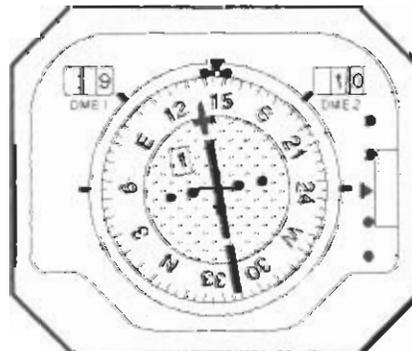
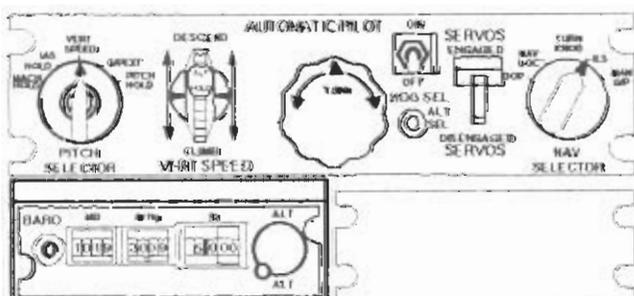
Figure 10

- 19.10.12: Fig. 10: At 8 NM IKL, the altitude on the GP should have been 4000 ft/QNH or 2598 ft/QFE. As the PIC remarked "3.8 almost 4 miles", the actual height was 1100 ft/QFE (outer marker height 1248 ft/QFE). These distance figures referred to the ILS-DME distance to the Outer Marker. At 19.10.27 hrs the COPI asked whether they had already passed the Outer Marker. At 19.10.39 hrs he repeated this question once again. The PIC responded "No, no, it hasn't changed yet" It is not clear what this answer meant.

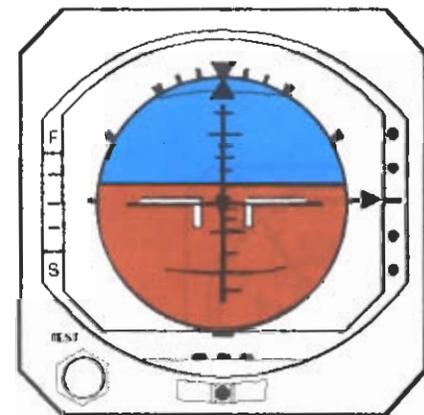
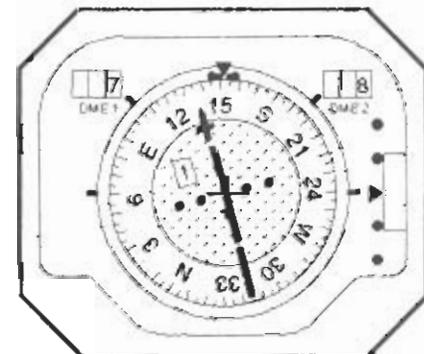
Figure 11

- 19.10.43: Fig 11: The PIC remarked that the ILS-DME showed 7 NM and possibly began an analysis of the position. His thoughts were interrupted by the order from ZRH APP to change to ZRH TWR on frequency 118,10 MHz. The instruction to change frequency with an indication of the relative position to the prelying airplane and the clearance that there were no more speed restrictions did not give the crew any reason to analyse their position. At 19.10.56 hrs the Captain's uncertainty was heard "That doesn't make sense to me ...", the COPI responded "... nor to me ...".

1910.43	A/P	Oh it shows 7 (Miles, maybe starting a cross check)
	APP	AZA 404 speed now as convenient, 4 miles behind a DC-9, contact TWR 118.1 Good night.
1910.50	404	118.1 Good <u>bye</u>
1910.56	F/P	...That doesn't make sense to me...
	A/S	Not to be...

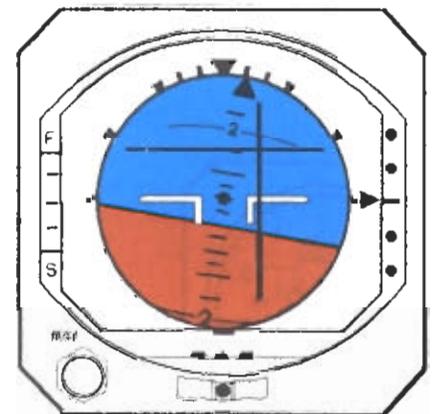
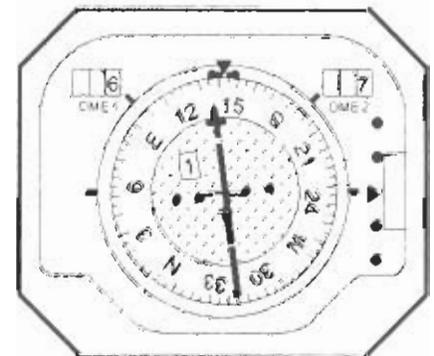
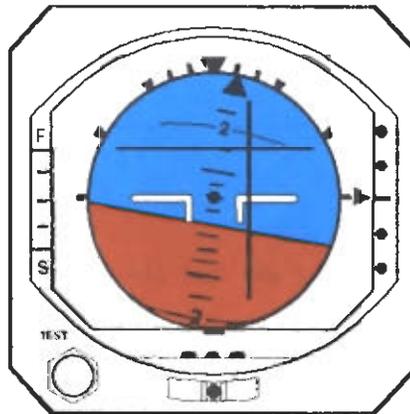
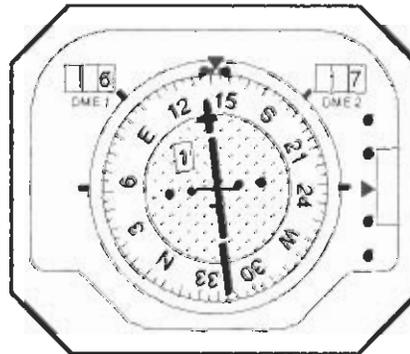
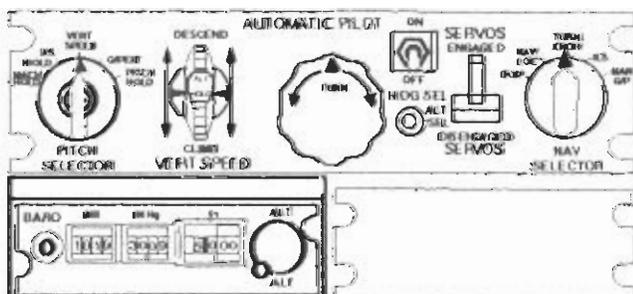
Figure 12

19.10.59: Fig. 12: At 19.10.57 hrs the PIC called out "Pull, pull, pull, pull" upon which disconnection of the Autopilot is heard. The PIC, due to misreading the altimeter, was obviously of the opinion that they were still at 1300 ft/QFE. Possibly the PIC wanted the COPI to fly the aircraft level until they reached the Outer Marker. The COPI probably interpreted the altimeter correctly and read a height of 300 ft/QFE. This caused him to commence a missed approach with the order "Go Around" (position about 6 NM from touchdown).

1910.57 A/P Pull, pull, pull, pull!
 - Click of Auto-pilot disengage is heard

1910.59 F/P ... AROUND
