AIRCRAFT ACCIDENT REPORT

INADVERTENT IN-FLIGHT SLAT DEPLOYMENT
CHINA EASTERN AIRLINES FLIGHT 583
McDONNELL DOUGLAS MD-11, B-2171
950 NAUTICAL MILES SOUTH OF SHEMYA, ALASKA
APRIL 6, 1993

Abstract: This report explains the inadvertent deployment of the MD-11 airplane's leading edge wing slats while the airplane was in cruise flight, about 950 nautical miles south of Shemya, Alaska, on April 6, 1993. Safety issues in the report focused on the inadequate design of the flap/slat actuation handle, the inadvertent extension of the leading edge wing slats, the longitudinal stability of the airplane during the pitch upset, the pilot-induced oscillations that can occur during recovery, the premature deterioration of the seat cushion fire-blocking material, and the inability of the material to provide the required seat cushion fire protection on transport-category airplanes. Safety recommendations on these issues were made to the Federal Aviation Administration.

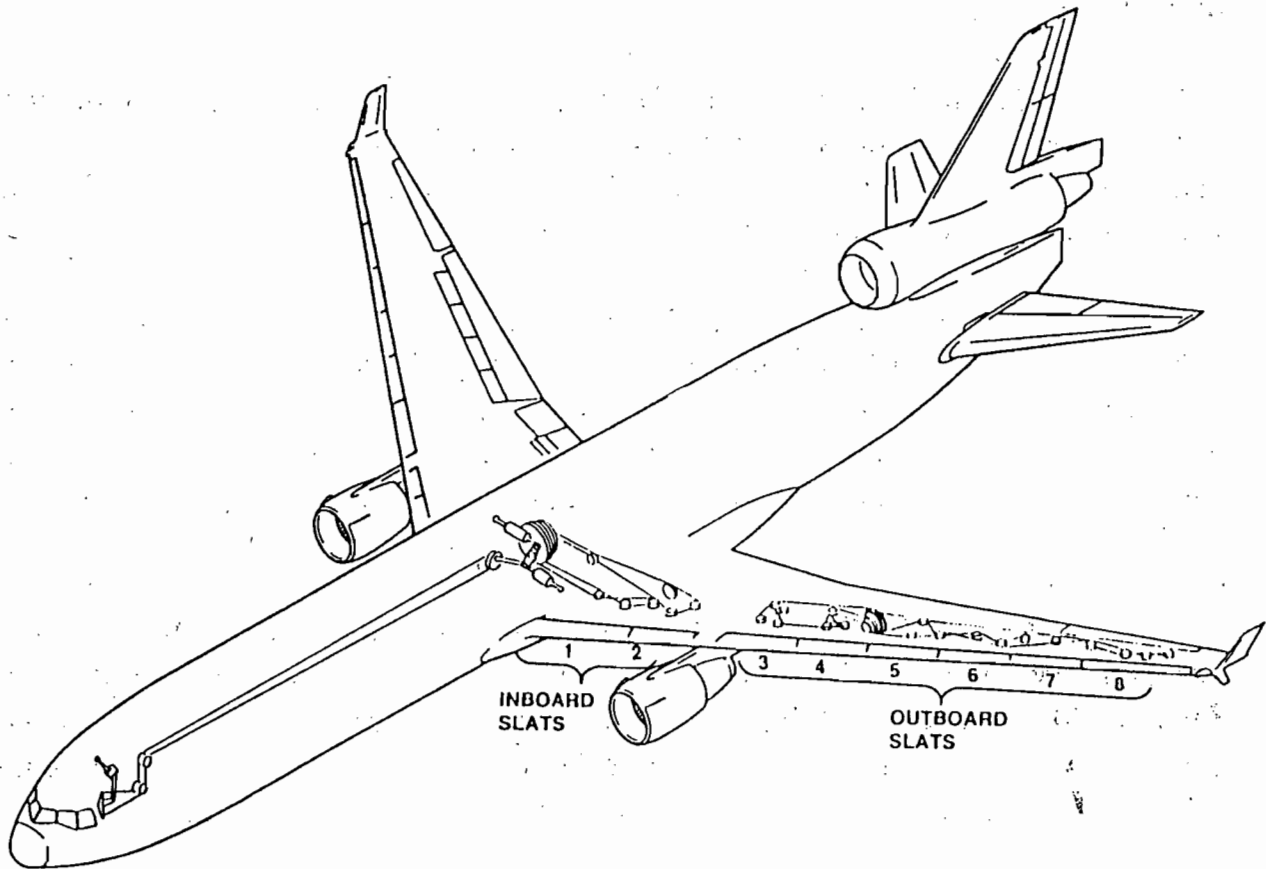
Figure 1.--Slat cable system.

The flap/slat handle moves a closed-loop control cable system (see figure 1) to operate the inboard slat control valve. The inboard slat control valve supplies hydraulic pressure to two inboard slat actuators. These actuators rotate the inboard cable drive drum to extend or retract the inboard slats. As the inboard slats extend or retract, follow-up cables and mechanical linkages move the outboard slat control valve.

The outboard slat control valve supplies hydraulic pressure to four outboard slat actuators. These actuators rotate the outboard drum to extend or retract the outboard slats. The slats are supplied pressure by two completely

separate and independent hydraulic systems. If one system should fail, the second system will operate the slats.

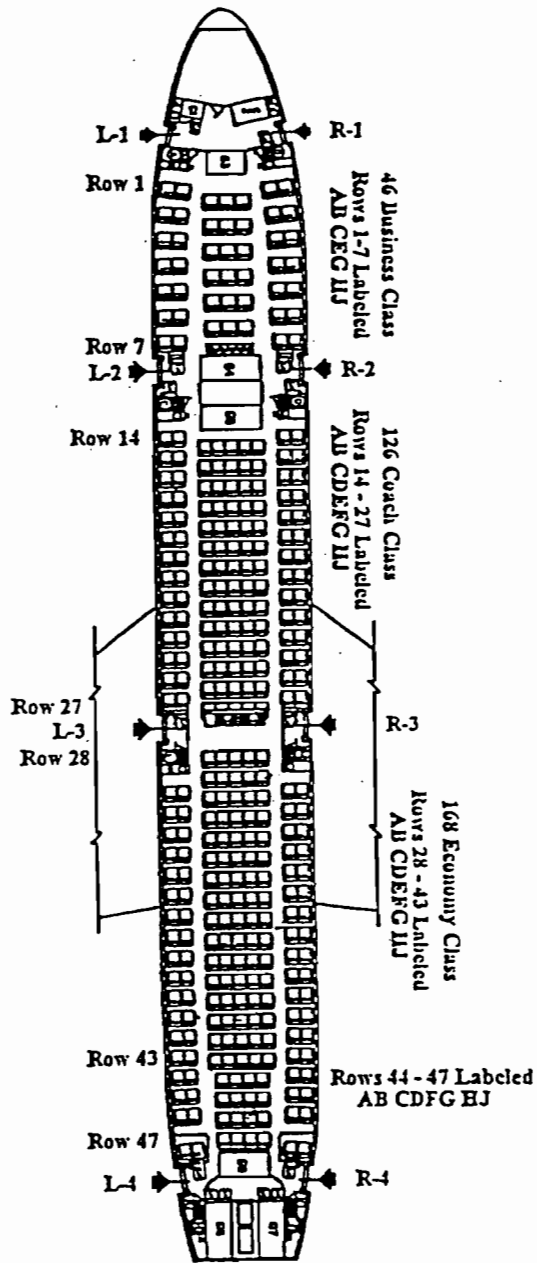
Figure 6.--Passenger cabin configuration.

The passenger cabin was configured for 46 business and 294 coach class seats. (See figure 6).
