# **Aviation Occurrence Report**

**TransAsia Airways Flight GE235**

**Loss of Control and Crashed into Keelung River**

**Report Number: ASC-AOR-16-06-001**

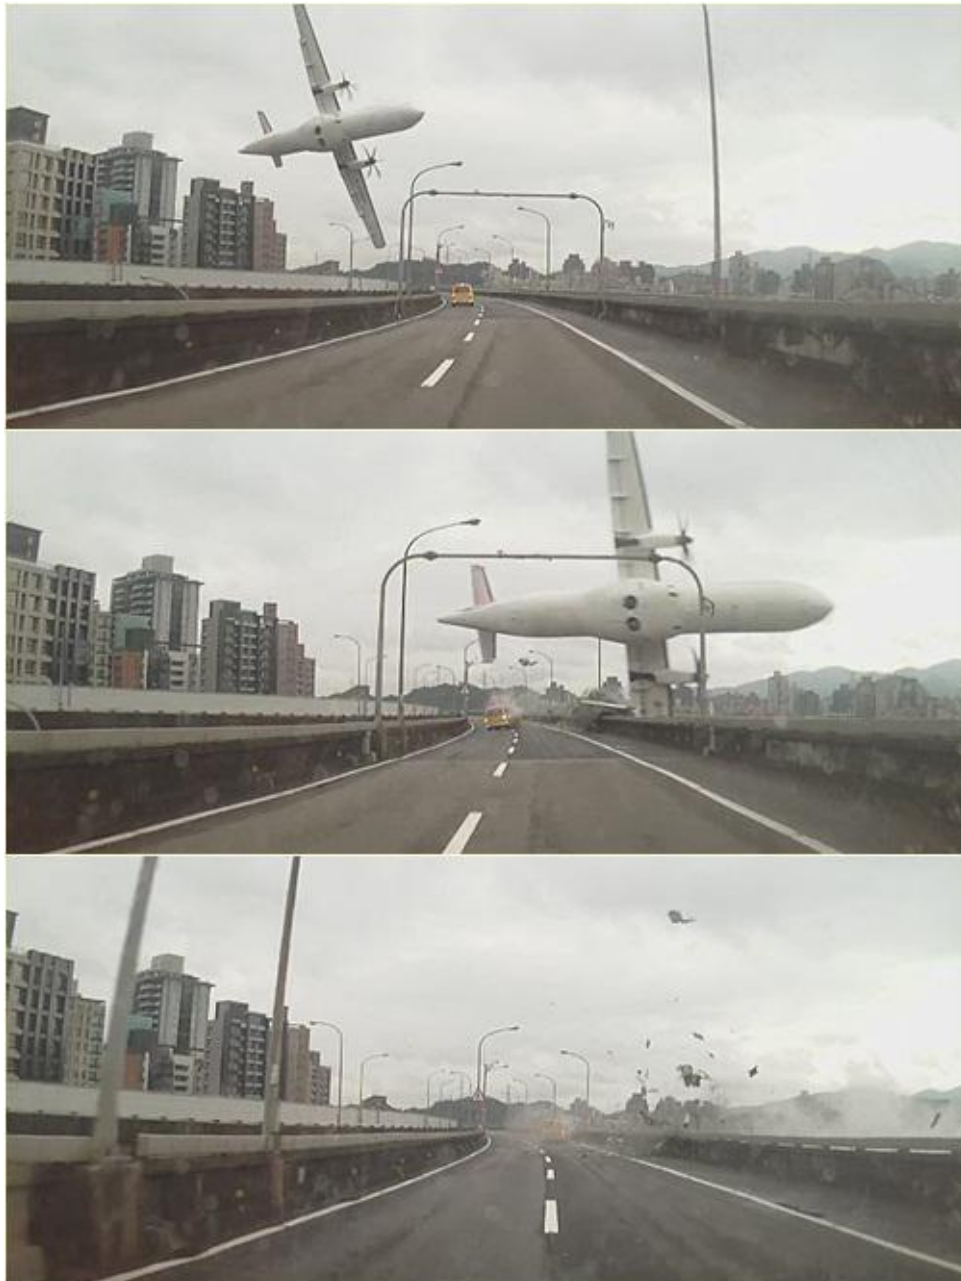
Figure 1.1-2 GE235 loss of control and initial impact sequence.

At 1054:34, the enhanced ground proximity warning system (EGPWS) “pull-up” warning was annunciated in the cockpit. At 1054:35 the aircraft's left bank angle increased from 10 to 80 degrees. The aircraft's left wing then collided with a taxi driving on the overpass. The wing then impacted the fence and a light pole at the edge of the overpass located southwest of the Keelung river occurrence site (see Figure 1.1-2). The aircraft continued to bank to the left after those collisions and then entered the river inverted.

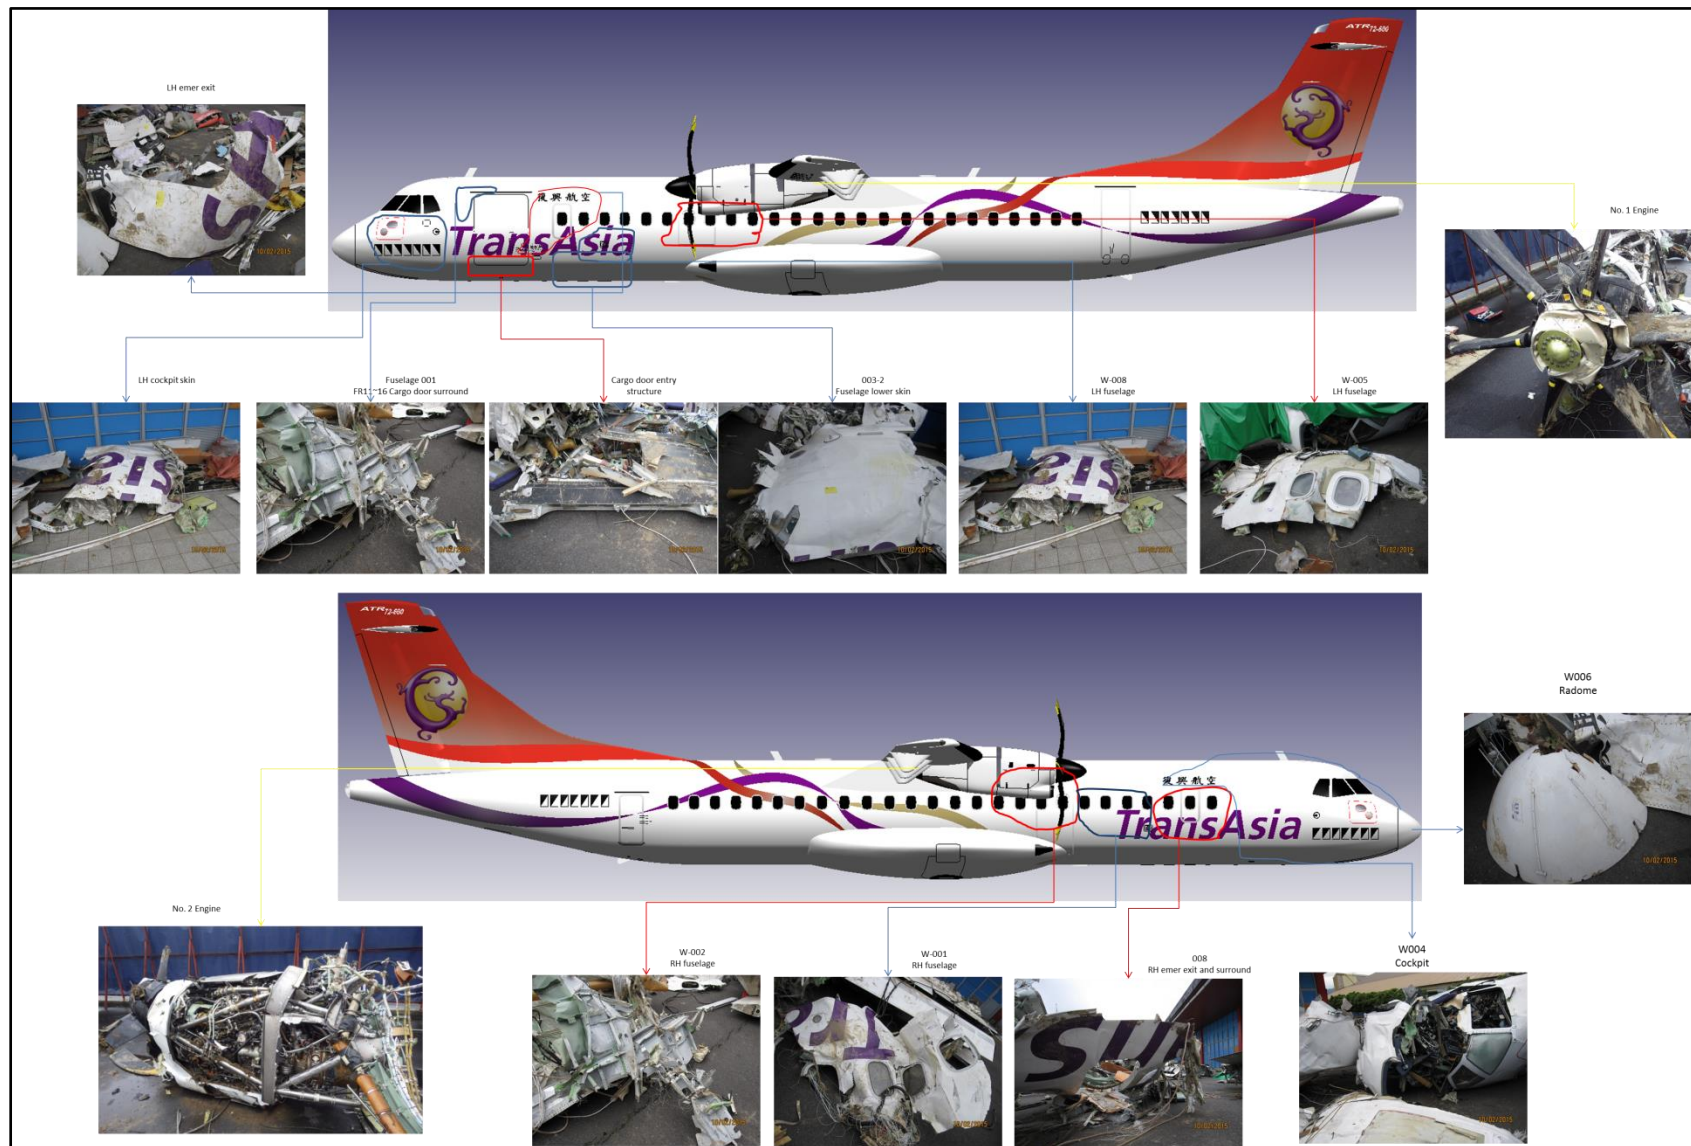
Figure 1.12-3 Recovered aircraft wreckages (2)

Figures 1.12-2 and 1.12-3 identify and map the major sections and components of the aircraft that were recovered. The recovered wreckage represented approximately 85% of the whole aircraft. The remaining unrecovered

15% of the aircraft was primarily in the area aft of the cargo area and forward of the ice shield area.

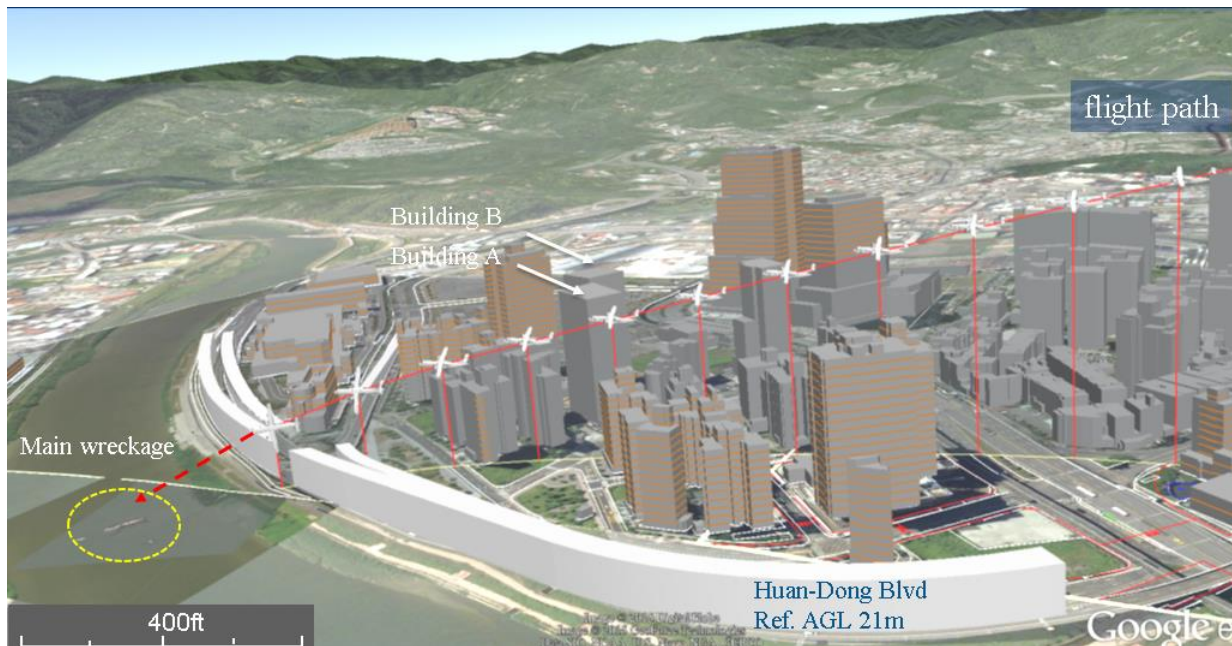
Figure 1.12-6 Aircraft's final trajectory and impact location

The main wreckage was near inverted in the middle of the Keelung River on a heading of about 025 degrees magnetic. The primary wreckage site's reference position was N25°3'48.54", E 121°37'3.13".

Figure 1.12-6 illustrates the aircraft's final trajectory and impact location. The image utilized the FDR derived flight path superimposed on related satellite imagery and ground building models generated from the digital terrain data and aerial photos provided by Taipei City Government's Department of Urban Development. Figure 1.12-7 presents an aerial photo of the accident site taken from a rescue helicopter.

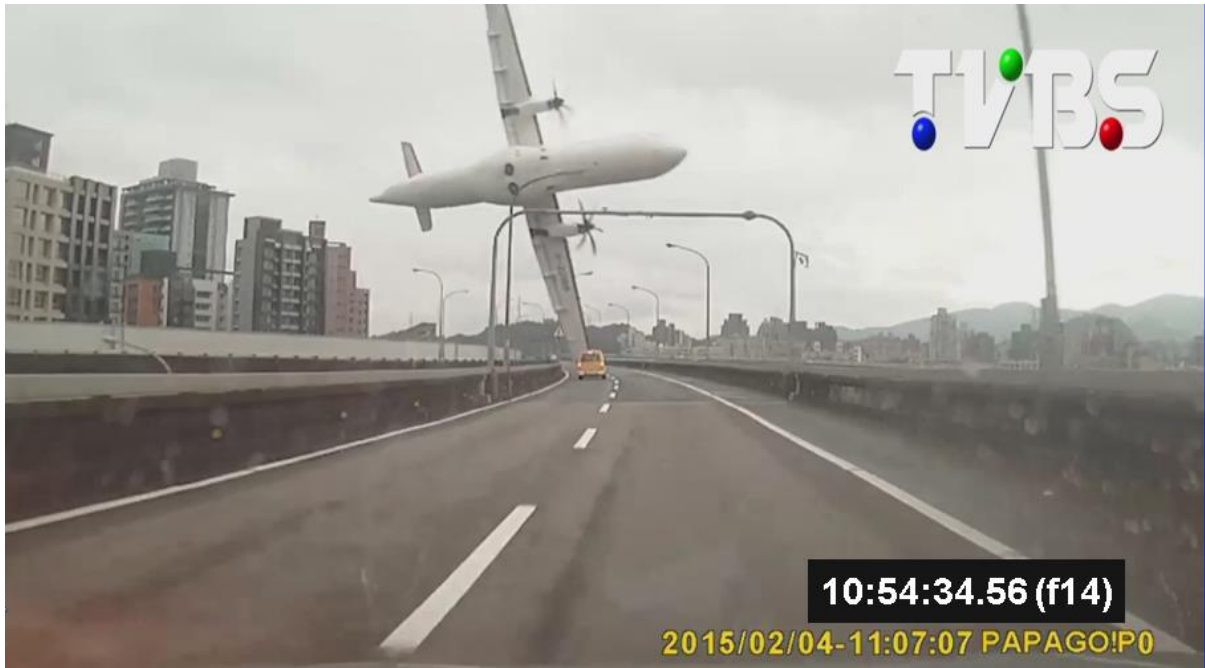
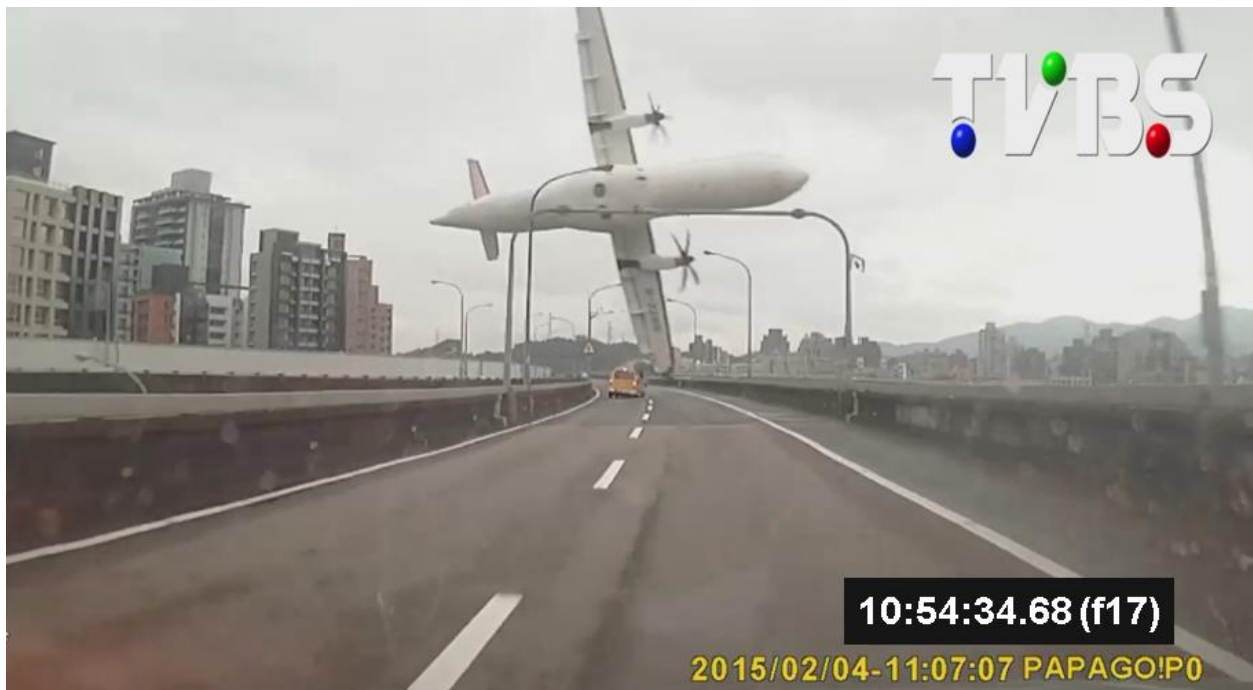
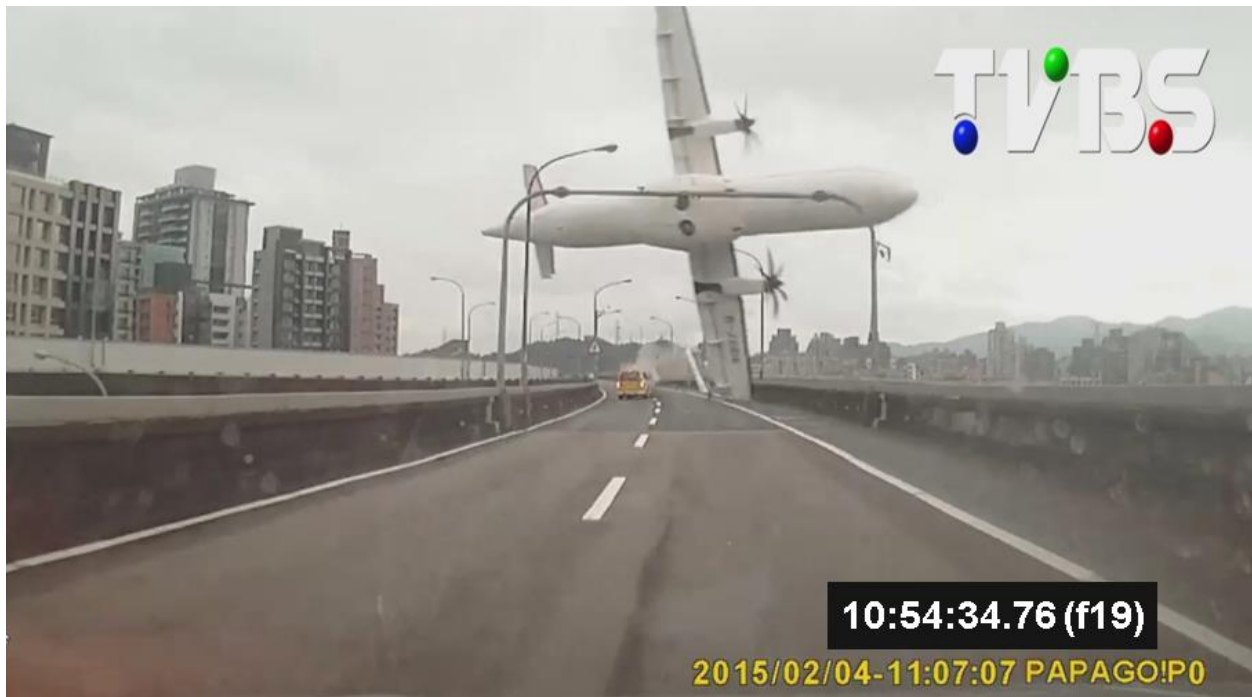
The video frame rate of the vehicles dashboard camera was 25 frames per second, which meant that a frame was equal to 0.04 seconds. Figures 1.12-9 to Figure 1.12-11 present the dashboard camera video images of the aircraft's the final trajectory. In conjunction with the site survey data, the aircraft banked to the left at about 90 degrees as it collided with the taxi on the overpass. The estimated distance between the taxi and the overpass barrier was about 9 meters. Figure 1.12-11 indicated that the aircraft impacted the northern barrier of the Huan-Dong overpass at 1107:07 on the video, which corresponded to a CVR time of 1054:34.76.

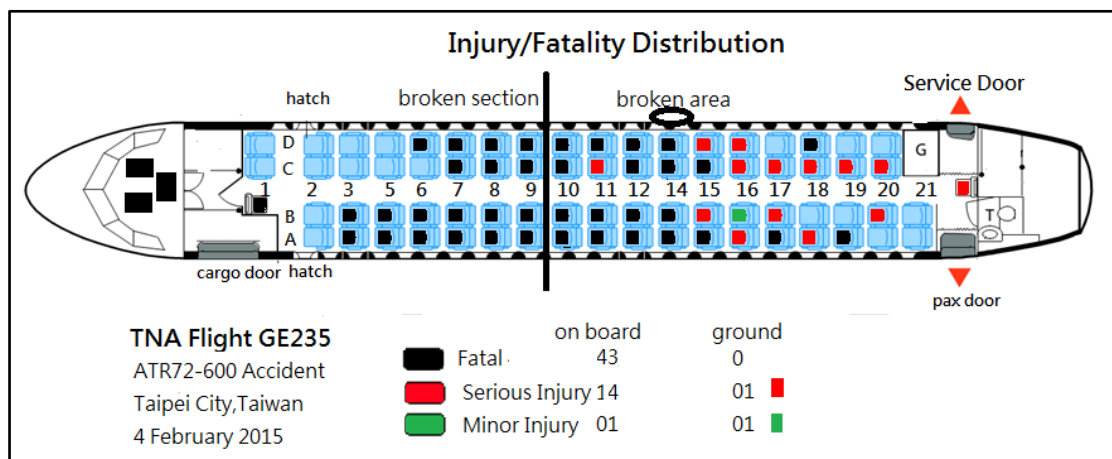
Figure 1.15-1 Injury and fatality distribution

Figure 1.15-1 illustrates the cabin configuration with the passenger and crew injury and fatality distribution. The passenger seating positions were based on the airline seating plan and interviews with the surviving passengers.

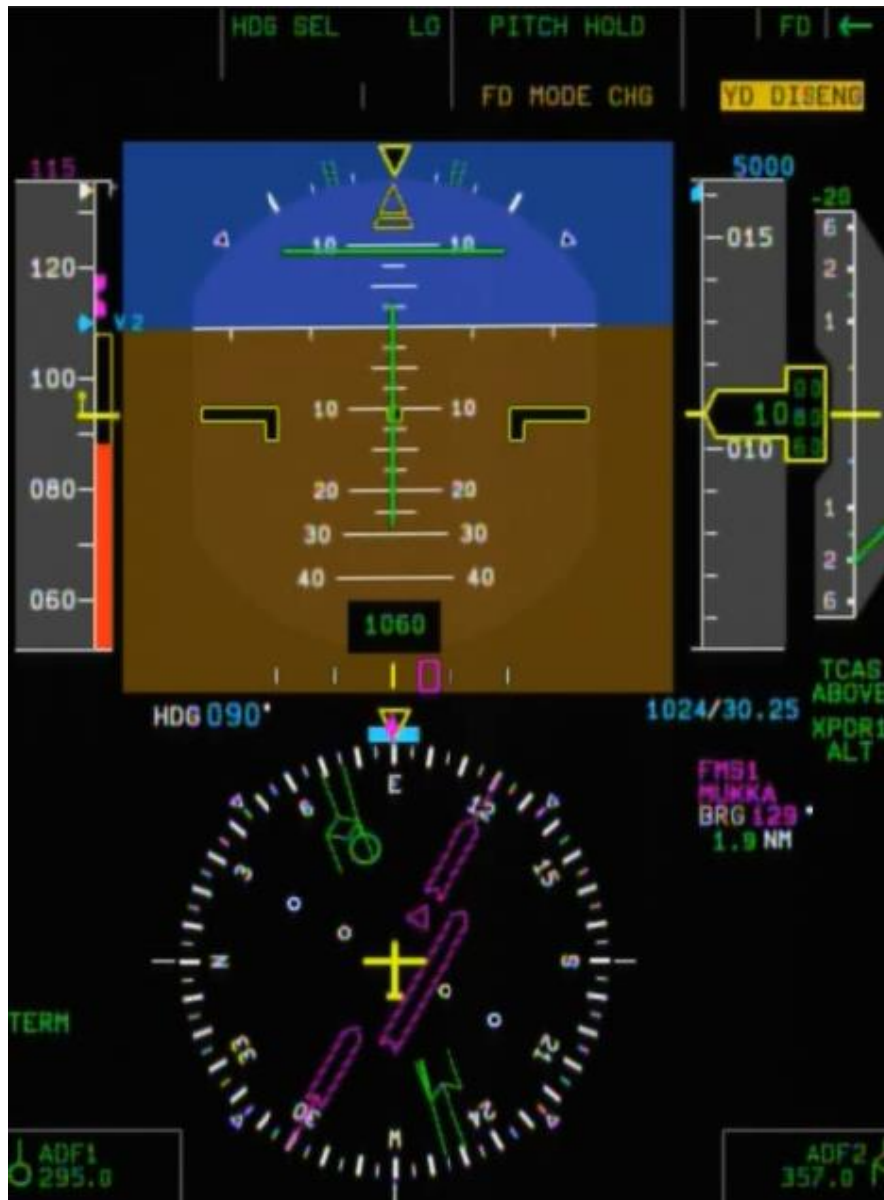
Figure 1.16-1 PFD display while the stick pusher activated

- The stall test results showed that the stick shaker and stick pusher worked as designed. It took approximately 10 seconds and 400 feet of altitude to recover the simulated aircraft from stick pusher activation at 93 knots until the aircraft acquired 118 knots. If the stall recovery maneuver was conducted immediately after stick shaker activation at 99 knots, it took the test crew approximately 6 seconds and less than 100 feet of altitude to recover the aircraft and increase the airspeed to 118 knots. There is another phenomenon has been observed in the stall test; as the FMA vertical mode had previously reverted to "PITCH HOLD" mode, the flight director (FD) bars provided guidance to maintain a pitch target of 8°. When the stick shaker and subsequently the stick pusher activated the aircraft pitch was consequently decreased to approximately 10° nose-down while the FD bars were still showing a nose-up guidance on the primary flight display (PFD) according to the "PITCH HOLD" mode.(Ref Fig. 1.16-1)

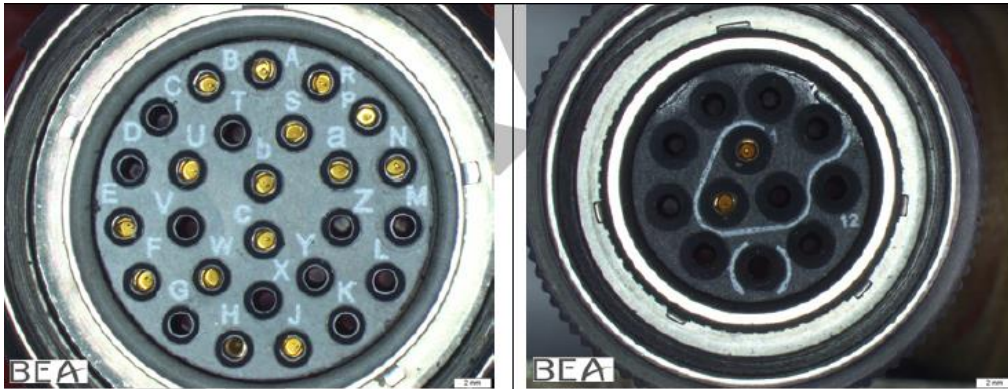
Figure 1.16-7 Connectors of AFU (left) and torque sensor (right)

The wiring harnesses connecting the No. 1 torque sensors to the AFUs of both engines were removed from the occurrence aircraft and dispatched to BEA for further examination. A visual or macroscopic inspection and X-ray examination were conducted. The connection between the torque sensor and the AFU was achieved through (see Figure 1.16-7):

The X-ray examination of both harnesses showed no anomaly. The X-ray pictures of the connectors which connect AFU and the torque sensor of ENG 2 are shown in Figure 1.16-8.

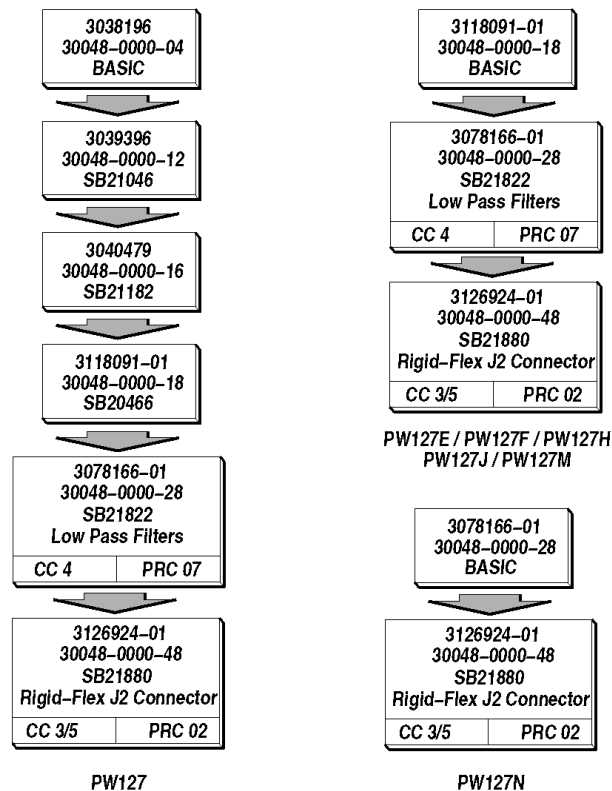
Progression of the Autofeather Control  
Figure 1 (Sheet 1 of 2)

TURBOPROP ENGINE  
AUTOFEATHER CONTROL UNIT - REPLACEMENT/MODIFICATION OF

A. Refer to Figure 1 for parts progression of the autofeather control.
