Interim Report n°3

On the accident on **1st June 2009**
to the **Airbus A330-203**
registered **F-GZCP**
operated by **Air France**
flight AF 447 Rio de Janeiro - Paris

Bureau d'Enquêtes et d'Analyses
pour la sécurité de l'aviation civile

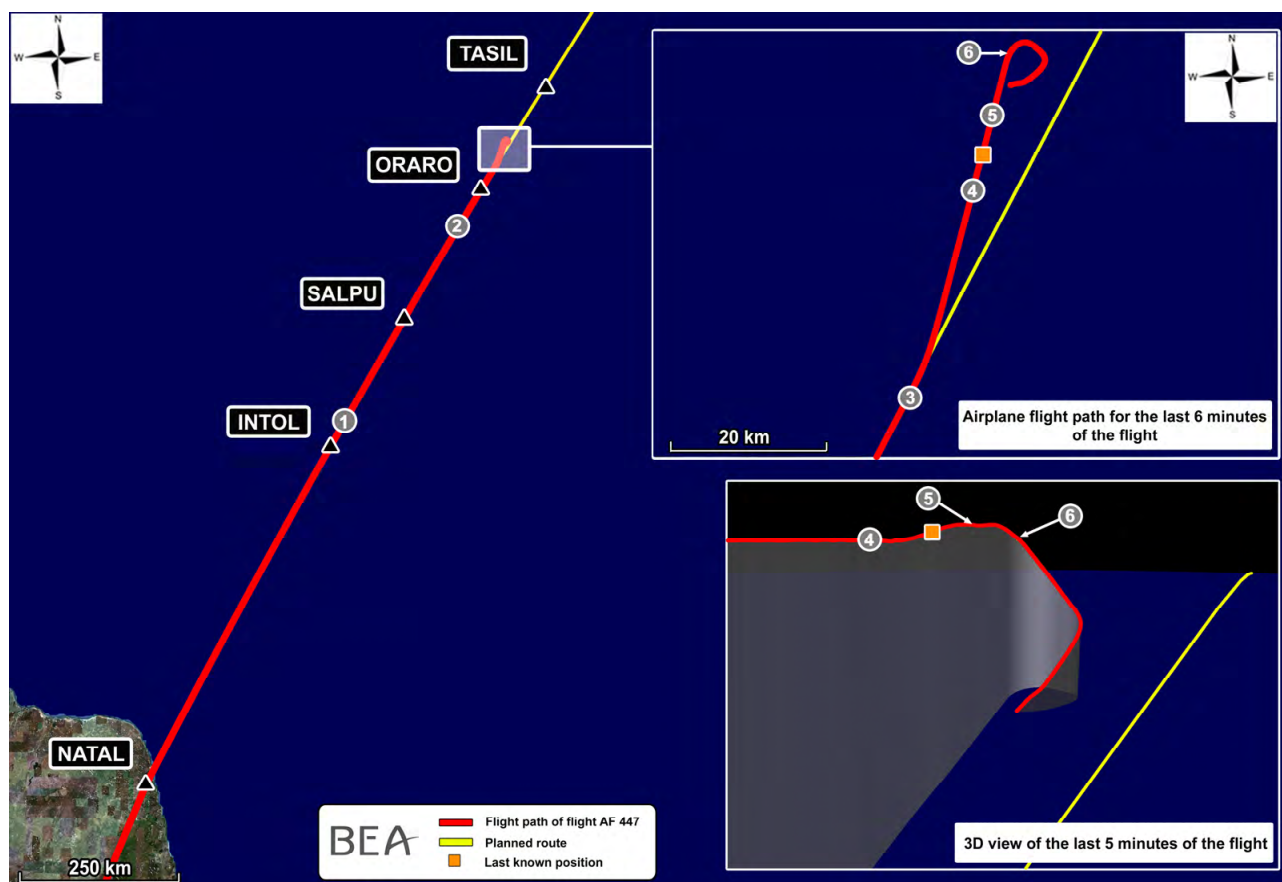
Airplane flight path

The recordings stopped at 2 h 14 min 28 Ⓜ. The last recorded values were a vertical speed of -10,912 ft/min, a ground speed of 107 kt, pitch attitude of 16.2 degrees nose-up, roll angle of 5.3 degrees left and a magnetic heading of 270 degrees.

No emergency message was issued by the crew. The wreckage was found at a depth of 3,980 metres on 3 April 2011 at about 6.5 NM and to the north of the last position transmitted by the aircraft.

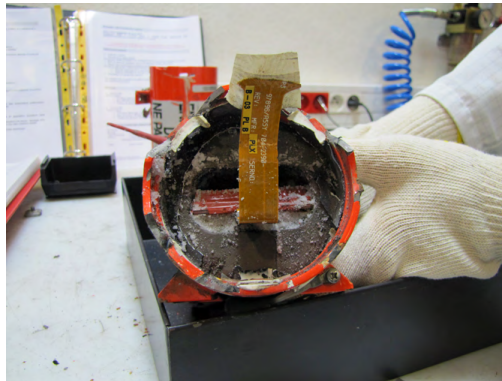
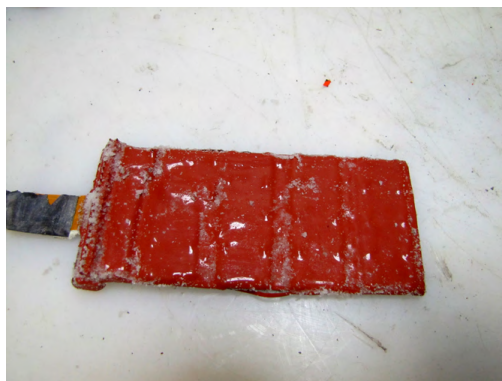
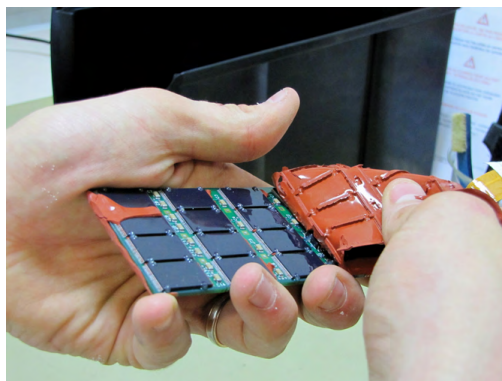
FDR CSMU after removal of cover

FDR memory board

Removal of protective coating

The memory board was cleaned. Visual inspection did not reveal any damage to the board. The board was placed in an oven for 36 hours in order to remove the moisture in the components and the printed circuit board. The impedance measurements that were then made on the input connector were in accordance with the measurements made on reference units.

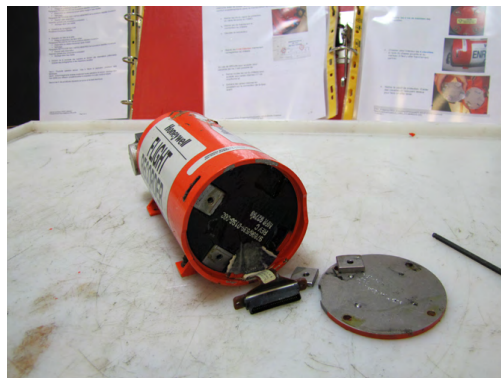
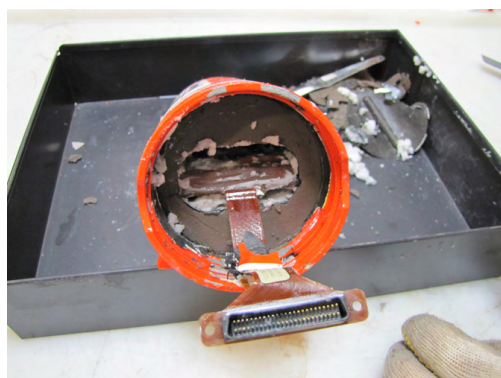
Opening of CVR CSMU

CVR memory board after removal of thermal protections

Visual inspection of the boards revealed damage: a capacitor and a resistor were cracked on one of the boards; two decoder-type components were damaged on the other board.

The boards were placed in an oven for 42 hours. The damaged components were unsoldered and replaced. The impedance value measured at the input connector complied with the measurements made on reference boards.

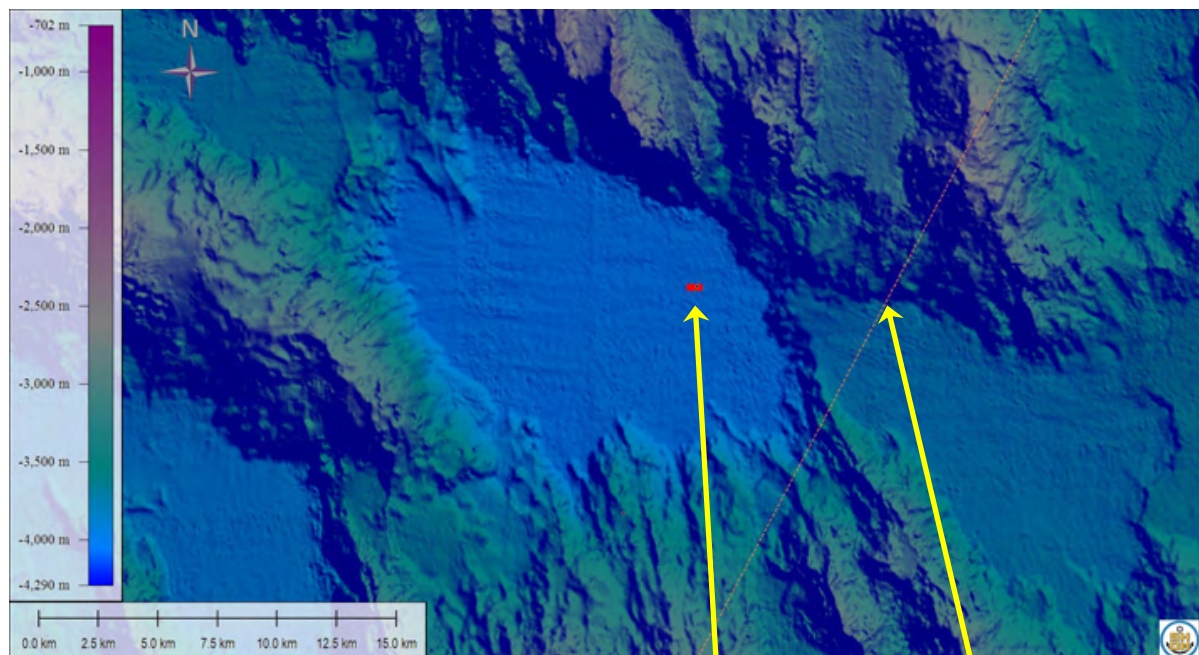
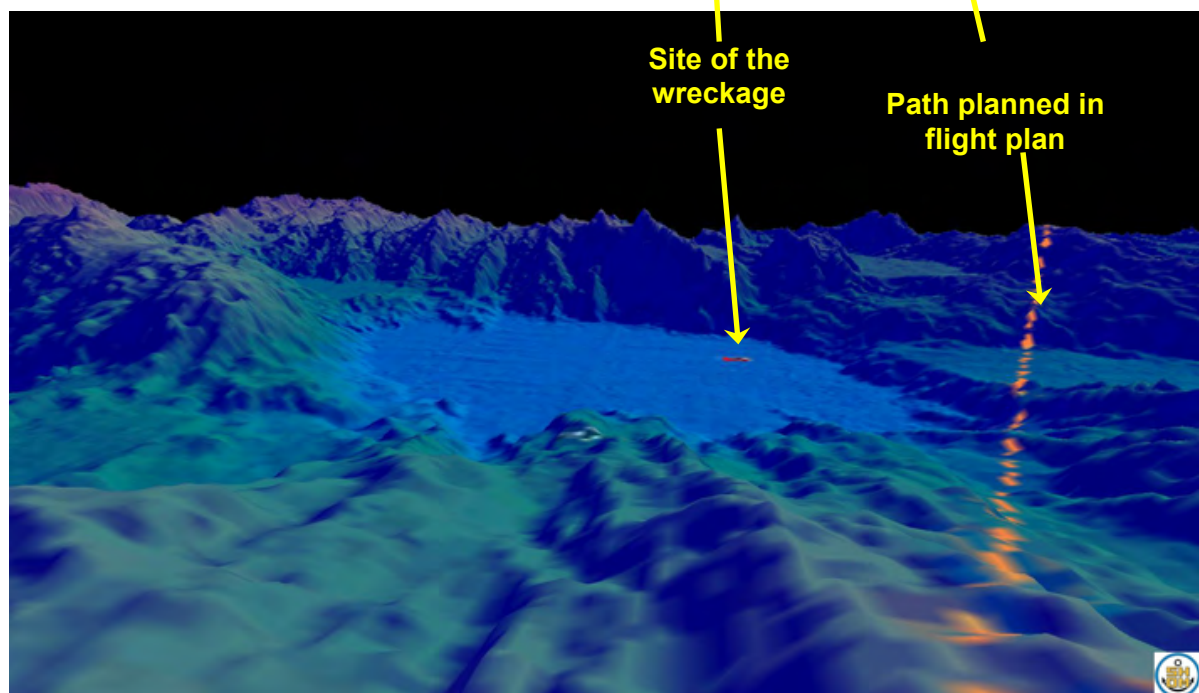
Site of the accident

The wreckage rested on an abyssal plain at a depth of 3,980 metres. This plain, surrounded by terrain, made of a clay type sediment, was around 15 km wide and was located west of the scheduled airplane flight path.

The densest debris (central section, engines, APU, landing gear) was found to the east of the site and the lighter debris to the west.

Outside the main area of 600 metres by 200 metres, a rear left fuselage panel containing eleven windows and around seven metres long was found approximately two kilometres south-west of the area. Part of the lower surface of the trimmable horizontal stabiliser was also found slightly to the south-west of this area.

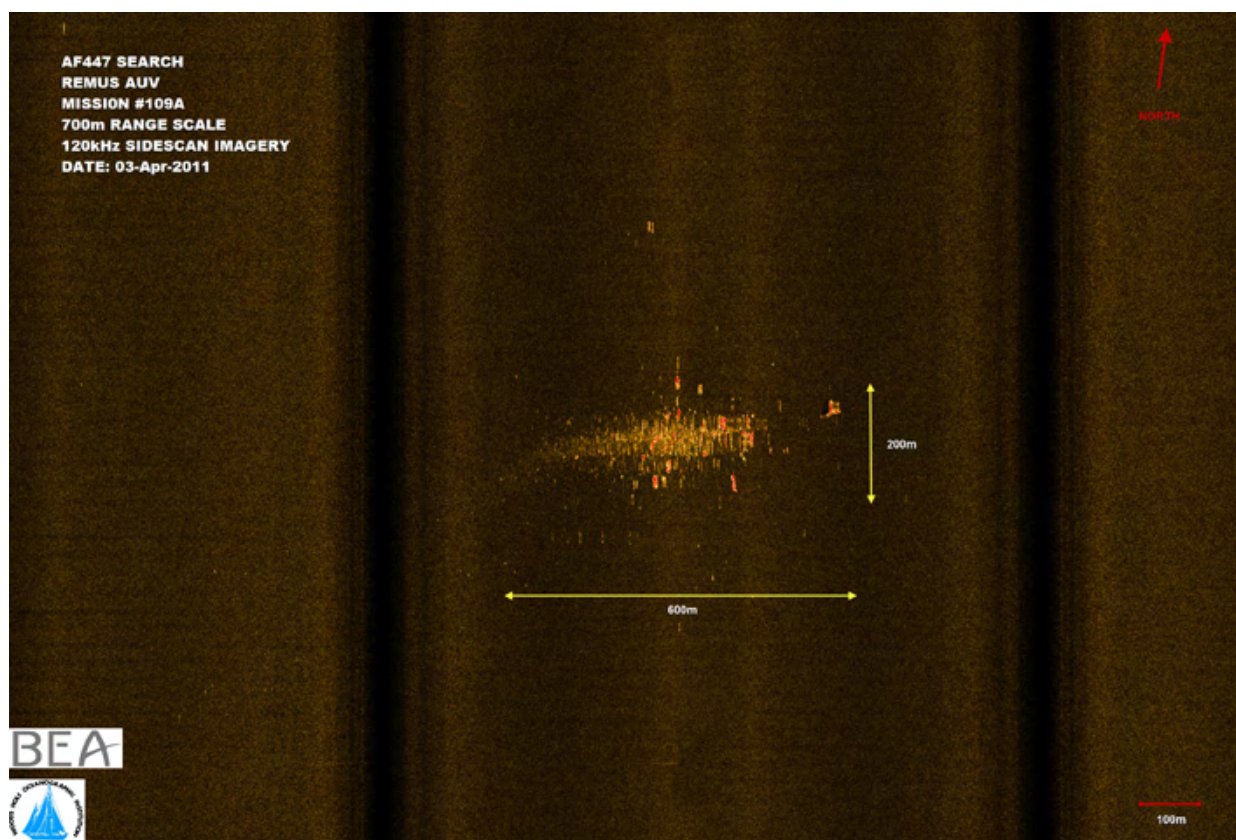
General view using sonar imaging: 120 kHz, range of 700 m

The first passage highlighted a bottom feature of backscattered data on an area of around 600 metres by 200 metres.

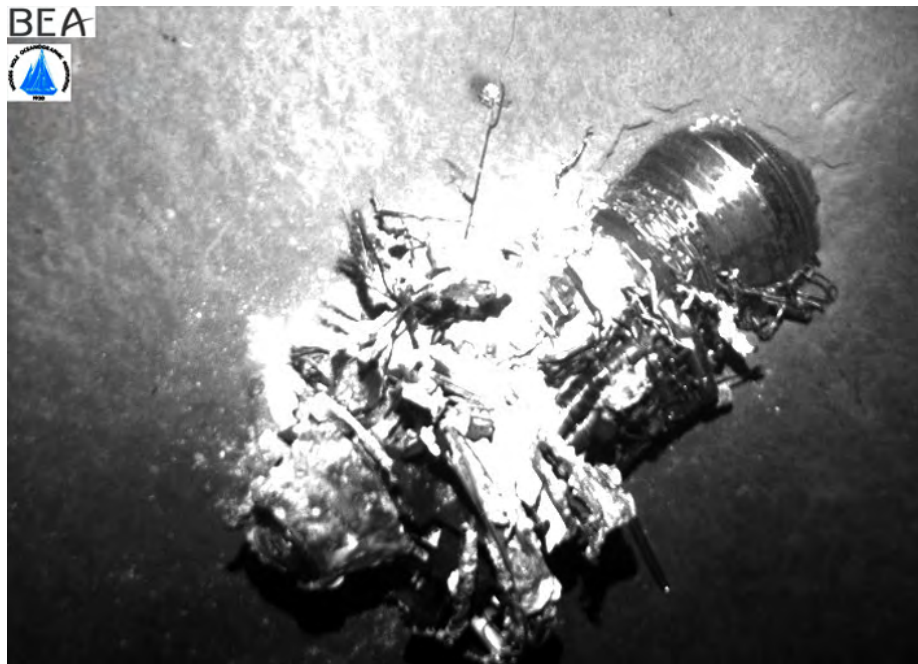
Engine

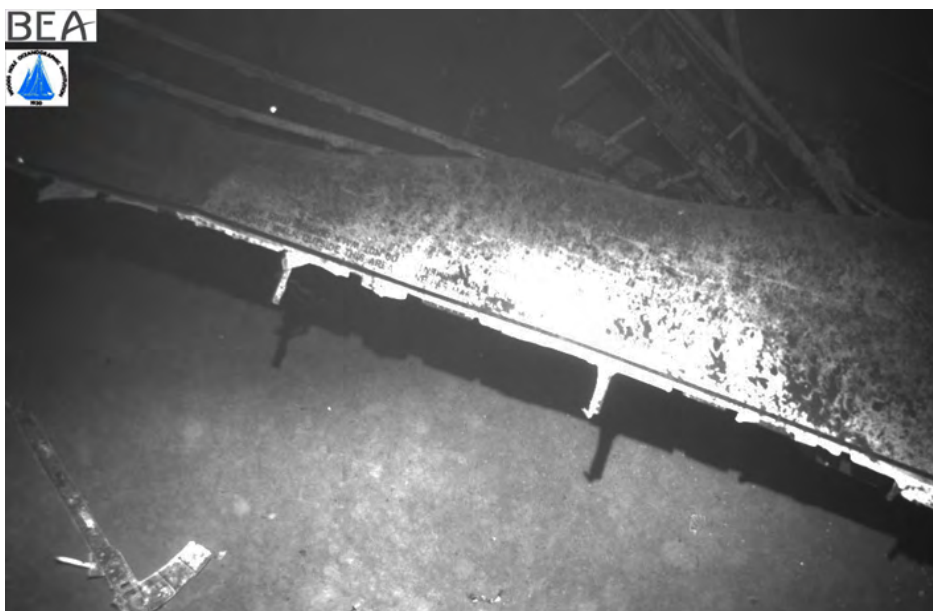
Wing

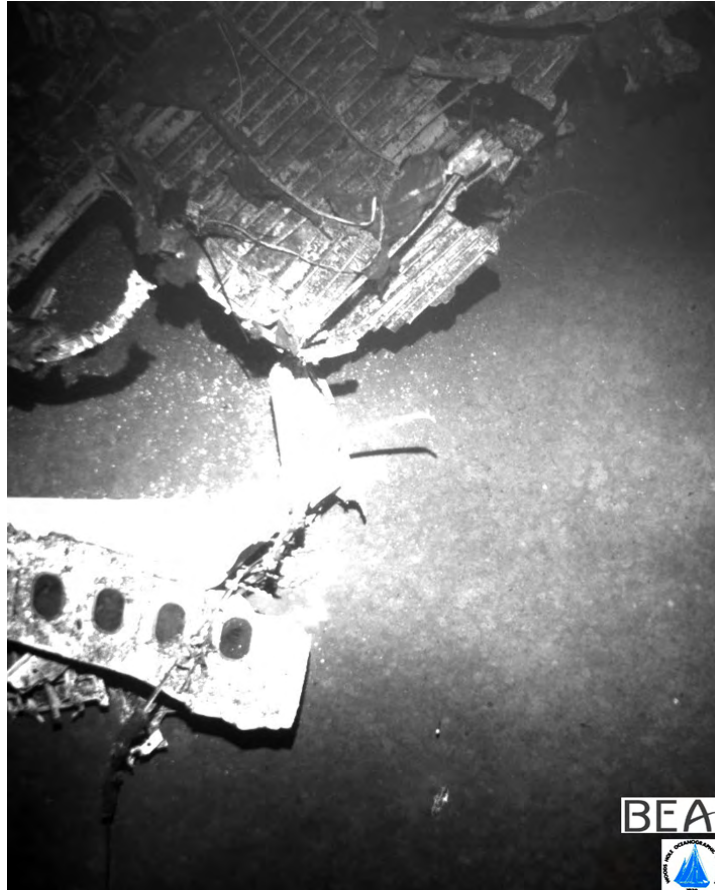
Section of fuselage

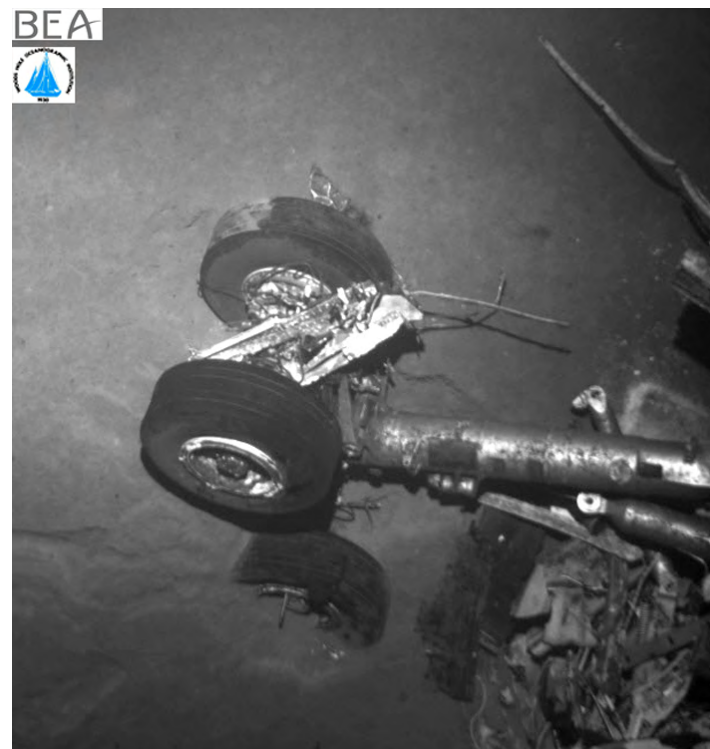
Landing gear

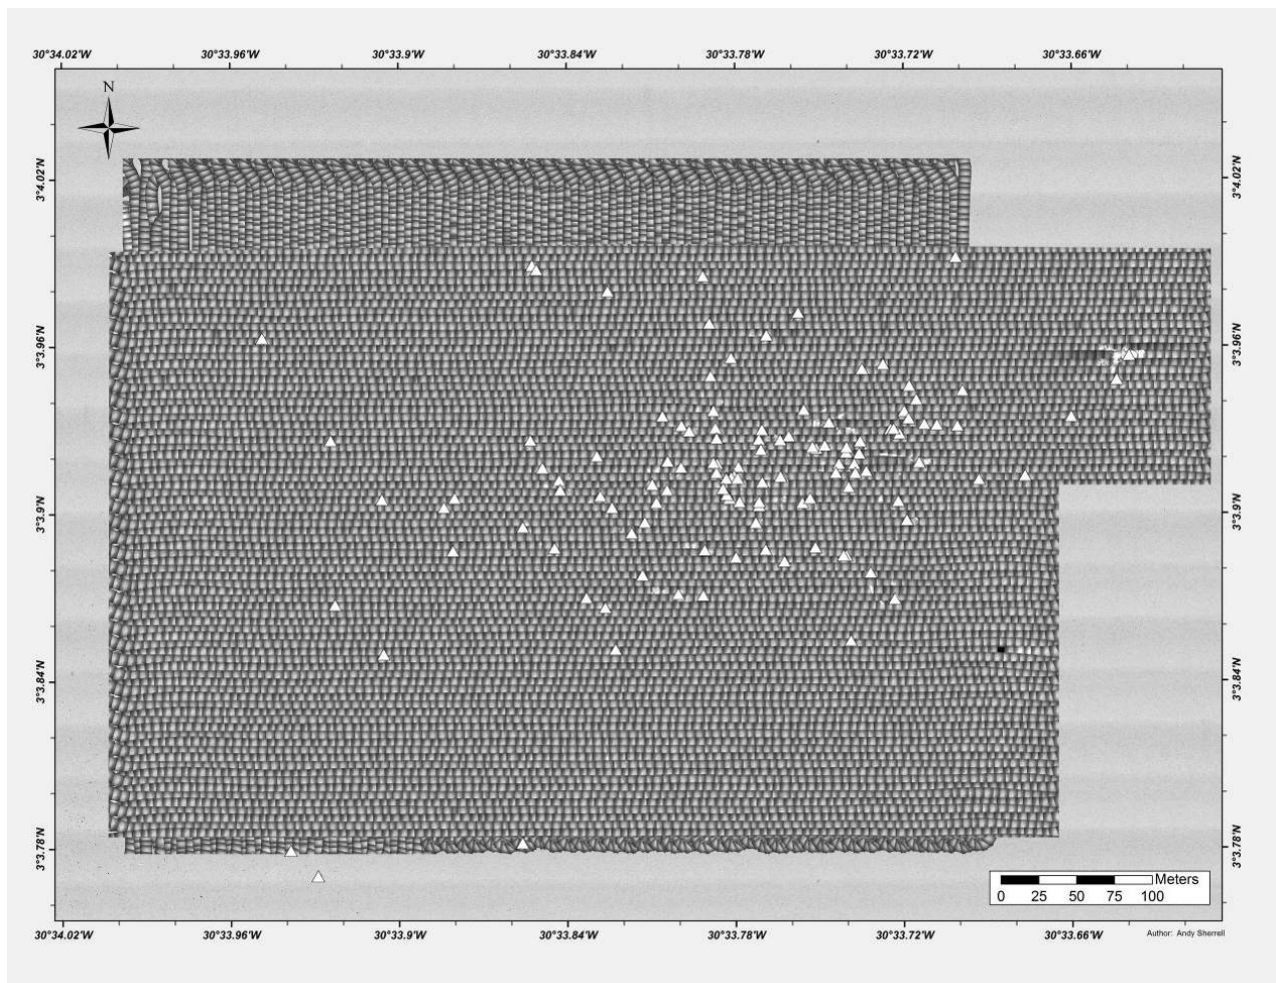
*Visualisation of the photo mosaic obtained with REMUS AUV images
and the airplane debris identified by using the REMORA ROV*
